Year 1 Monitoring Report for Stream Restoration of Thompsons Fork and Unnamed Tributary

McDowell County, NC
SCO # D06030-A

Submitted: December 2009

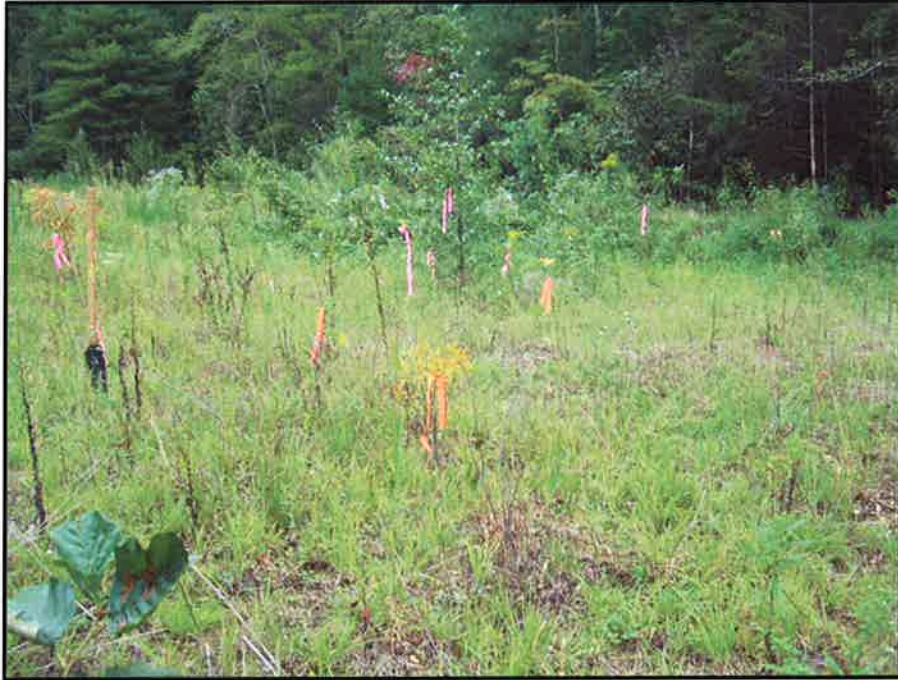
VPA 3

Several areas along the unnamed tributary were noted to have low overall herbaceous cover along the riparian corridor on the right bank. These areas are patchy and scattered throughout the corridor, with none of the areas showing banks that are completely bare. However, due to the threat by invasive species in the same areas along the tributary, particularly *Sericea lespedeza*, the sparse vegetation is noted as an area of concern. If the herbaceous cover does not increase, the open patches will provide an avenue for colonization and spread of the invasive species. The coverage of herbaceous vegetation and the spread of *Sericea lespedeza* along the right bank of the tributary are considered areas of low concern at this time, and will therefore be watched during future years of monitoring. In addition, proactive management in the form of herbicide treatments were conducted on the *lespedeza* throughout the fall, with follow-up planned for the spring, to limit the impact of this species on the vegetative success of the project.

**View of the patchy vegetation along the right bank of UT1. This is only considered a problem due to the threat of spread by *Sericea lespedeza* in the same area of the project.
(EMH&T, Inc. 9/18/09)**
