Town Creek Restoration Project – Option B Year 4 Monitoring Report

Stanly County, North Carolina

DMS Project ID Number – 95026; NC DEQ Contract No. 003990

Report Prepared and Submitted by Michael Baker Engineering, Inc.

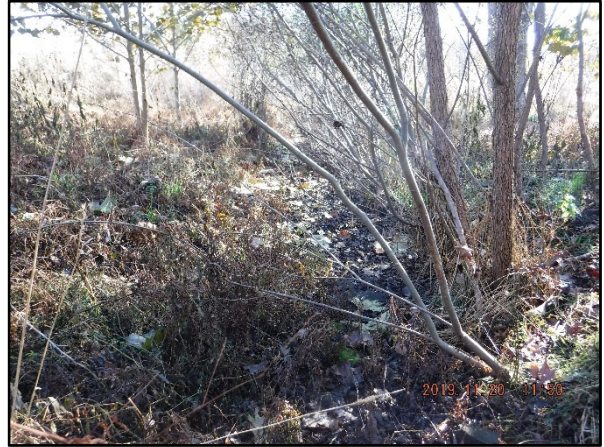
PID 36: Station 43+25 – Downstream (11/20/19)

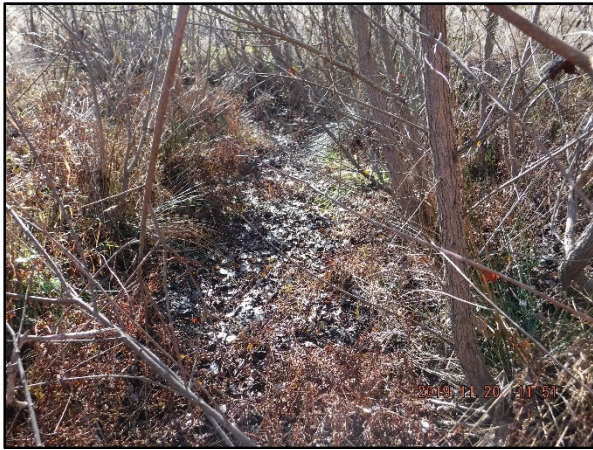
PID 37: Station 44+25 – Downstream (11/20/19)

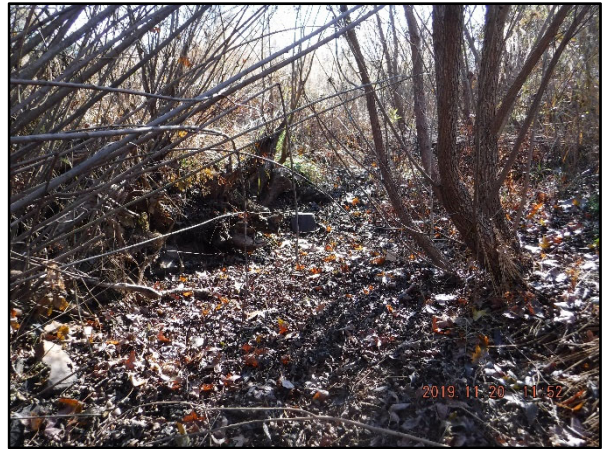
PID 38: Station 45+30 Downstream (11/20/19)

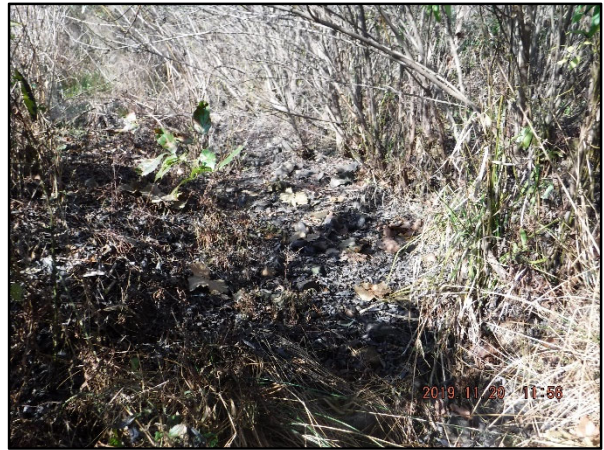
PID 40: Station 46+90 – Upstream (11/20/19)

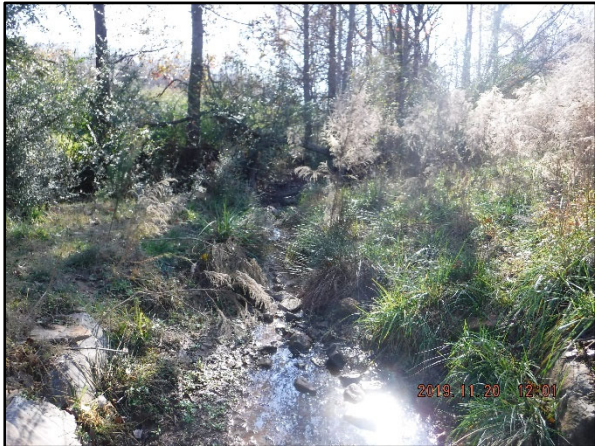
PID 43: Station 48+05 – Downstream (11/20/19)

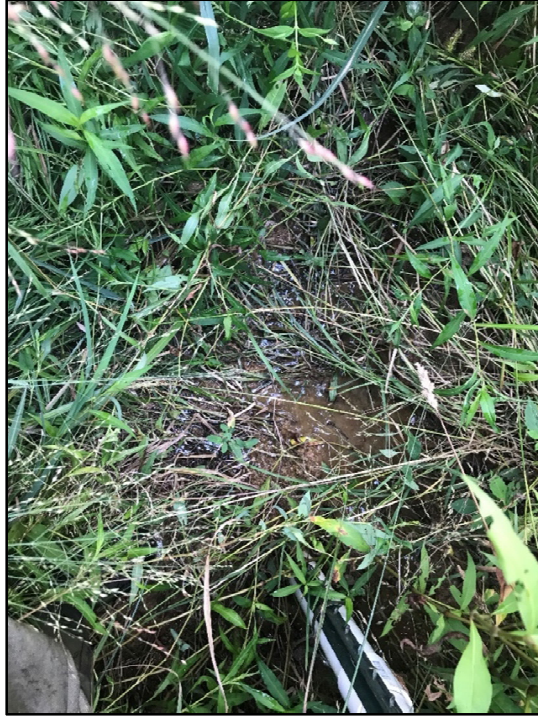
Flow Documentation Photo – Located at TCFL 2 (7/26/2019)
