**YEAR 2 of 5 Monitoring Report  
Tributaries of Wicker Branch Stream Restoration  
Union County, North Carolina  
DMS Project Number: 95022  
Contract No: 003982  
USACE Action Id No: SAW 2013-01680**

**Data Collection Period October 2015  
Submitted: January 2017**

**AECOM**

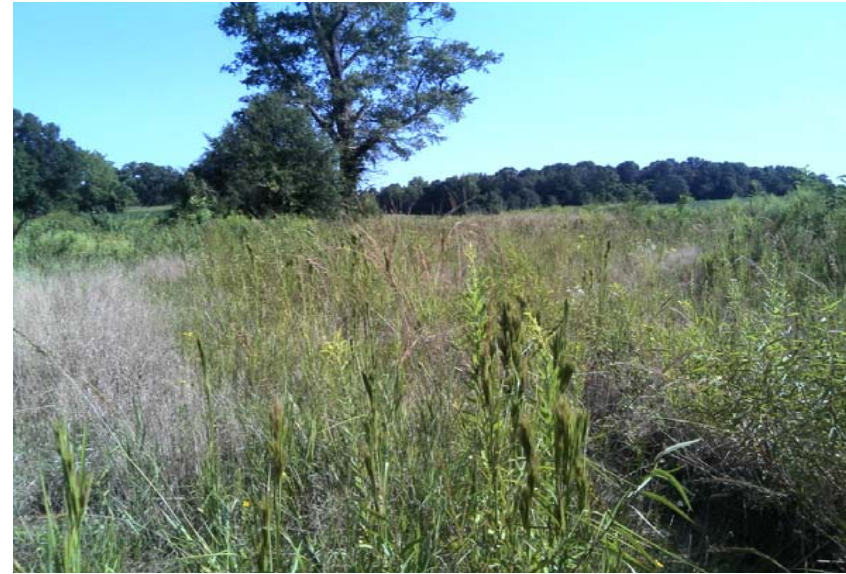
Photo: Cross-section 3 looking upstream

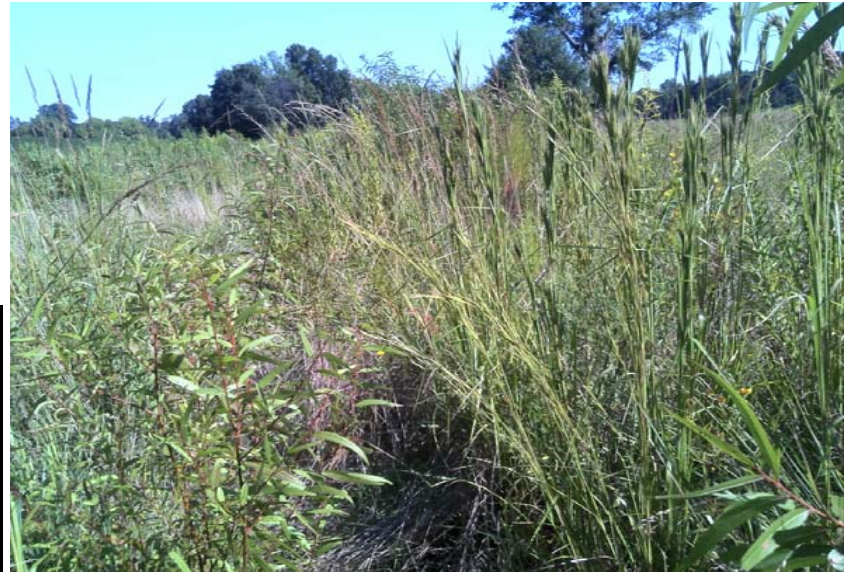
Photo: Cross-section 4 looking upstream

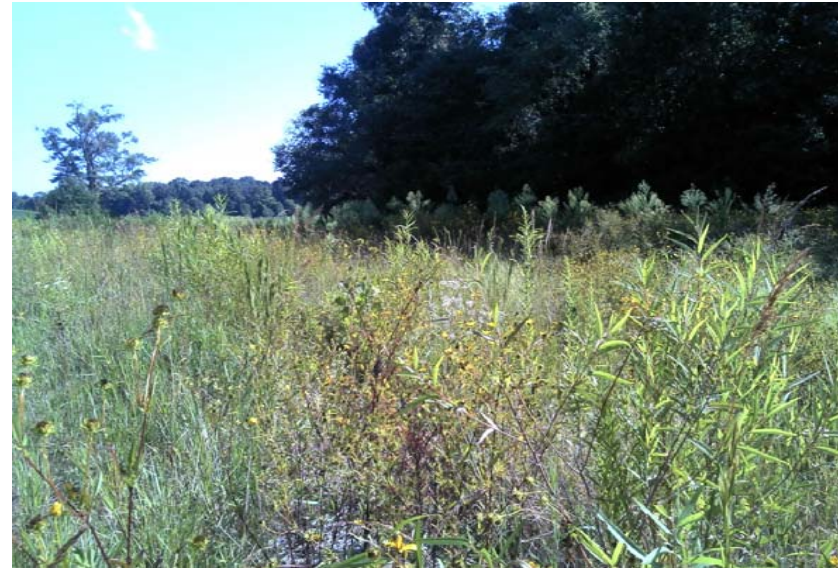
Photo: Cross-section 5 looking upstream

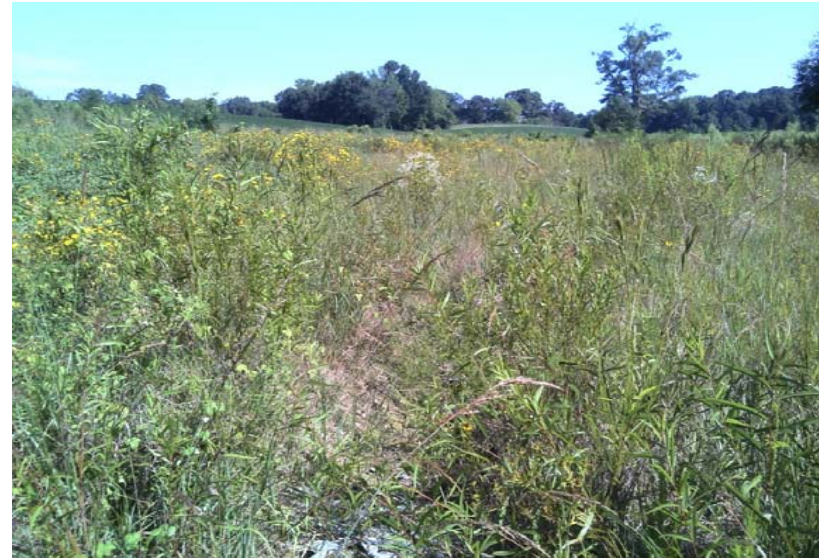
Photo: Cross-section 6 looking upstream

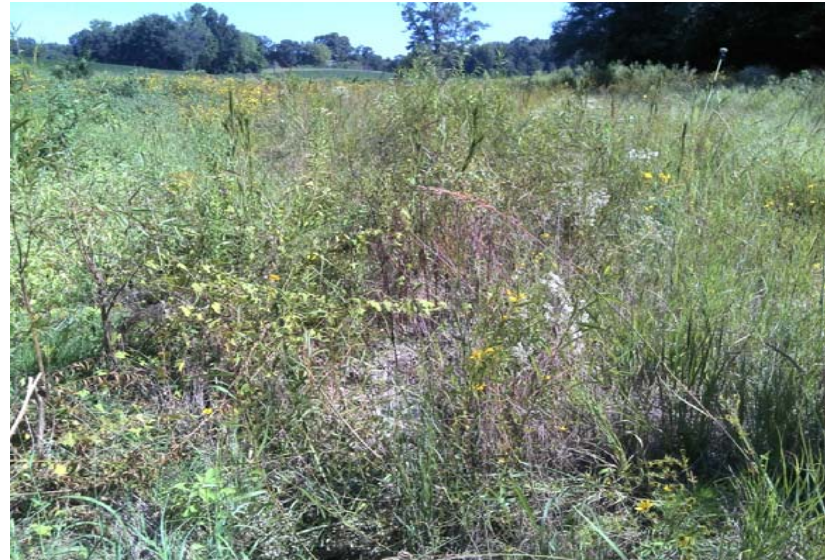
Photo: Cross-section 7 looking upstream

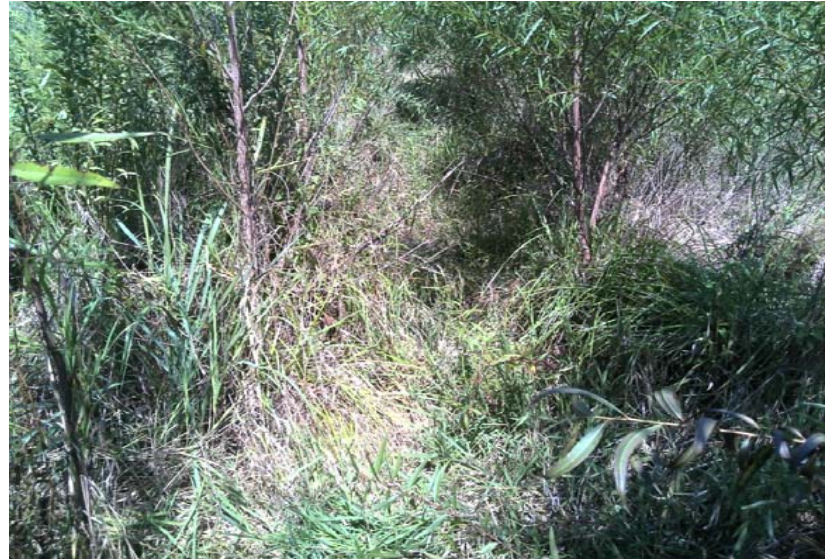
Photo: Cross-section 8 looking downstream

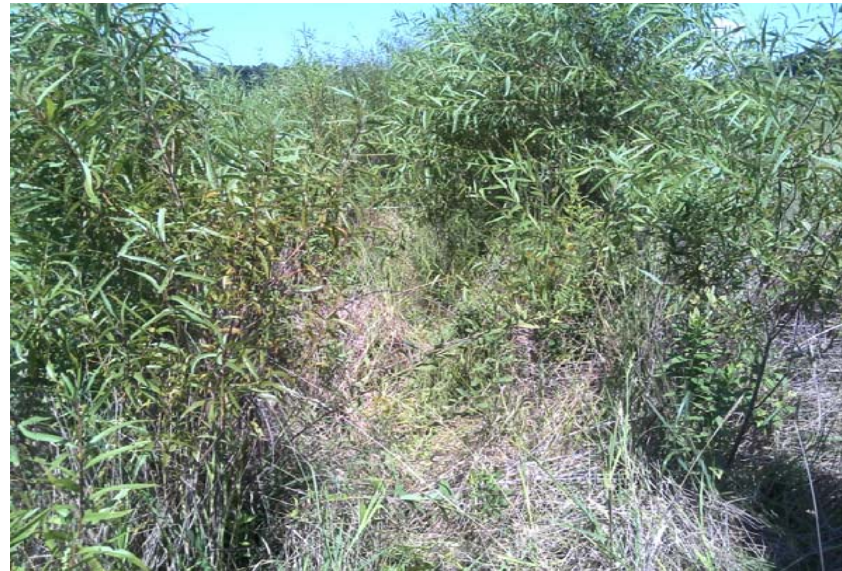
Photo: Cross-section 9 looking upstream

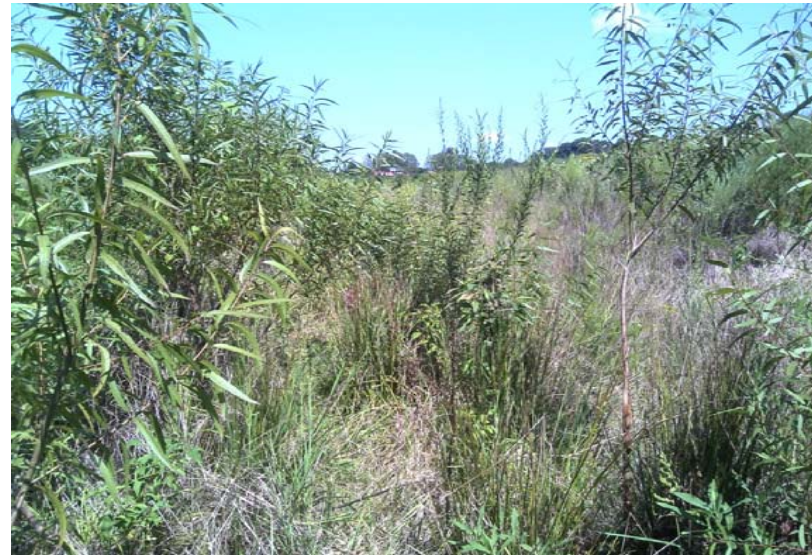
Photo: Cross-section 10 looking upstream

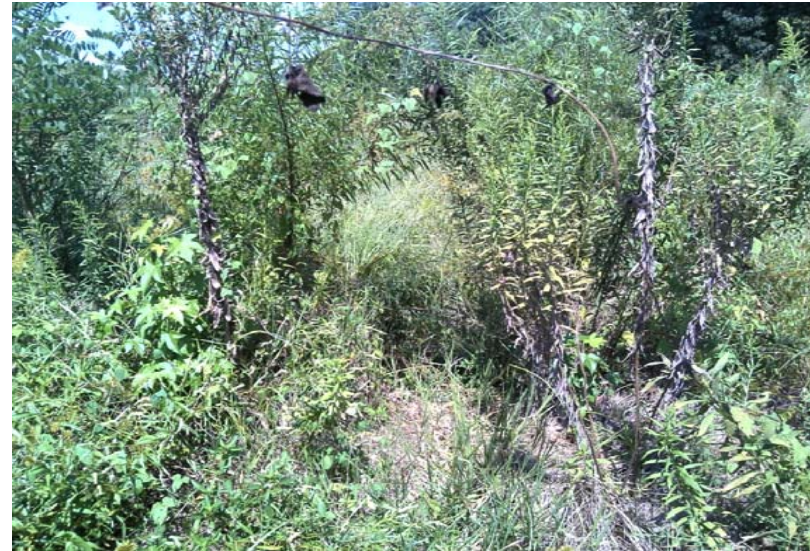
Photo: Cross-section 11 looking upstream

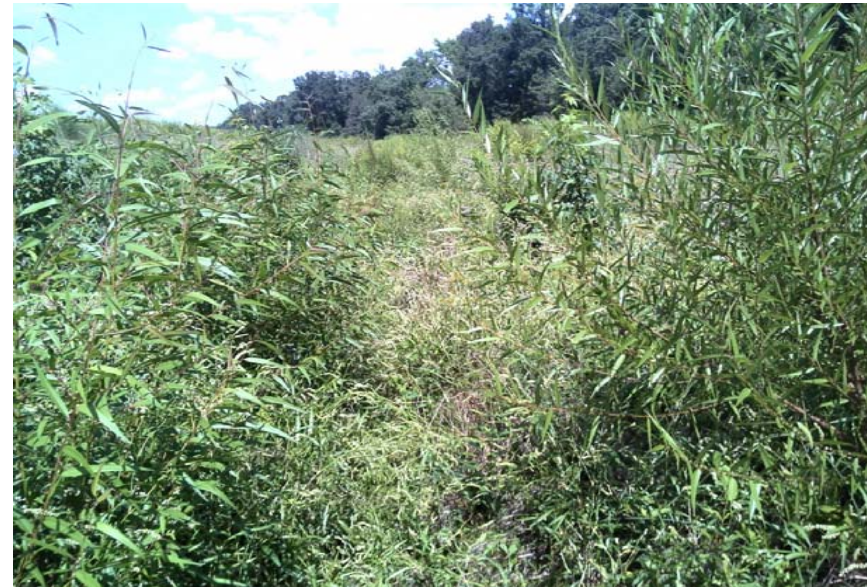
Photo: Cross-section 12 looking upstream
