**YEAR 4 of 5 Monitoring Report
Tributaries of Wicker Branch Stream Restoration
Union County, North Carolina
DMS Project Number: 95022
Contract No: 003982
USACE Action Id No: SAW 2013-01680**

YEAR 4 of 5 Monitoring Report
Tributaries of Wicker Branch Stream Restoration
Union County, North Carolina
DMS Project Number: 95022
Contract No: 003982
USACE Action Id No: SAW 2013-01680

RE: Year 4 (2018) Monitoring Report the Tributaries of Wicker Branch Project (DMS Project # 95022)

To	Harry Tsomides, DMS Project Manager	Page	1
CC			
Subject	Tributaries of Wickers Branch – 10/16/2018 Site Visit Comments		
From	Ron Johnson		
Date	January 23, 2019

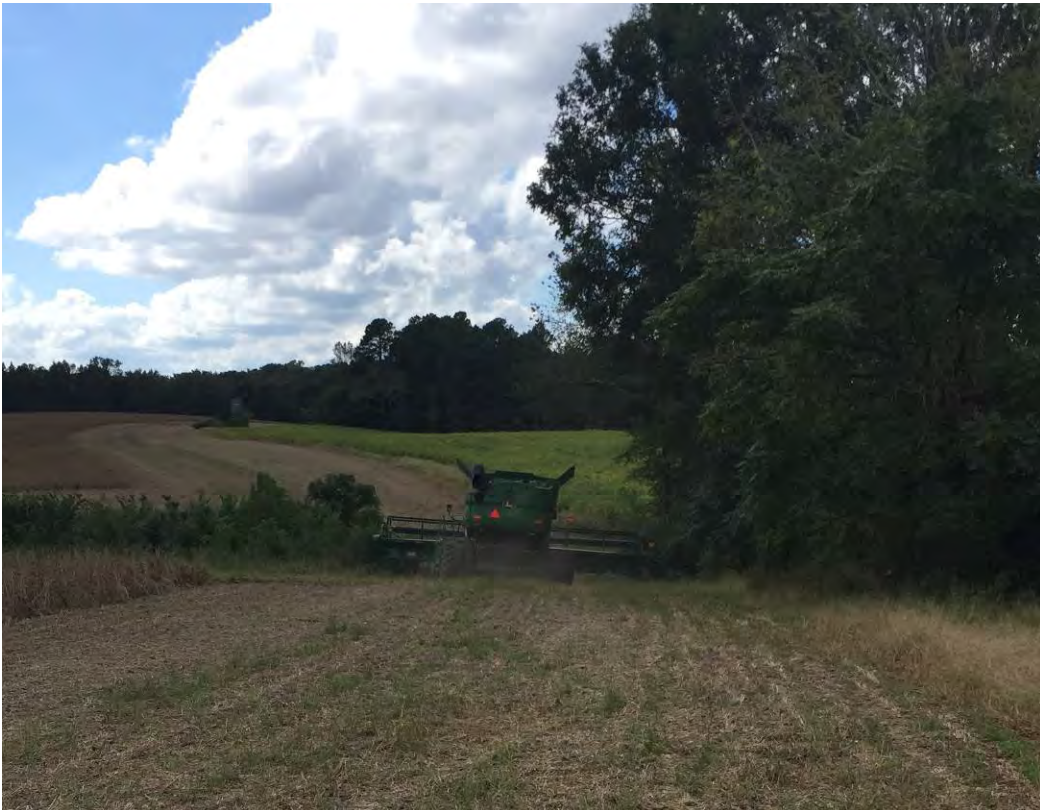
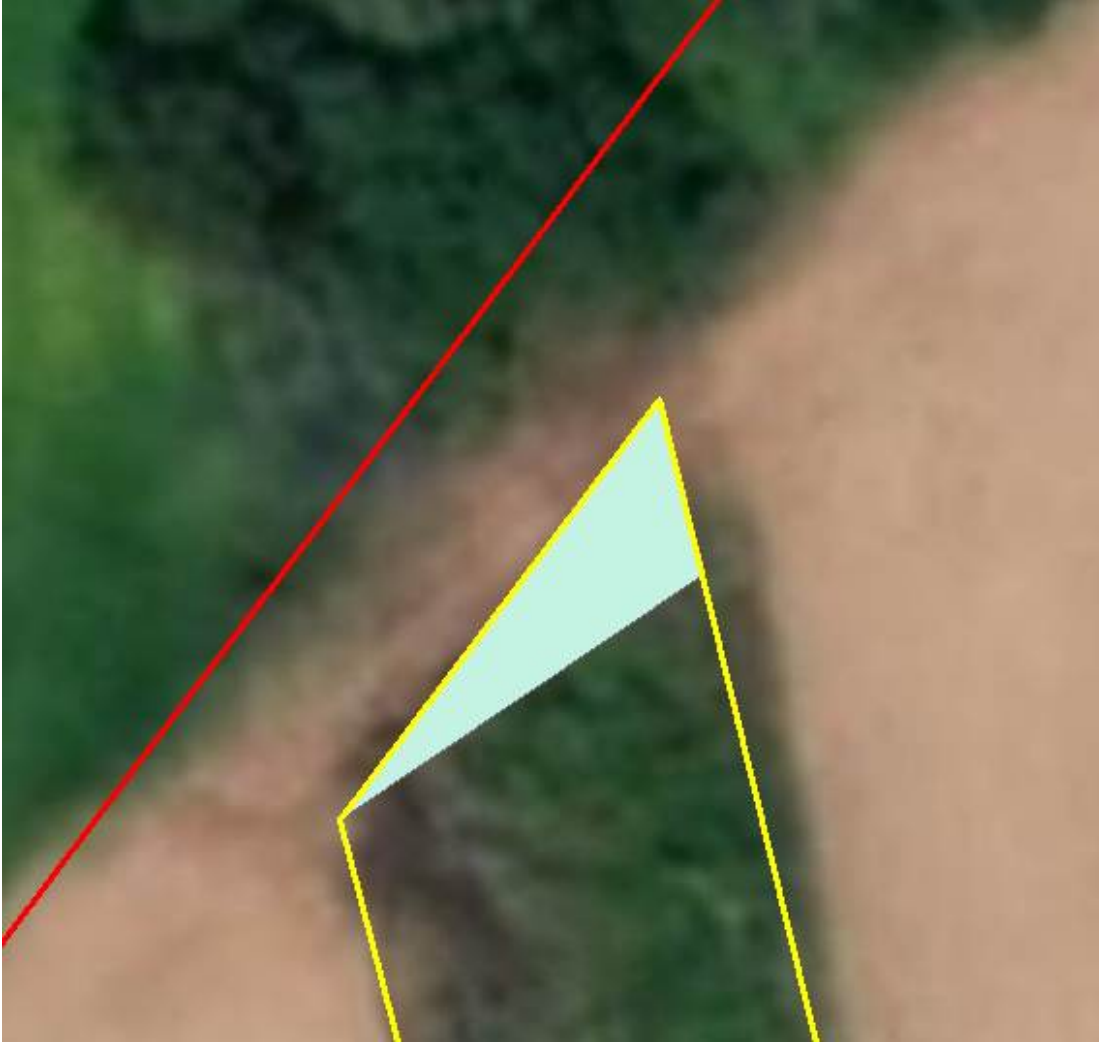
Easement encroachment – Clipping of crossing corners. What is being done to rectify this? This was noted in the MY03 report as an issue in progress with the landowner. What is the current status?

The above photo depicts the location of the corner of the easement at the top of Tributary 2 in relation to the treeline. The Yellow Line is the far (northeast) corner of the easement and the wood post with the sign is the northwest corner. There is sufficient room at the northeast corner but not at the southeast corner. The photo below shows the farm equipment crossing the easement.

Expanding (or clearing) the crossing to the property line to allow for full use of the crossing would require removal of several large trees.

AECOM would like permission to modify the easement to allow adequate room for the equipment. We would work with the farmer to determine the exact distance but anticipate that it would look something like the photo above. The above photo shows reducing the length of the easement by about 35 feet on one side and maintaining it on the other. This would reduce the easement by about 1530 square feet or 0.035 acre. It should be noted that the easement in this area is not actually buffering an asset. Tributary 2 is an ephemeral feature that does not generate any stream credits.

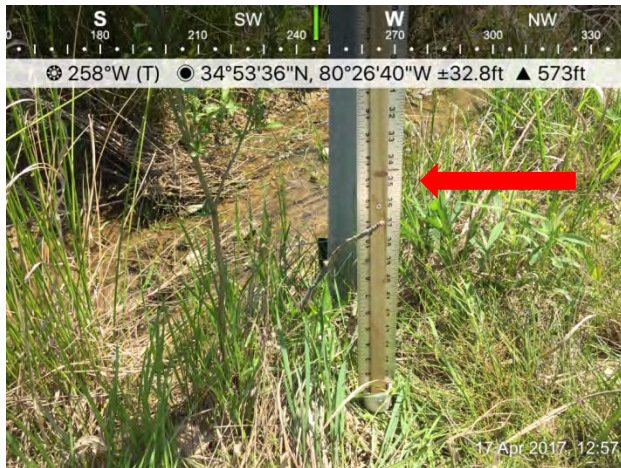
Tributary 1 Crest Gauge 4/17/2017

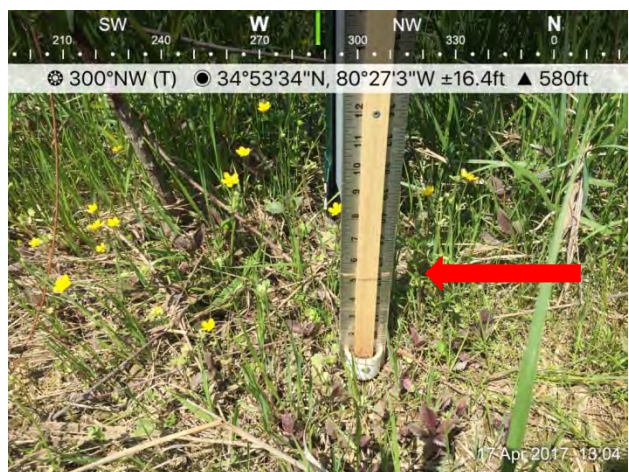
Tributary 3 Crest Gauge 4/17/2017

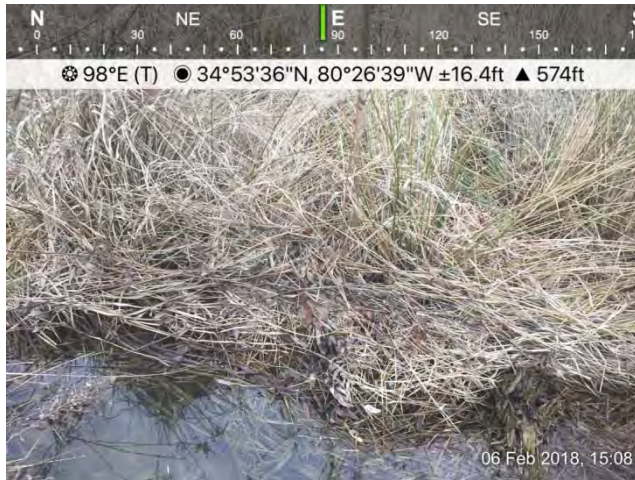
Tributary 1 wrack lines 2/6/2018

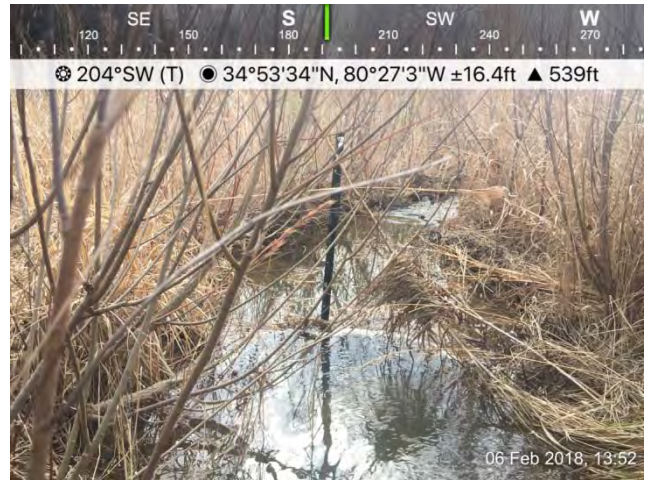
Tributary 3 wrack lines 2/6/2018
