# **Year 4 Monitoring Report**

## **Tulula Stream & Wetland Restoration**

**January 2007**  
**EEP Project No. 392**

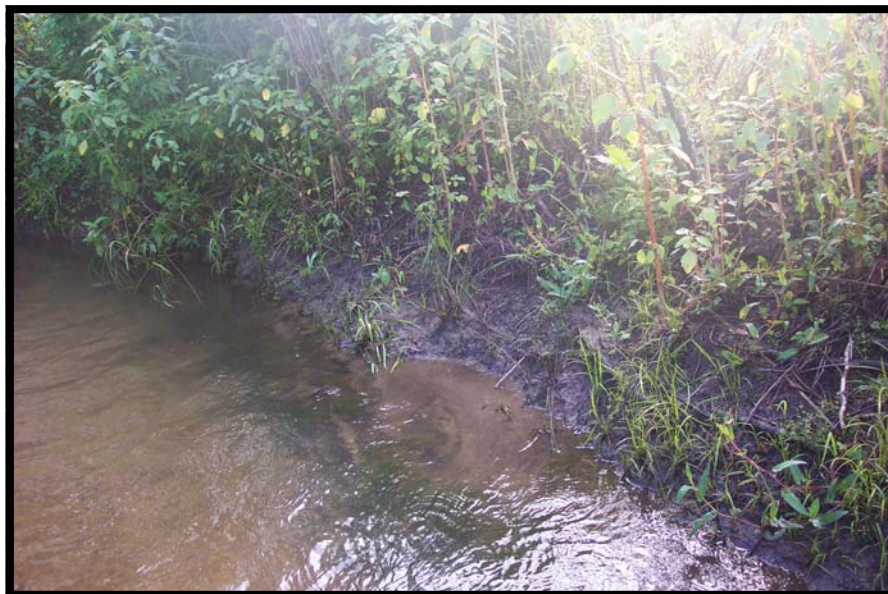
During a field inspection in November, 2006, several areas of bare streambank were observed. It is believed this area is due to excessive wildlife grazing and/or undercutting banks. Representative photos are included in Appendix A.

Figure 1— Bare Bank 1

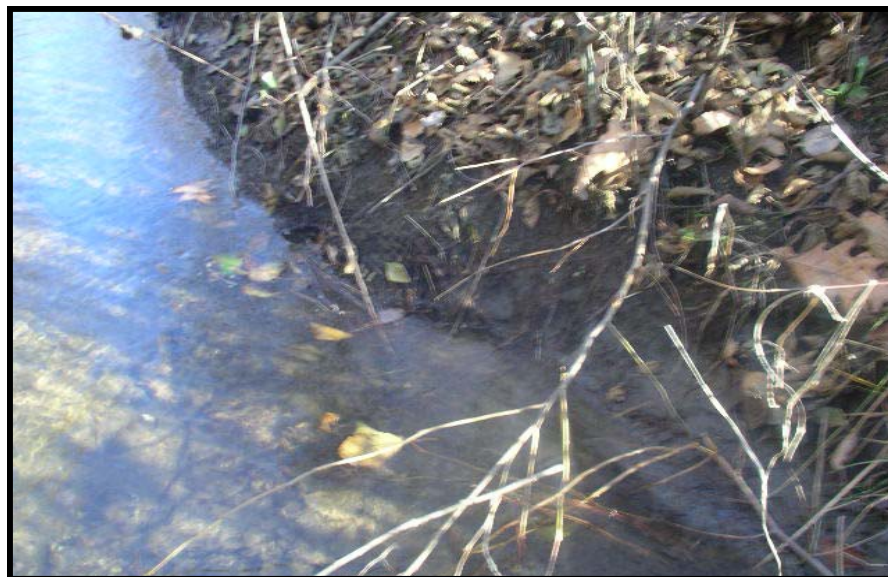
Figure 2— Bare Bank 2

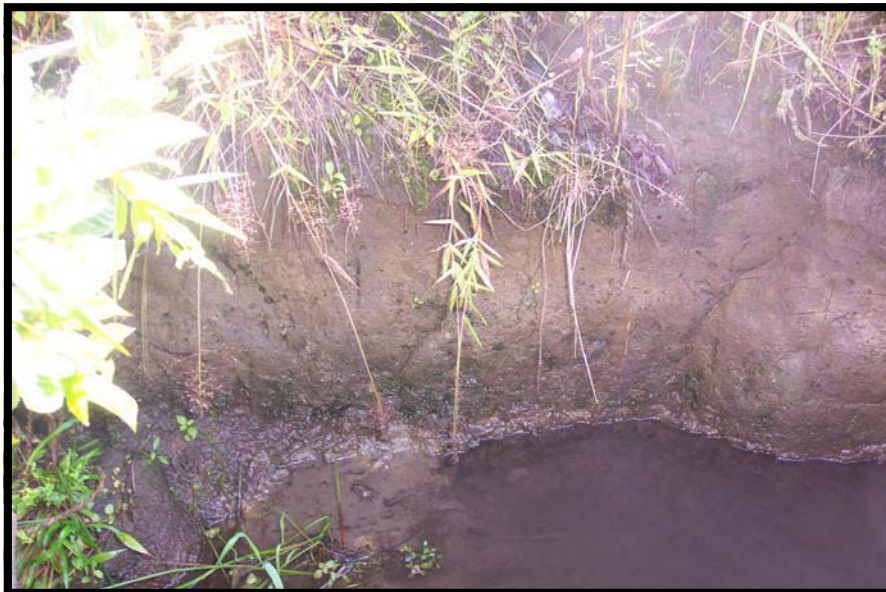
| Table IX: Stream Problem Areas<br>Tulula Stream and Wetland Restoration Site (EEP Project #392 ) | | | |
|--|---|---|---|
| Bank Scour | 1 | Coir failure | 1-6 |

Figure 2— Typical Bank Scour

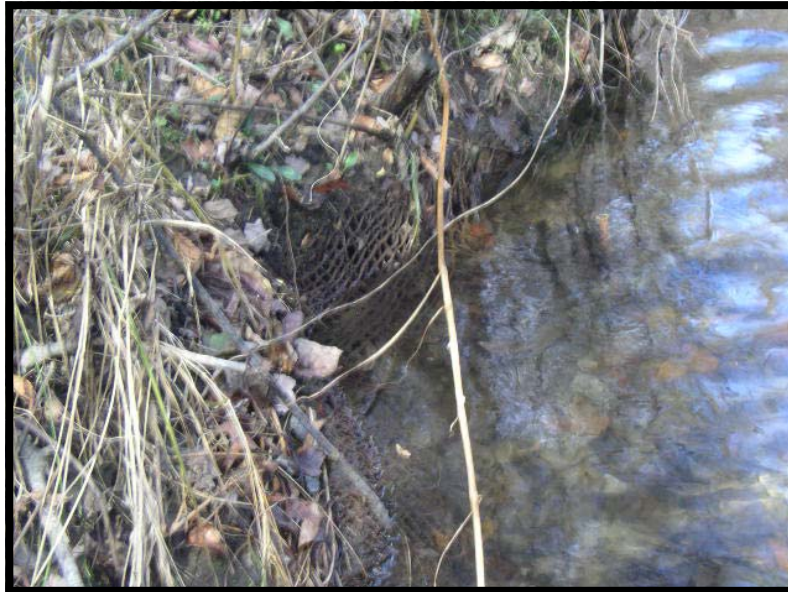
Figure 3— Typical Bank Scour

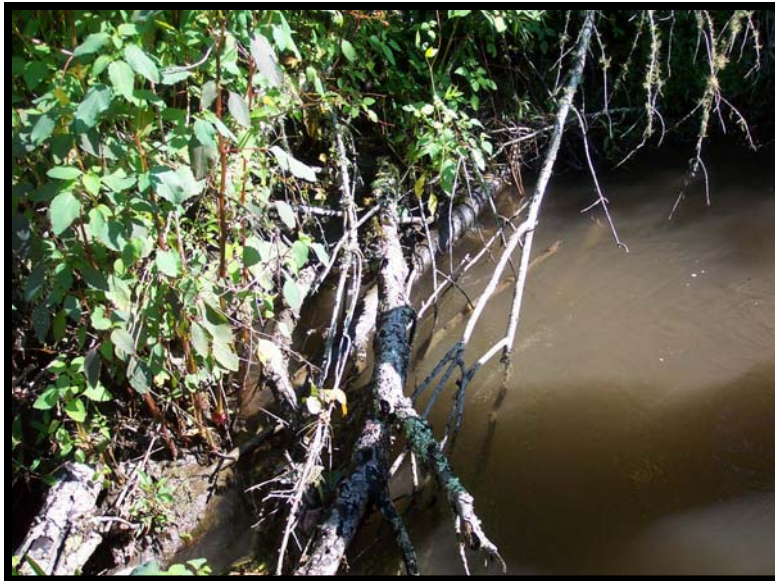
Figure 7—Debris Jam
