Tulula Stream & Wetland Restoration
NCEEP Project Number: 392
Monitoring Year 6
2008 Final Report

Submitted to
Ecosystem Enhancement Program
North Carolina Department of Environment and Natural Resources
May 2009

Tulula Stream and Wetland Restoration – 2008 Monitoring Report (MY 6)

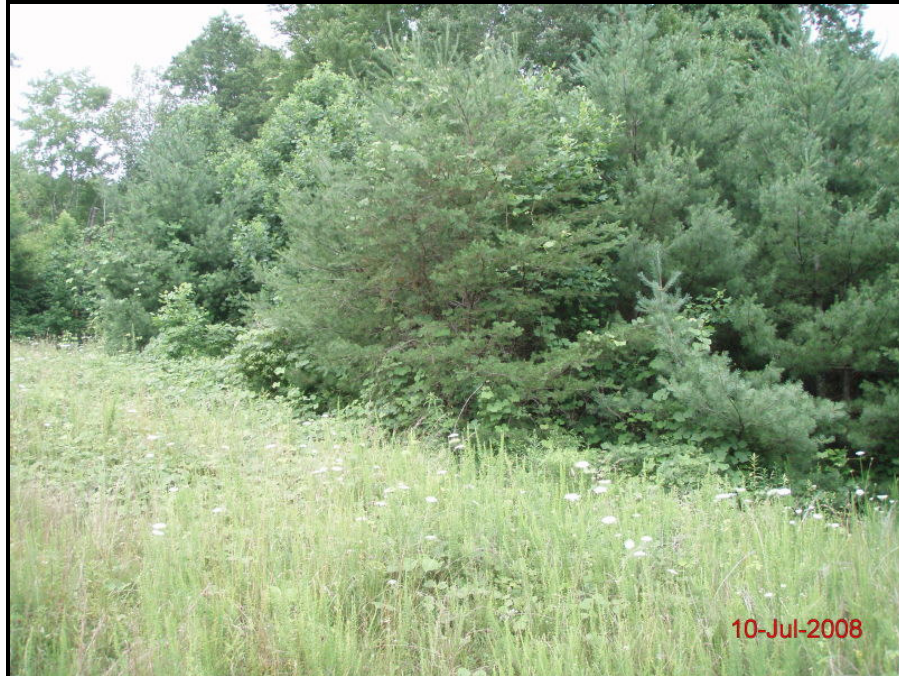
Vegetation Problem Area (VPA 3) – *Pueraria Montana*
Monitoring Year 6 – July 10, 2008

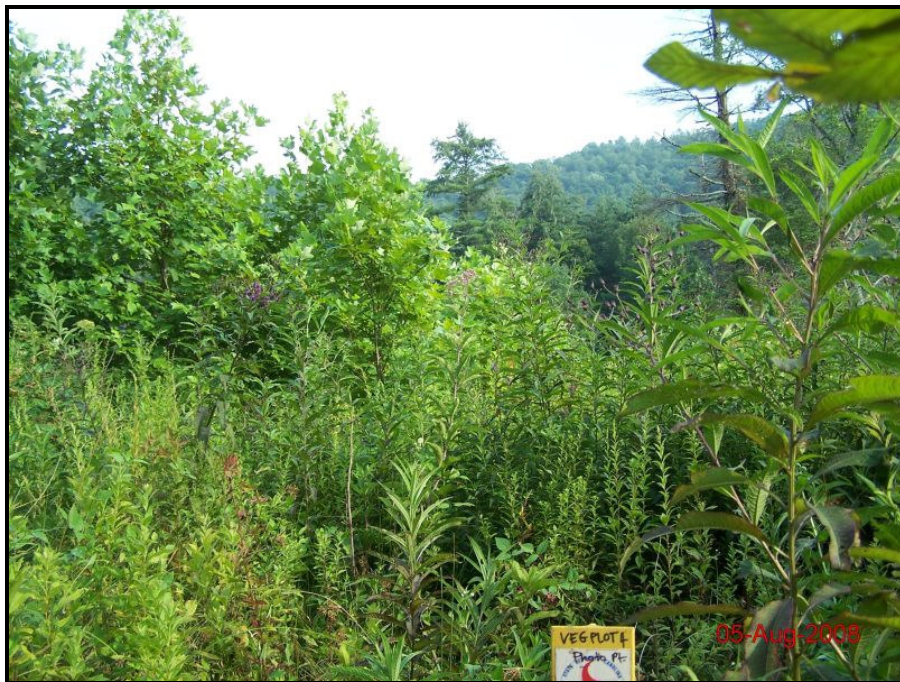
Vegetation Monitoring Plot #4
Monitoring Year 6 – August 5, 2008

On average, there was 93% survival of planted stems between MY 5 and MY 6 among five of the seven previously established vegetation monitoring plots. In particular, the 100% mortality recorded for planted vegetation in monitoring plots 3 and 5 is attributed to inundation resulting from beaver activity. Evidently, these plots do not meet the established vegetative success criteria as indicated in Appendix D – Integrated Current Condition Plan View. The modification in hydrologic conditions has facilitated the encroachment and dominance of species better adapted to anaerobic conditions, including Soft rush (*Juncus effuses ssp. solutus*) and, to a lesser extent, Tag alder (*Alnus serrulata*).

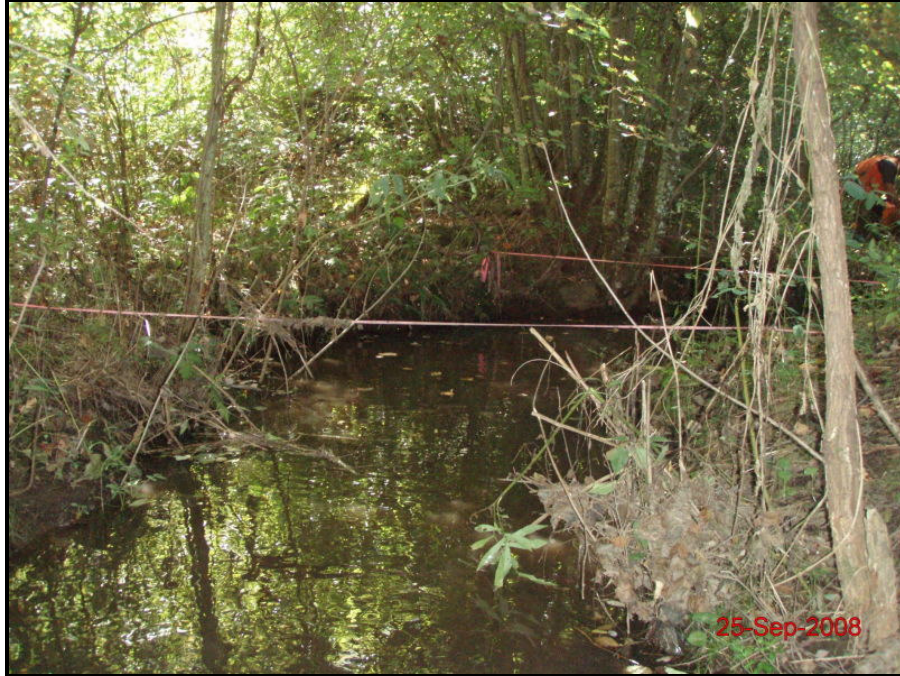
Reach IA – Cross Section #1 – Riffle
Looking Upstream
Monitoring Year 6 – September 25, 2008

Table 5. Verification of Bankfull Events Tulula Stream & Wetland / Project No. 392			
Date of Data Collection	Date of Occurrence	Method	Photo # (if available)
2005	Unknown	Wrack lines, stained vegetation, displaced/flattened vegetation, and sediment deposition	
2006	Unknown	Wrack lines, stained vegetation, displaced/flattened vegetation, and sediment deposition	
2007	Unknown	Wrack lines, stained vegetation, displaced/flattened vegetation, and sediment deposition	
9/25/2008	Unknown	Photographed On-site	Reach IA - XS #1

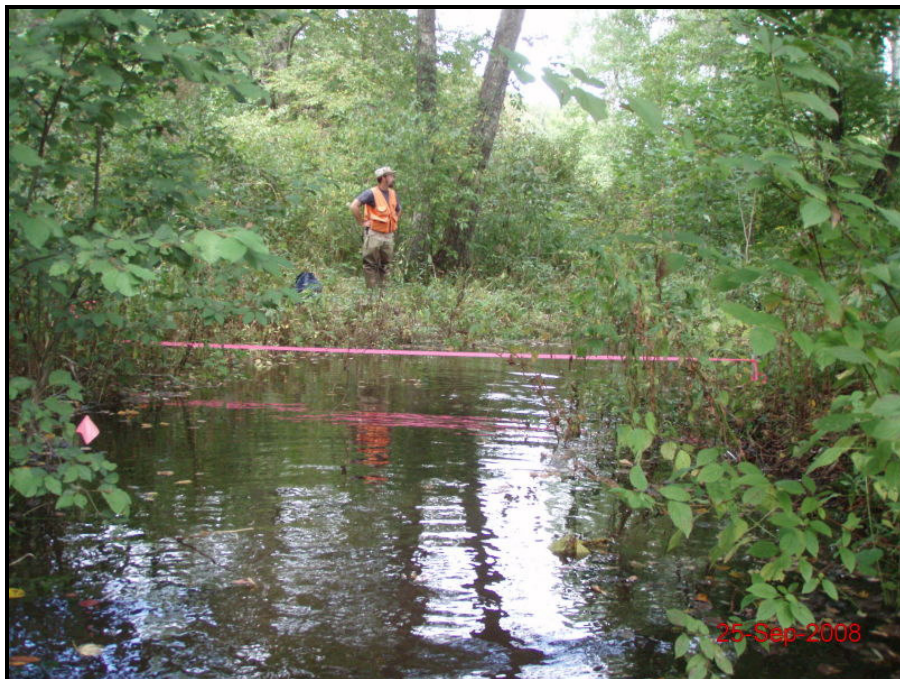
Reach II – Cross Section #2 – Pool
Looking Upstream
Monitoring Year 6 – September 25, 2008

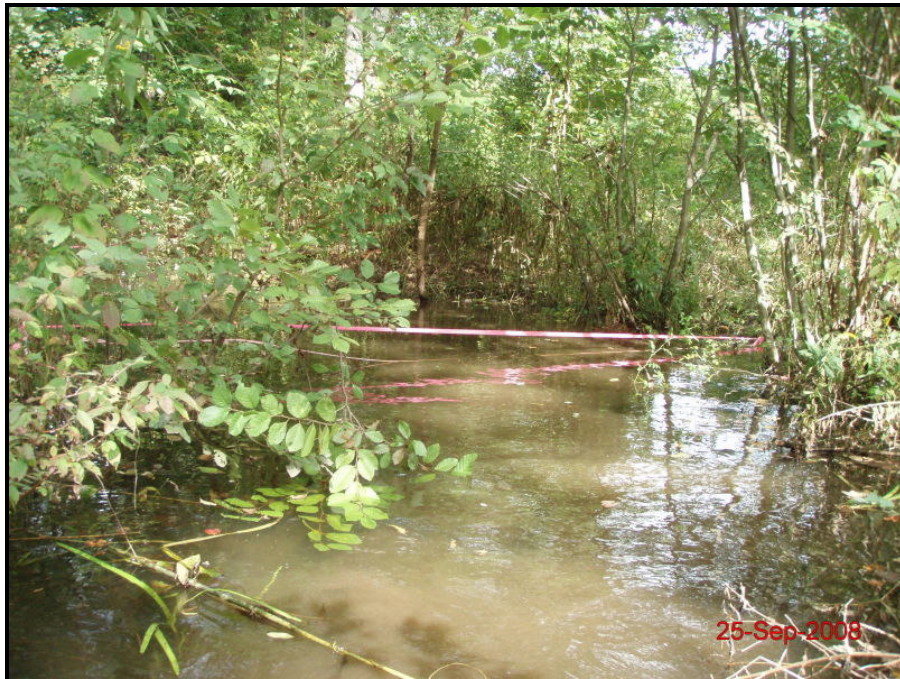
Reach II – Cross Section #4 – Pool
Looking Upstream
Monitoring Year 6 – September 25, 2008
