Subject: Response to DMS comments on the Year 3 Monitoring Report Review for the Upper Silver Creek Stream and Wetland Restoration Project; Catawba River Basin - CU# 03050101; Burke County, North Carolina; NCEEP Project # 94645; Contract No. 003270

Burke County, North Carolina
NCDMS Project ID Number – 94645

Figure 2 - Overview
Current Conditions Plan View
Monitoring Year 3
Upper Silver Creek Site

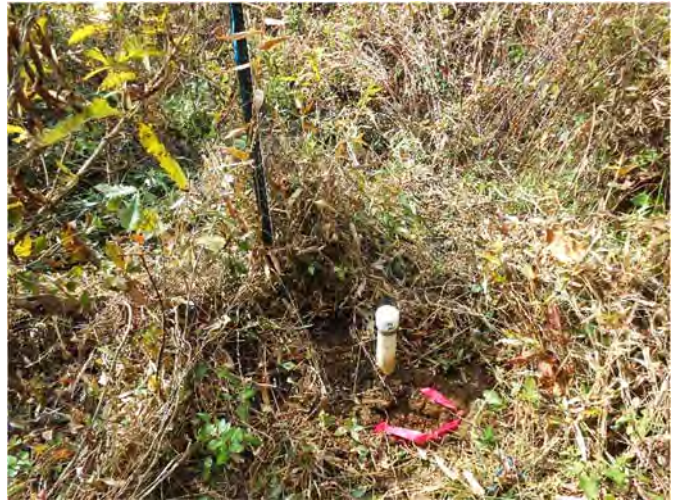
Photo 2. Wetland Photo Point – W2, replicates photo 51 in Baseline Report (November 1, 2017).

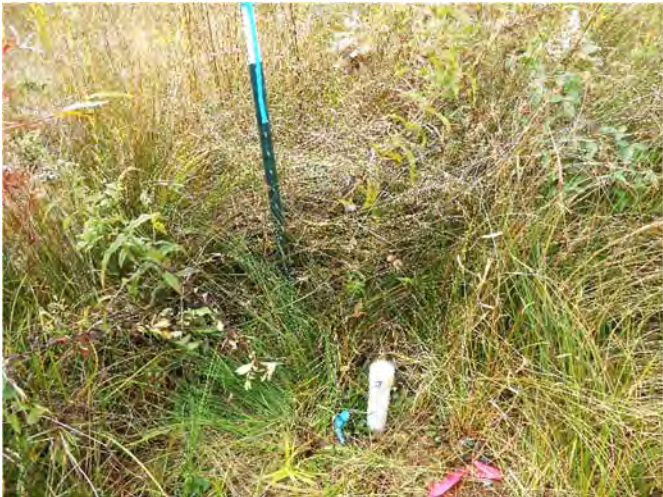
Photo 3. Wetland Photo Point – W3 replicates photo 52 in Baseline Report (November 1, 2017).

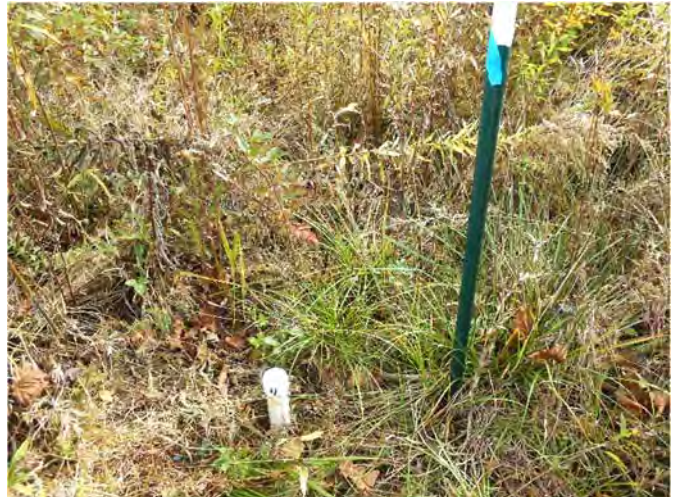
Photo 4. Wetland Photo Point – W4, replicates photo 53 in Baseline Report (November 1, 2017).

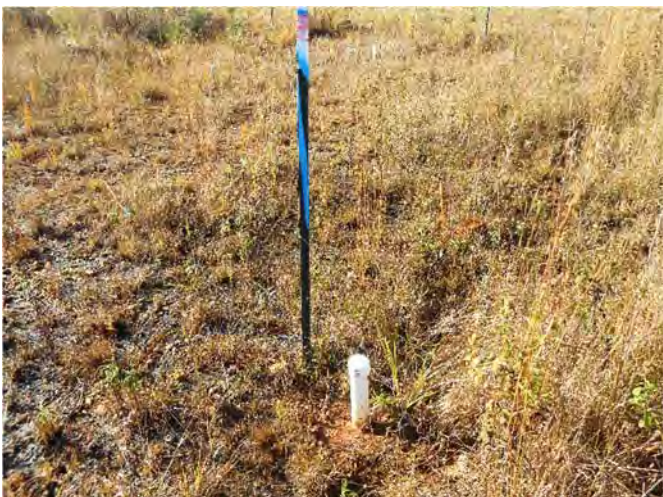
Photo 5. Wetland Photo Point – W5, replicates photo 54 in Baseline Report (November 1, 2017).

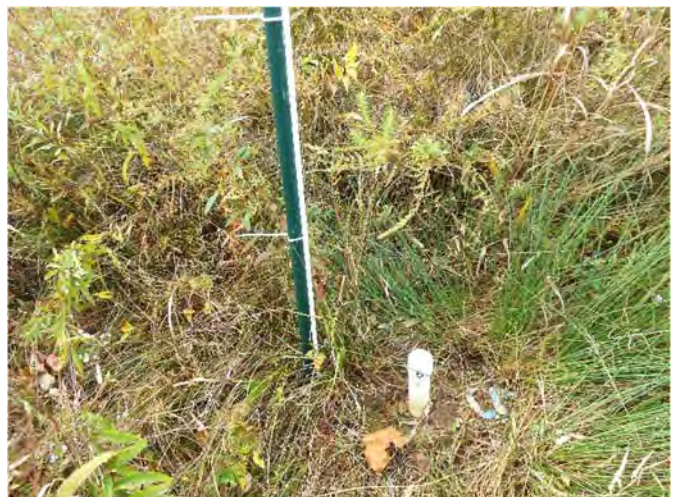
Photo 6. Wetland Photo Point – W6, replicates photo 55 in Baseline Report (November 1, 2017).

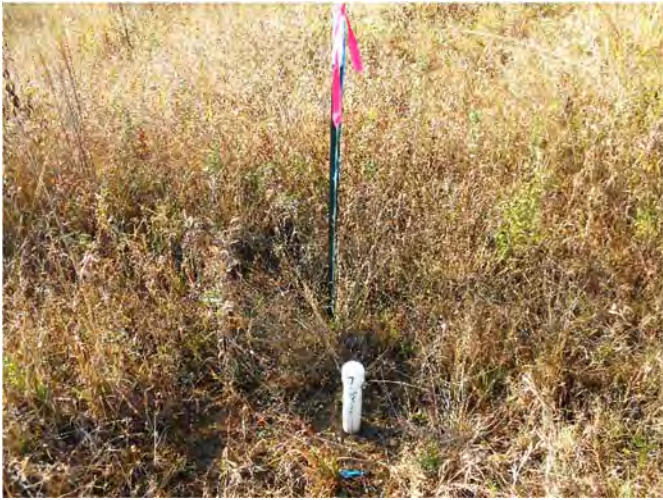
Photo 7. Wetland Photo Point – W7, replicates photo 56 in Baseline Report (November 1, 2017).

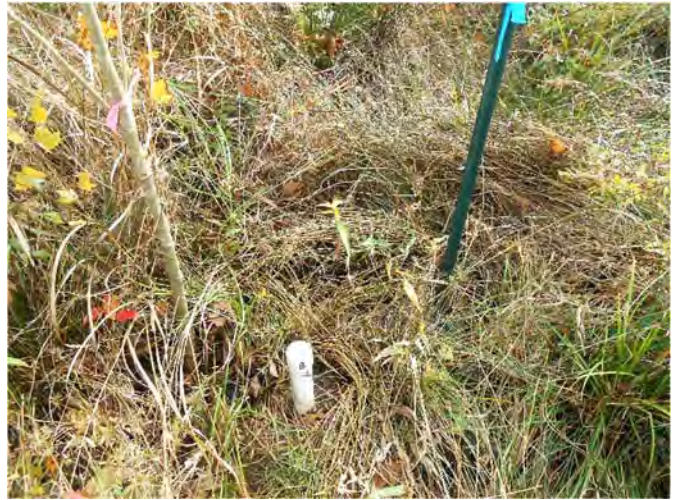
Photo 8. Wetland Photo Point – W8, replicates photo 57 in Baseline Report (November 1, 2017).

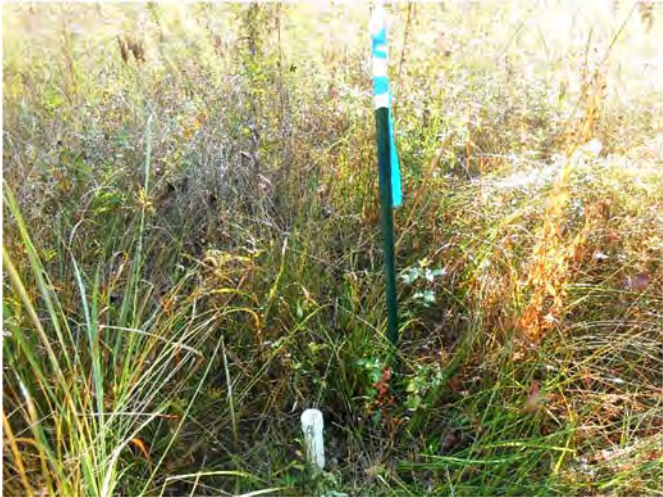
Photo 9. Wetland Photo Point – W9, replicates photo 58 in Baseline Report (November 1, 2017).

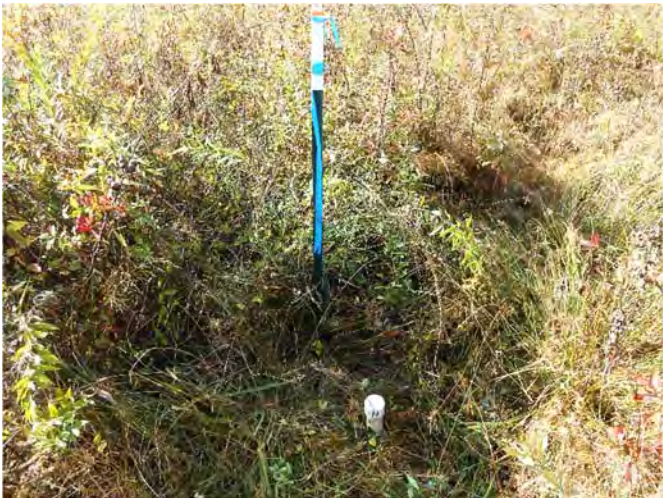
Photo 11. Wetland Photo Point – W11, replicates photo 60 in Baseline Report (November 1, 2017).

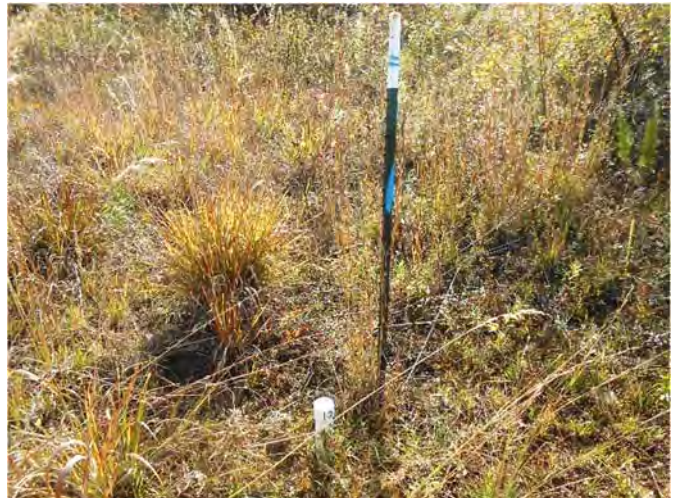
Photo 12. Wetland Photo Point – W12, replicates photo 61 in Baseline Report (November 1, 2017).
