**Baseline Monitoring Document
and
As-built (MY0) Baseline Report**

**Upper South Hominy Mitigation Site,
South Hominy Creek, French Broad River Basin,
Buncombe County, North Carolina**

EEP Project Number: 92632
Contract Number: D06082; Task Order: 08 FB05-1b-d

Data Collected: November 2011-February 2012
Submitted: 30 April 2013

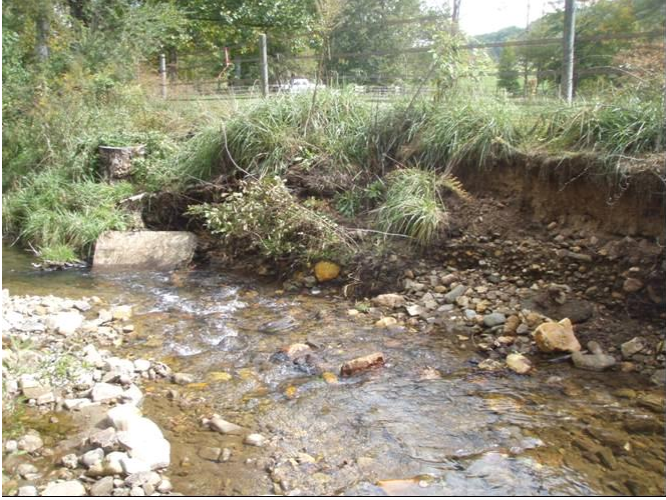
Photo Station 3

Right bank erosion, sta. 5+50, pre-construction, 30 September 2008.

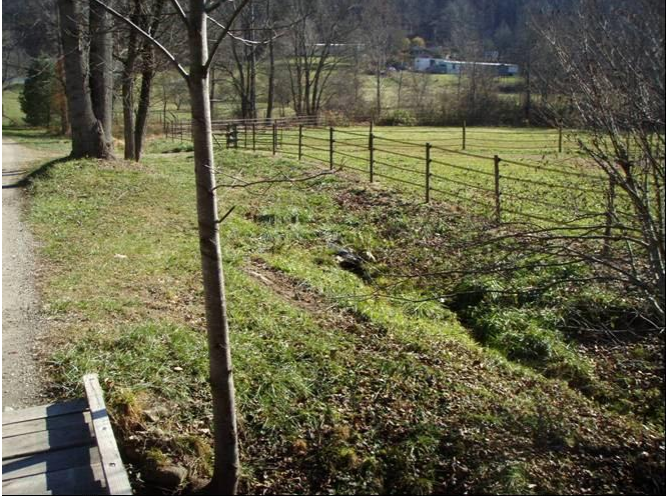
Photo Station 8

UT2 routed from original channel to a ditch, pre-construction, 30 November 2007.

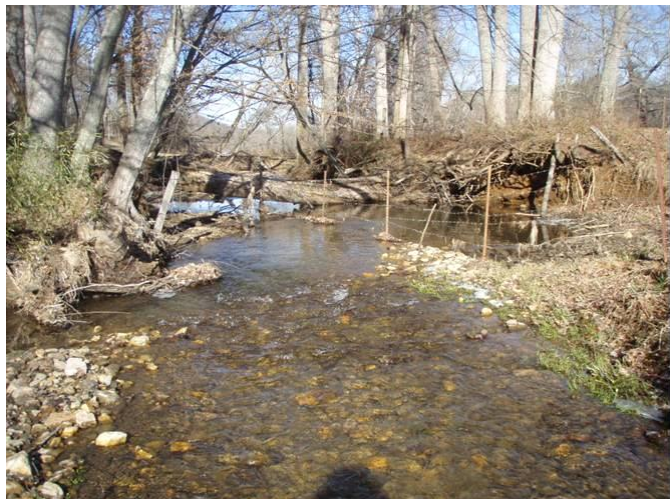
Photo Station 11

Livestock access right bank, sta. 1+00 to 1+50, facing downstream.
22 January 2009.

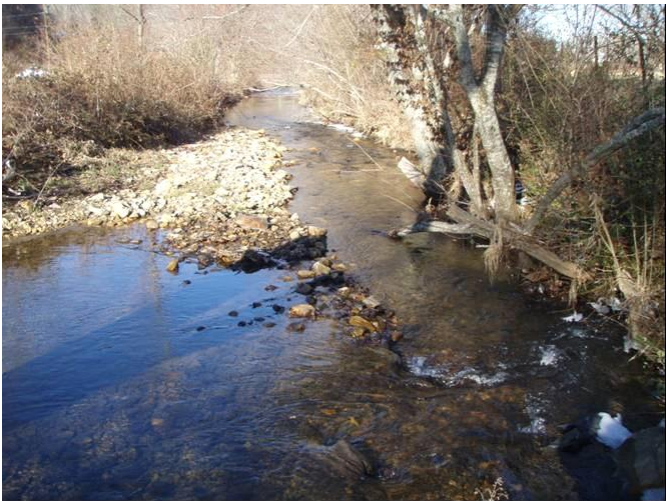
Photo Station 15

Bed aggradation and transverse bar, sta. 9+50 to 10+00, facing downstream, 22 January 2009.

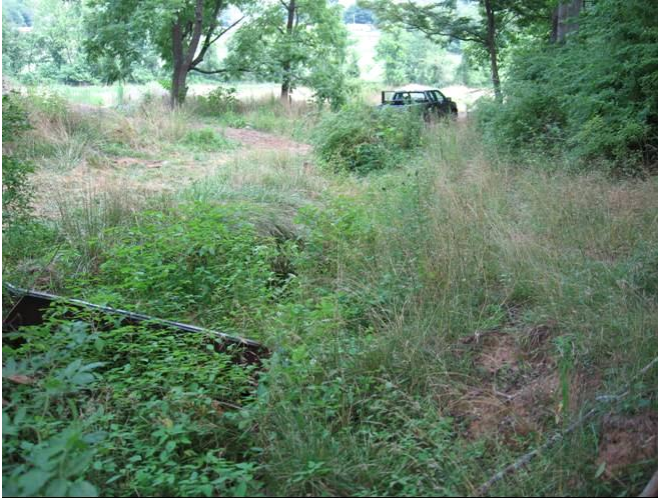
Photo Station 24

UT3 above ford, channel incision, facing downstream, 25 July 2008.

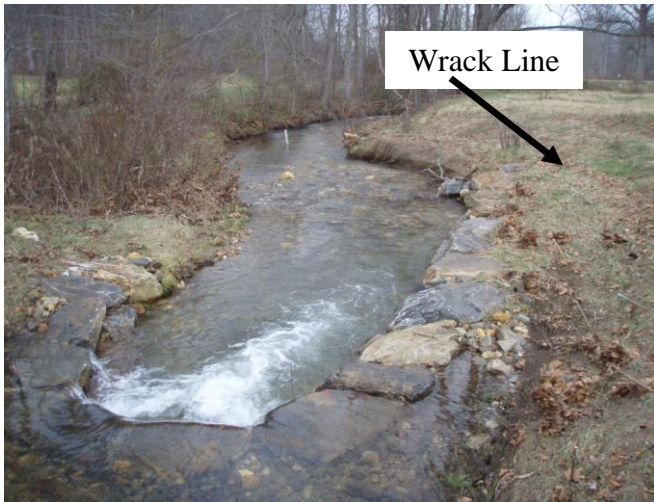
Photo 1 bankfull event on SHC, Bianculli property, 28 November 2011.

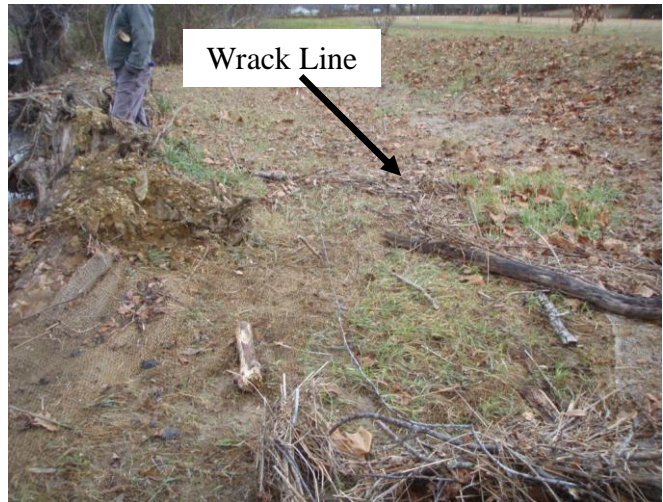
Photo 2 bankfull event on SHC, Roberson property, 28 November 2011.

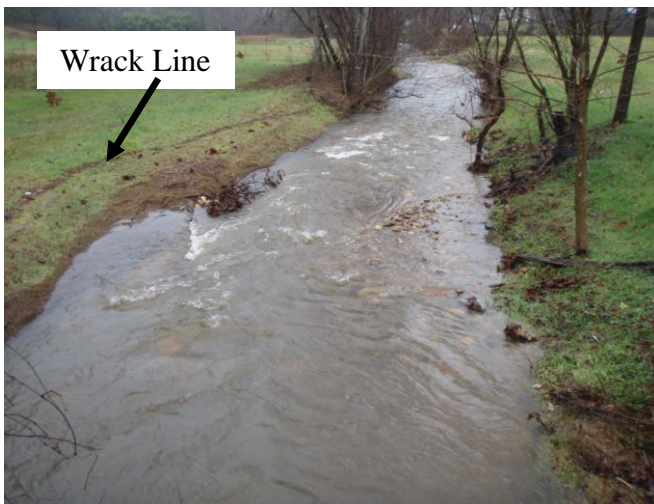
Photo 3 bankfull event on SHC, Davis property, 28 November 2011.

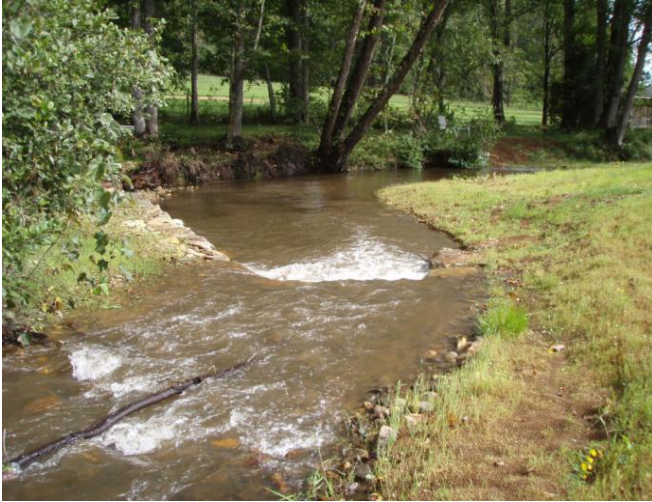
Problem Area 3

J-hook and meander post construction, sta. 2+50, facing downstream, 5 September 2011.

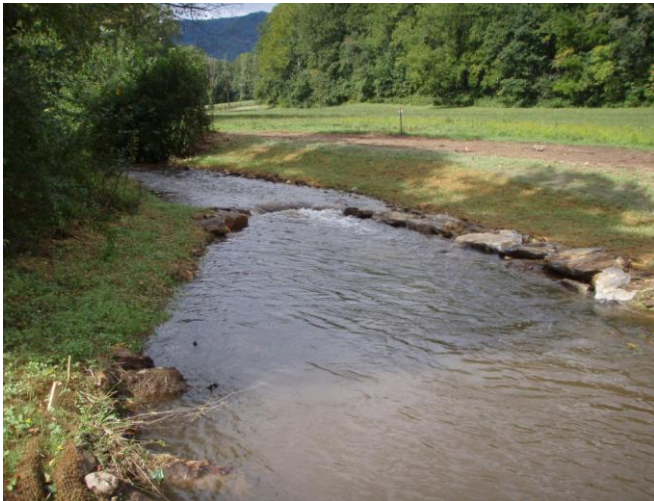
Problem Area 4

J-hook vane after construction, sta. 9+25, facing upstream, 5 September 2011.

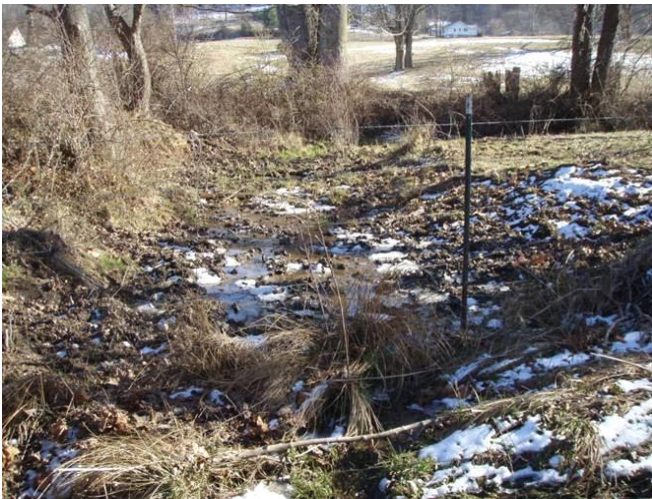
Wetland Station 5

Lower portion of Wetland D, livestock impacts, facing upstream, 2009.

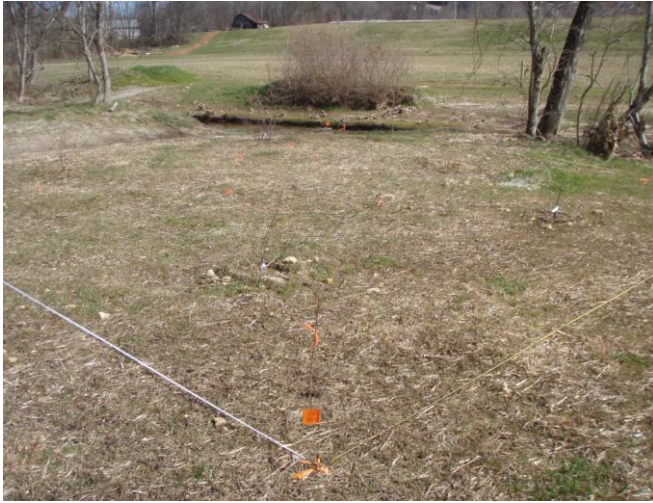
Vegetation plot 8, SHC facing downstream (0,0), 2 Feb 2012, MY0.

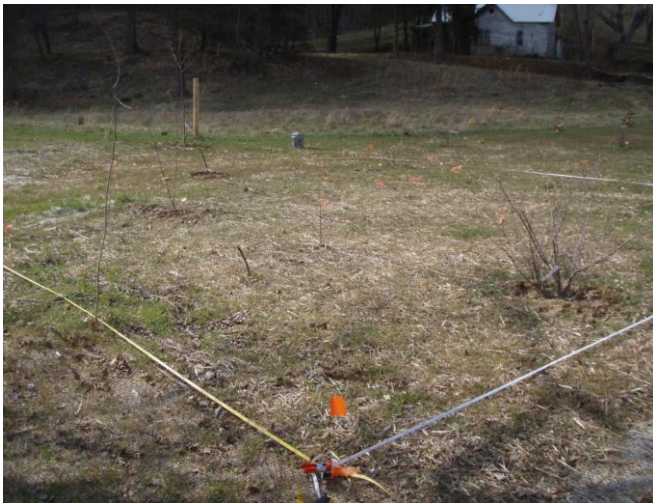
Vegetation plot 8, SHC facing upstream (10,10), 2 Feb 2012, MY0.

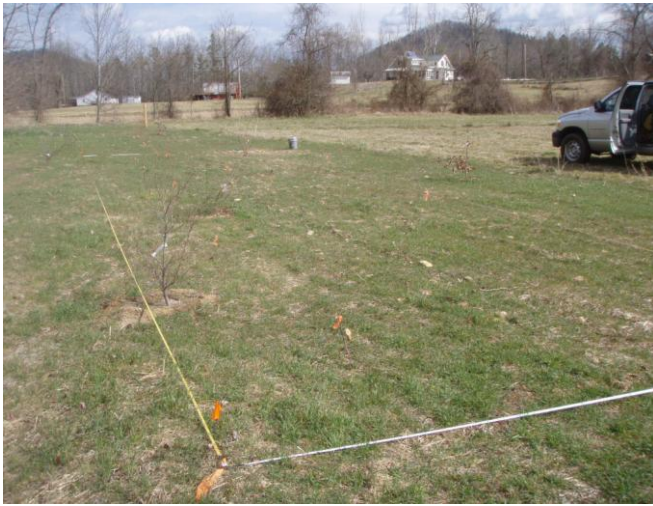
Vegetation plot 9, SHC facing downstream (20,0), 2 Feb 2012, MY0.

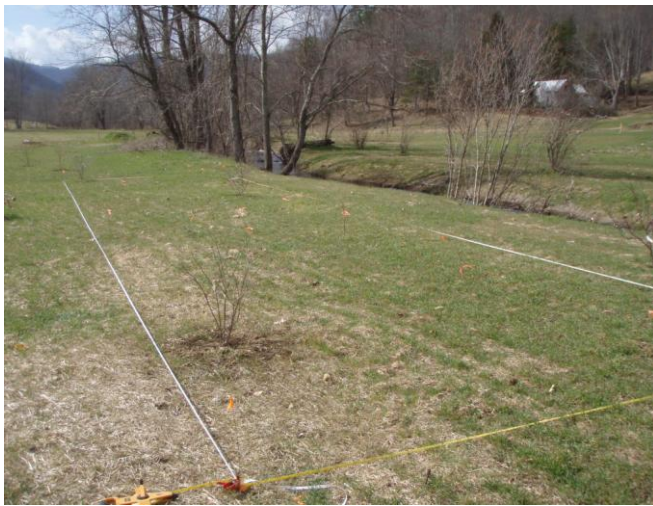
Vegetation plot 9, SHC facing upstream (20,5), 2 Feb 2012, MY0.

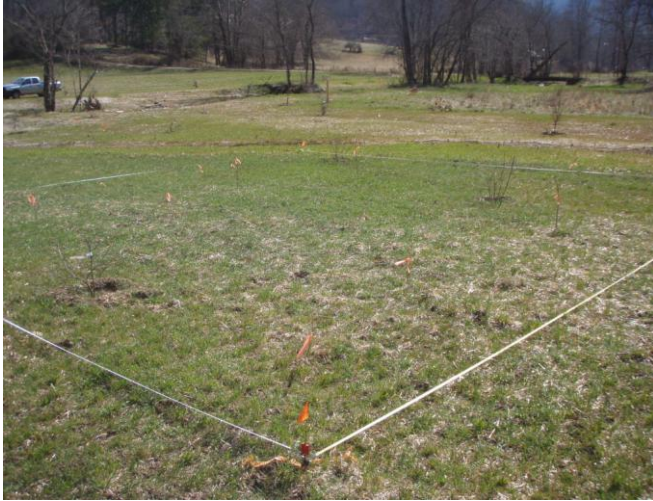
Vegetation plot 10, UT3 facing downstream (0,0), 2 Feb 2012, MY0.

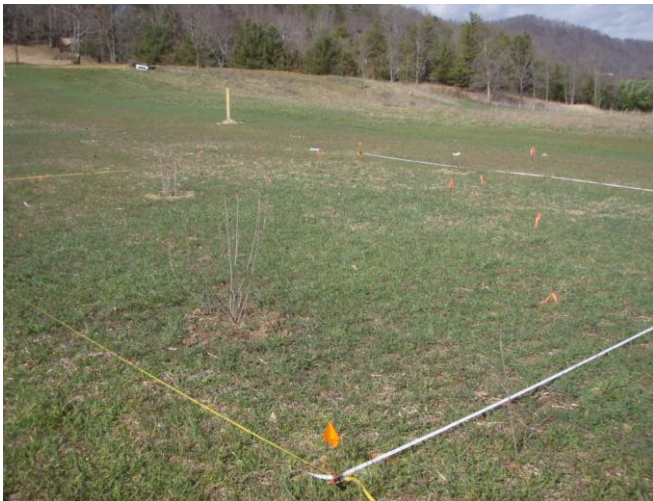
Vegetation plot 10, UT3 facing upstream (10,10), 2 Feb 2012, MY0.
