# Monitoring Year 1 Report

## Upper South Hominy Mitigation Site, South Hominy Creek, French Broad River Basin, Buncombe County, North Carolina

EEP Project Number: 92632  
Contract Number: D06082; Task Order: 08 FB05-1b-d

Data Collected: October 2012-November 2012  
Submitted: 7 February 2014

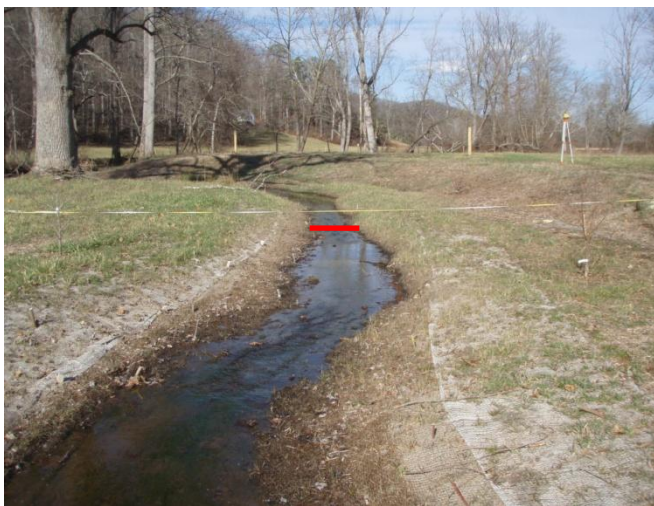
Cross-section 1, UT2 facing downstream, 2 February 2012, MY0.

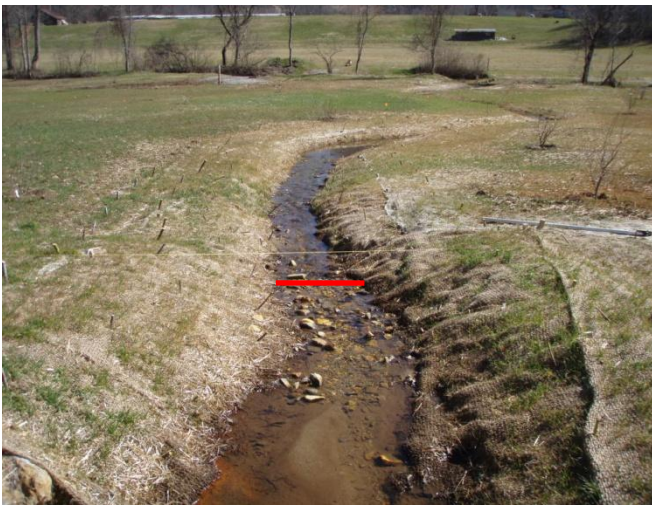
Cross-section 2, UT3 facing downstream, 2 February 2012, MY0.

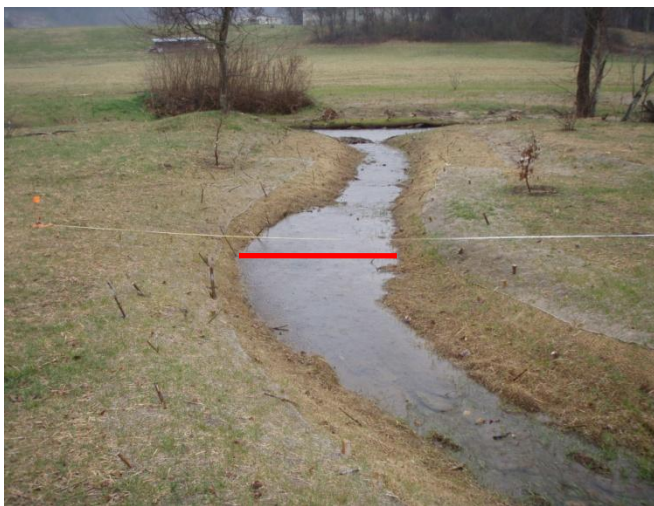
Cross-section 3, UT3 facing downstream, 2 February 2012, MY0.

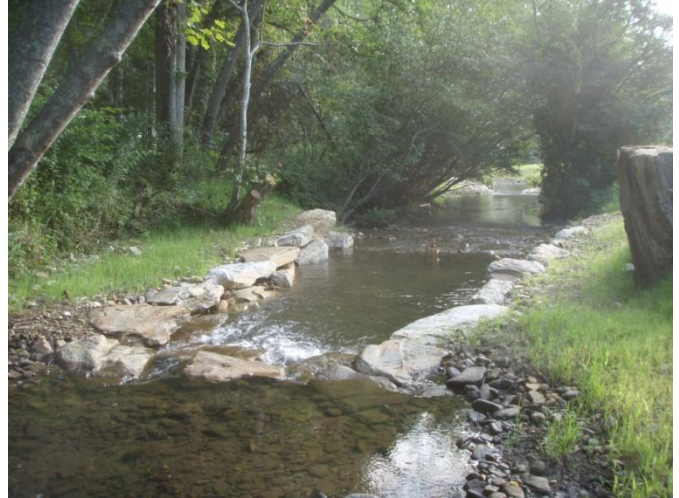
Cross vane, sta. 0+50, facing downstream, 14 August 2011.

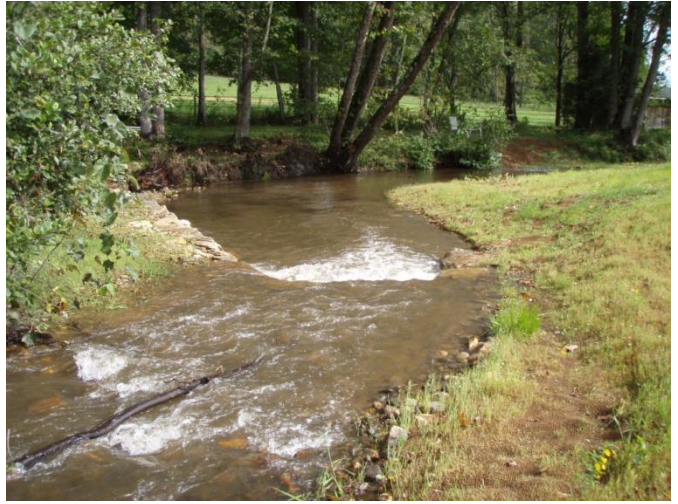
J-hook, sta. 2+50, facing downstream, 5 September 2011.

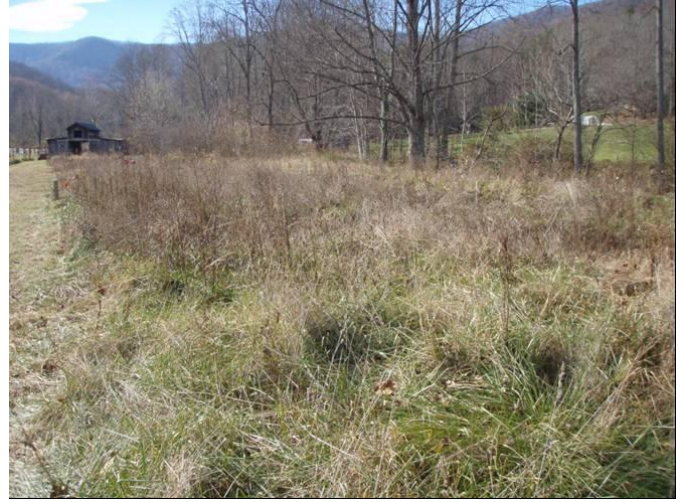
Sta. 6+50 to 8+00, right bank facing upstream, 20 November 2012.

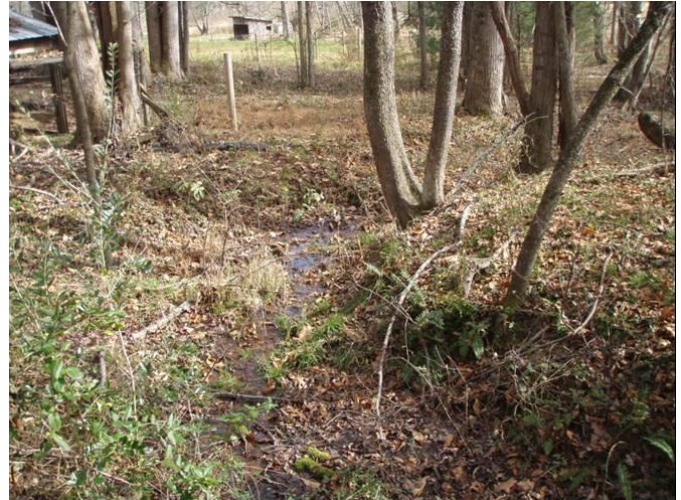
UT1 facing downstream, adjacent to small barn, 20 November 2012.

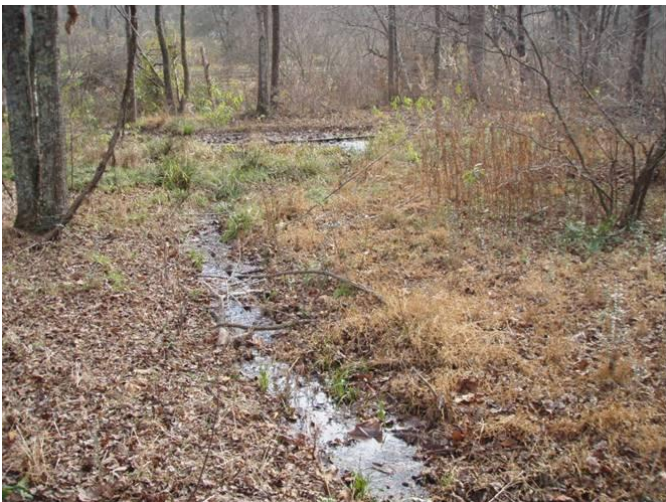
UT1 Priority I construction, above vernal pond, 20 November 2012.

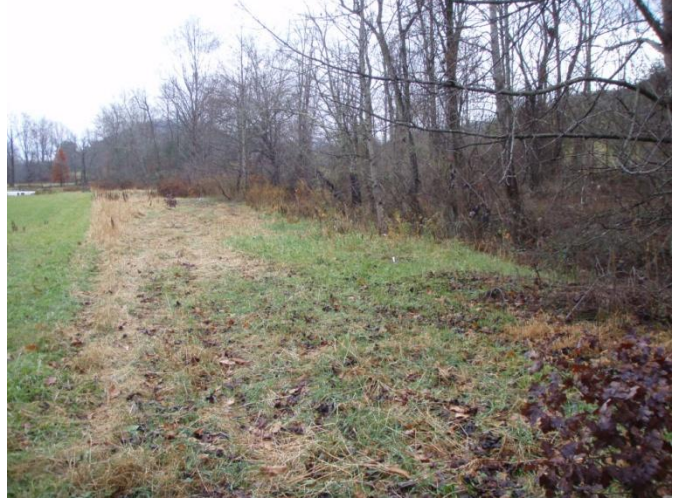
Photo Station 7

UT2 facing downstream, pre-construction, 30 November 2007.

UT2 facing downstream, post invasive removal, 5 December 2011.

UT2 facing downstream, post invasive removal, 20 November 2012.

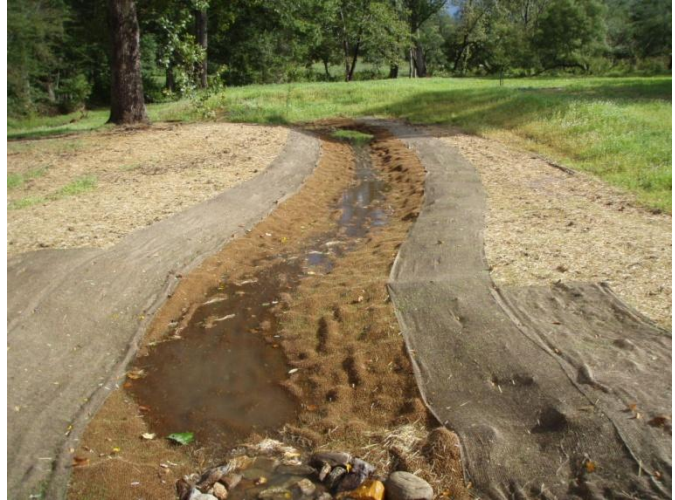
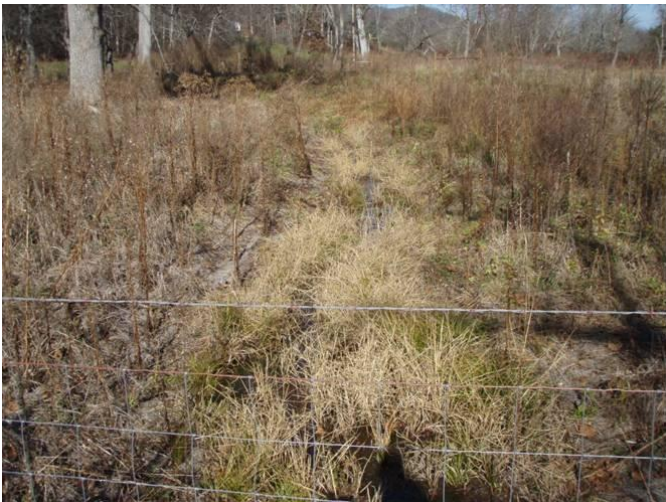
Photo Station 9

Upper portion of the UT2 abandoned channel east of Canterfield Lane, 26 April 2010.

UT2 restored portion, east of Canterfield Lane, 5 September 2011.

UT2 restored portion, east of Canterfield Lane, 20 November 2012.

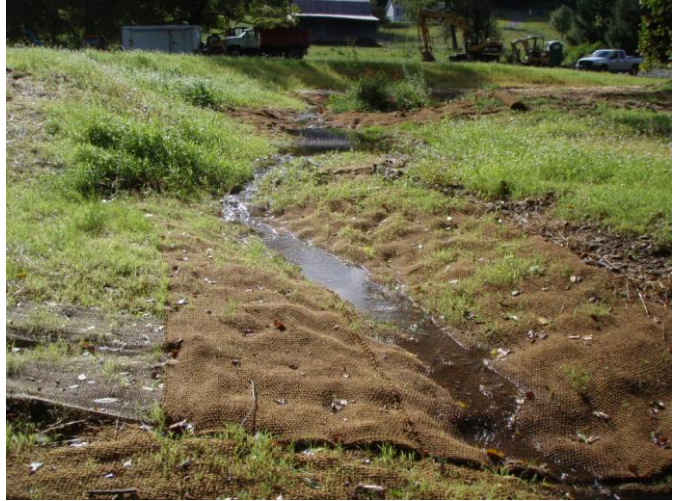
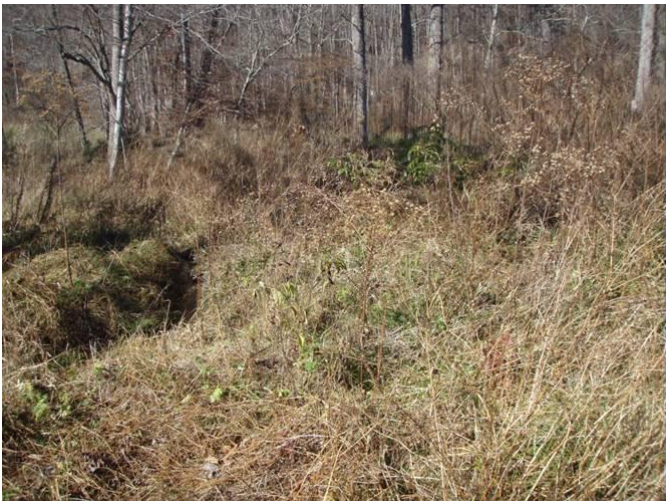
Photo Station 10

Lower portion of UT2 abandoned channel at confluence with SHC, Pre-construction, facing downstream, 26 April 2010.

Lower portion of UT2 at confluence with SHC, facing upstream, 5 September 2011.

Lower portion of UT2 at confluence with SHC, facing downstream, 20 November 2012.

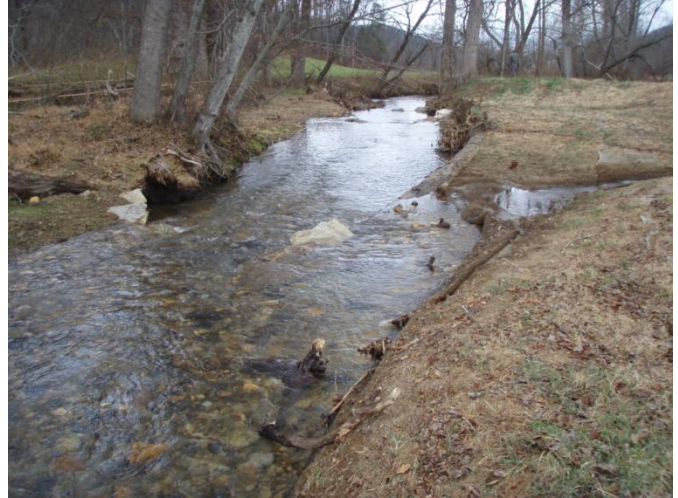
Photo Staton 11

Livestock access right bank, sta. 1+00 to 1+50, facing downstream.  
22 January 2009.

Log vane sta. 1+00 to 1+50, facing downstream

Log vane sta. 1+00 to 1+50, facing downstream, 20 November 2012.

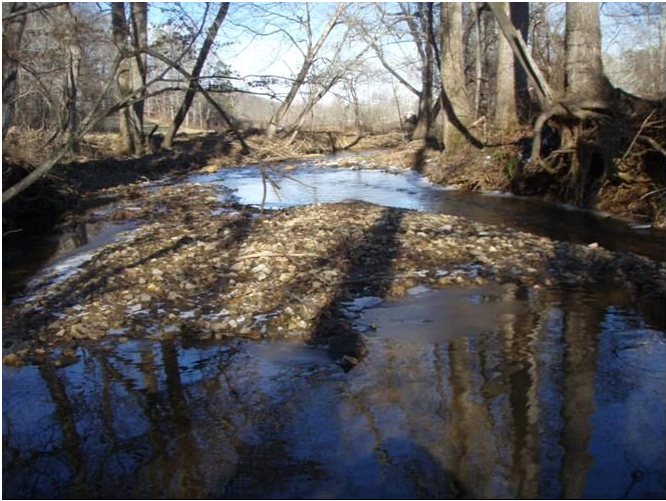
Photo Station 12

Mid channel aggradation, sta. 1+50 to 2+50, facing downstream.  
22 January 2009.

Log vane at sta. 1+50 to 2+50, facing downstream,  
5 December 2011.

Log vane sta. 1+50 to 2+50, facing downstream, 20 November 2012.

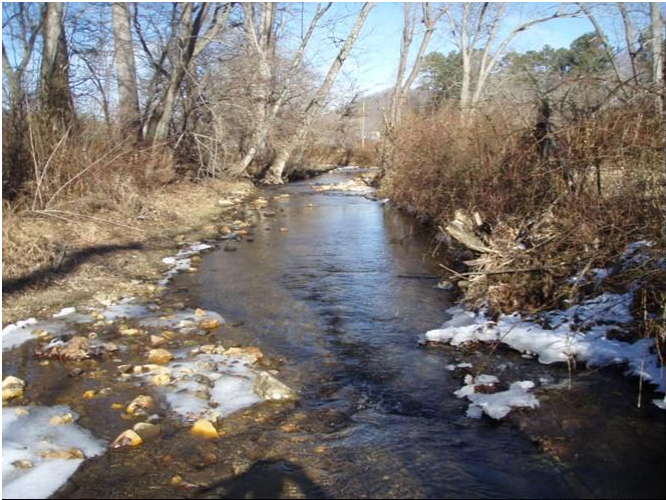
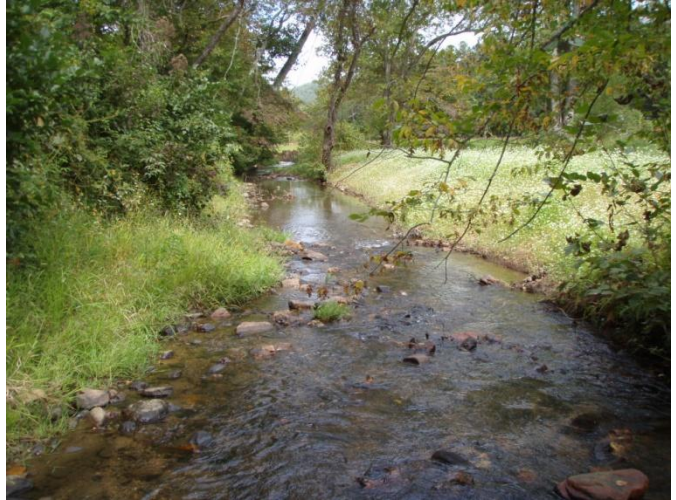
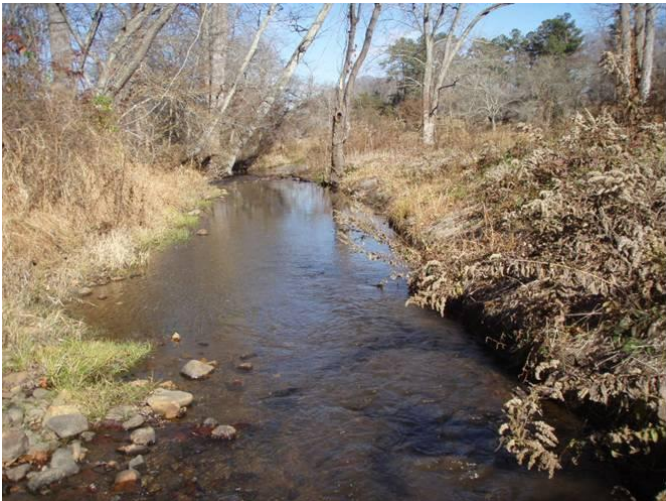
Photo Station 13

Typical features along channel in enhancement II reach, downstream, 22 January 2009.

Fence and invasive removal, bank sloping, sta. 5+00, facing downstream, 22 September 2011.

Fence and invasive removal, bank sloping, sta. 5+00, facing downstream, 20 November 2012.

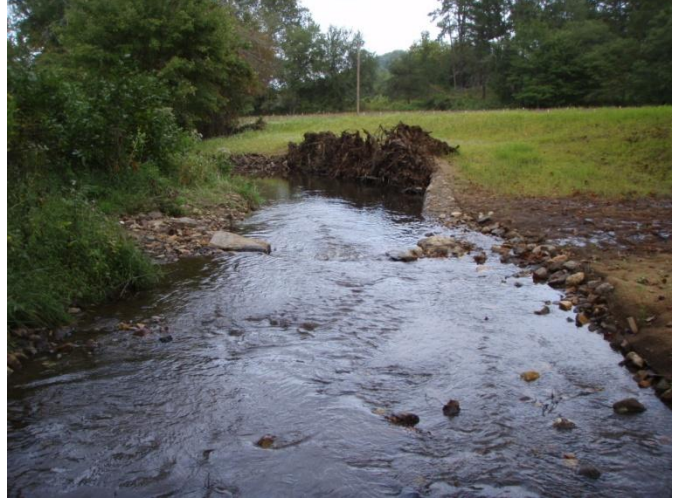
Photo Station 14

Outside meander bend bank stress, sta. 7+25 to 8+00, facing downstream, 22 January 2009.

Log vane, root wad, and bank shaping, sta. 7+25 to 8+00, 22 September 2011.

Log vane, root wad, and bank shaping, sta. 7+25 to 8+00, 20 November 2012.

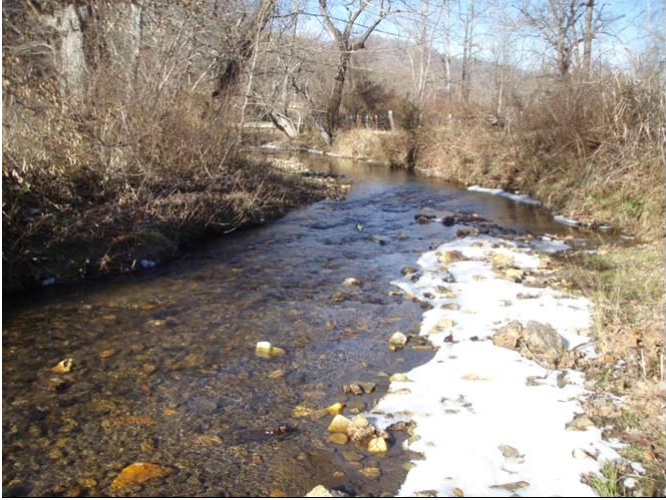
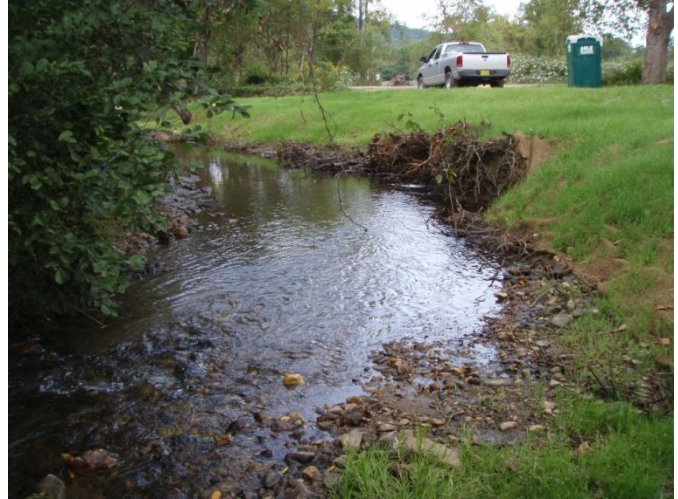
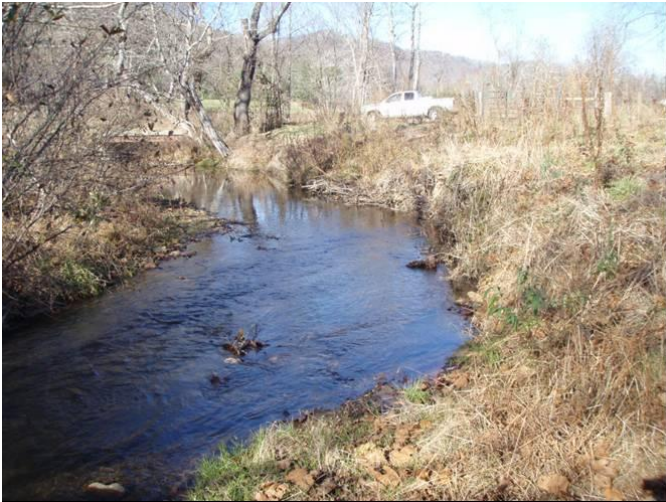
Photo Station 16

Lower portion of enhancement II, sta. 11+50 to 12+00, facing downstream, 22 January 2009.

Bank shaping, root wads, and toe-wood, sta. 11+50 to 12+00, facing downstream, 22 September 2011.

Bank shaping, root wads, and toe-wood, sta. 11+50 to 12+00, facing downstream, 20 November 2012.

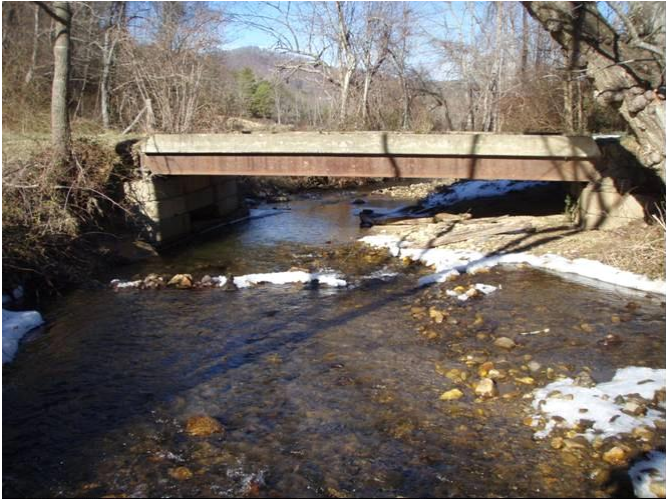
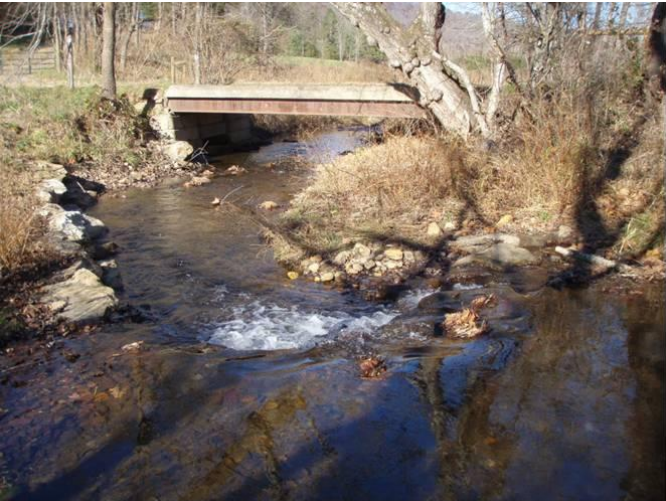
Photo Station 17

Driveway bridge at lower end of Bura/Roberson properties, sta. 12+50, facing downstream, 22 January 2009.

J-hook sta. 12+75, lower end of Bura/Roberson properties, 22 September 2011.

J-hook sta. 12+75, lower end of Bura/Roberson properties, 20 November 2012.

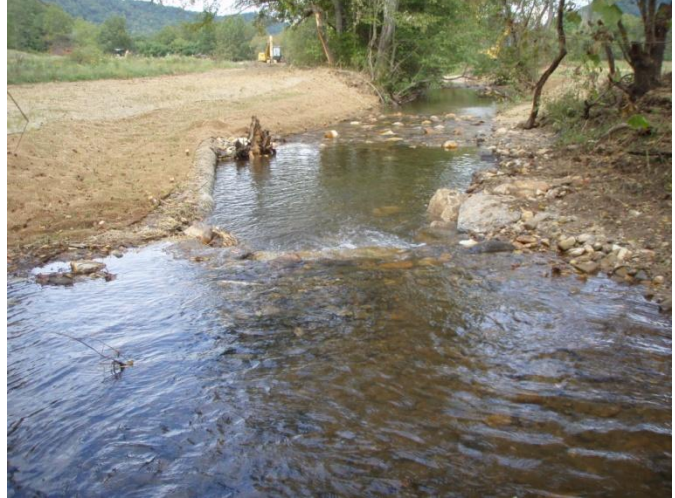
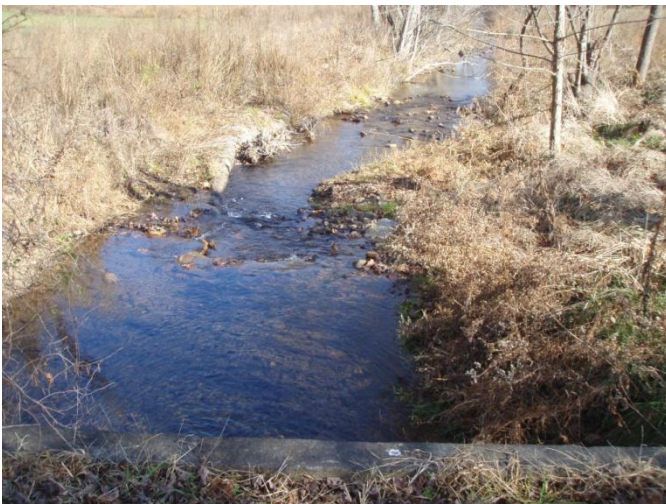
Photo Station 18

J-hook proposed, sta. 0+50, facing downstream, 25 July 2008, pre-construction.

Bank shaping, log vane, and riffle construction, sta. 0+25, 22 September 2011.

Bank shaping, log vane, and riffle construction, sta. 0+25, 20 November 2012.

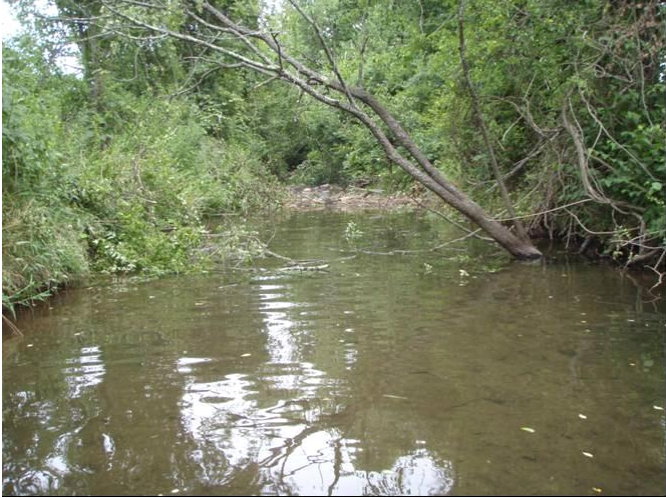
Photo Station 19

In-stream structures proposed to enhance habitat features, sta. 2+00 to 3+50, facing downstream, 25 July 2008.

Log vane, root wads, and bank shaping, sta. 2+25 to 3+50, facing downstream, 7 December 2011.

Log vane, root wads, and bank shaping, sta. 2+25 to 3+50, facing Downstream, 20 November 2012.

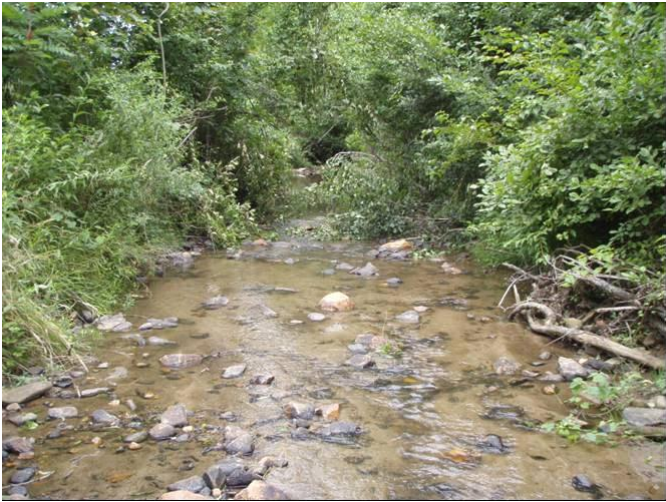
Photo Station 20

Lower end of Enhancement I, sta. 3+50 to 4+50, facing downstream. 25 July 2008.

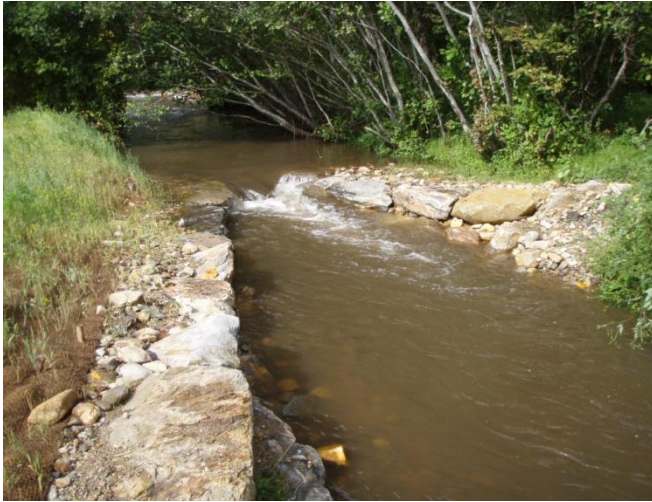
Problem Area 1

<b>Stream Problem Areas Upper South Hominy (EEP project number 92632)</b>			
<b>Feature/Issue</b>	<b>Reach / Station</b>	<b>Suspected Cause</b>	<b>Photo Number</b>
Aggradation/Bar Formation	Mainstem 1 - 2+25 to 2+75	flood event	Figure B.6, PA3
	Mainstem 2 – 9+00 to 9+50	flood event	Figure B.6, PA4
Bank Scour	Mainstem 1 – 1+75 to 2+25	flood event	Figure B.6, PA2
Engineered structures	Mainstem 1 - 1+50	flood event	Figure B.6, PA1

Rock vane after construction, sta. 1+50, facing upstream, 5 September 2011.

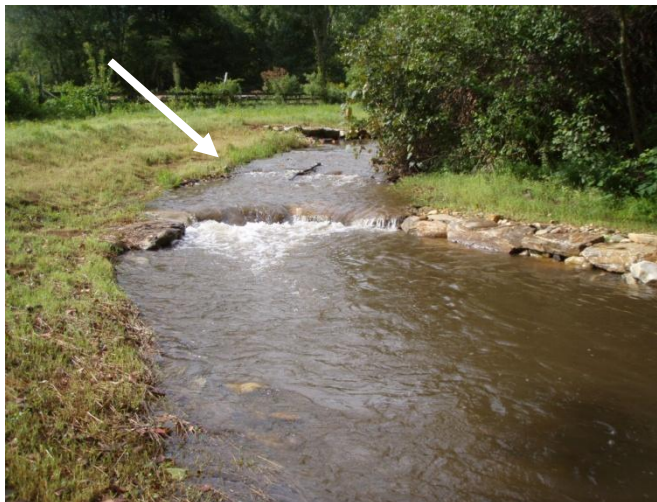
Problem Area 2

Right channel bank in stable condition, sta. 2+00, facing upstream, 5 September 2011.

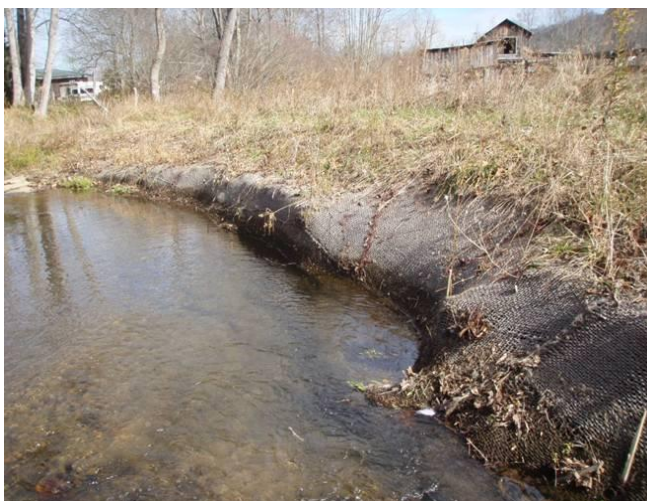
Right channel bank instability, sta. 1+75 to 2+25, facing downstream, 20 November 2012.

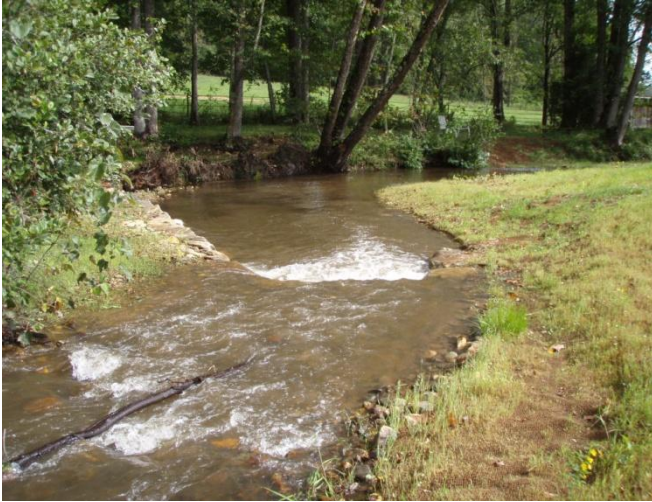
Problem Area 3

J-hook and meander post construction, sta. 2+50, facing downstream, 5 September 2011.

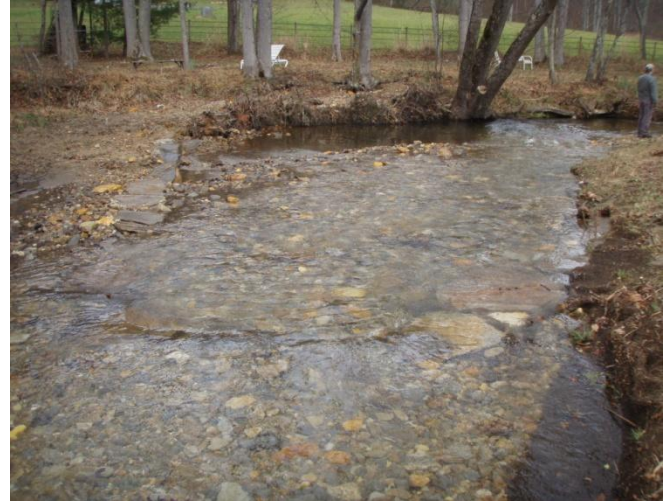
Aggradation and bar formation in meander below J-hook after flood event, sta. 2+50, facing downstream, 5 December 2011.

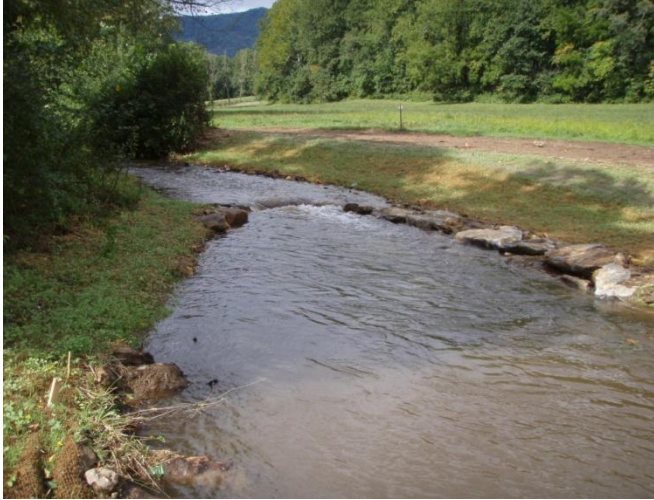
Problem Area 4

J-hook vane after construction, sta. 9+25, facing upstream, 5 September 2011.

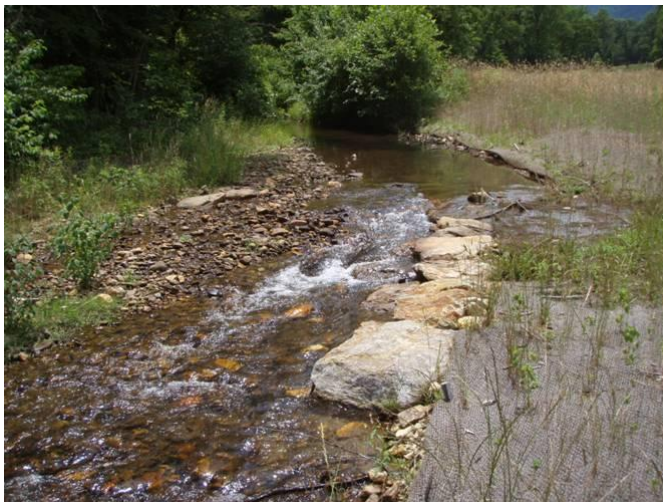
Aggradation and bar formation below J-hook, sta. 9+25 to 9+50, facing upstream, 14 June 2012

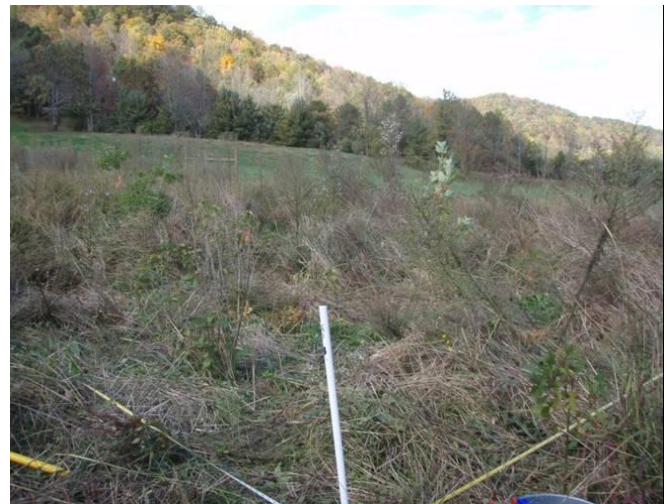
Vegetation plot 10, UT3 facing upstream (10,10), 23 October 2012, MY1.
