Monitoring Year 2 Report

Upper South Hominy Mitigation Site, South Hominy Creek, French Broad River Basin, Buncombe County, North Carolina

EEP Project Number: 92632
Contract Number: D06082; Task Order: 08 FB05-1b-d

Data Collected: October 2013-November 2013
Submitted: 30 May 2014

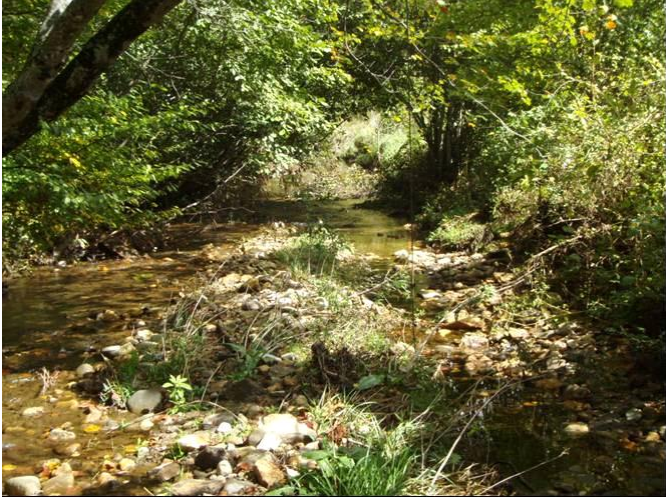
Photo Station 1

Mid channel bar, sta. 0+50, facing downstream, pre-construction. 30 September 2008.

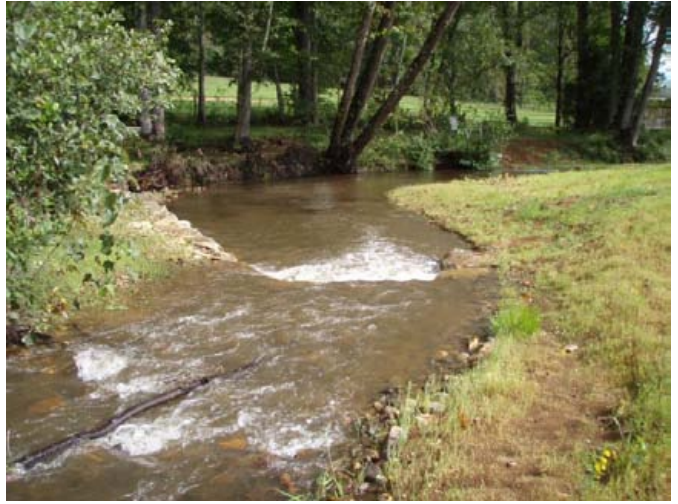
J-hook, sta. 2+50, facing downstream, 5 September 2011.

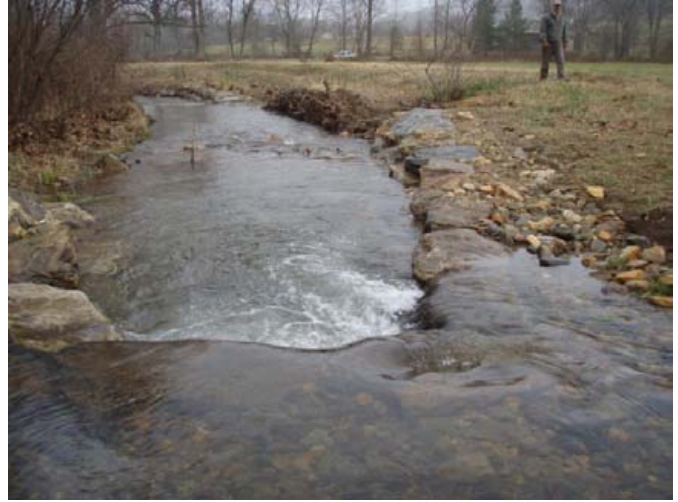
J-hook, sta. 5+00, facing downstream, 5 December 2011.

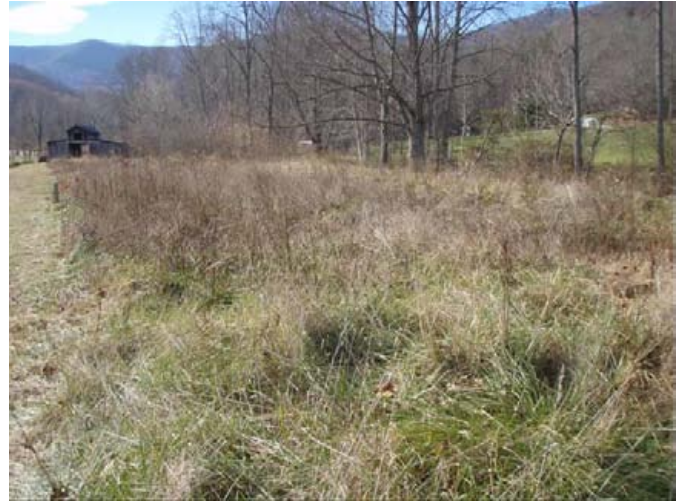
Sta. 6+50 to 8+00, right bank facing upstream, 20 November
2012.

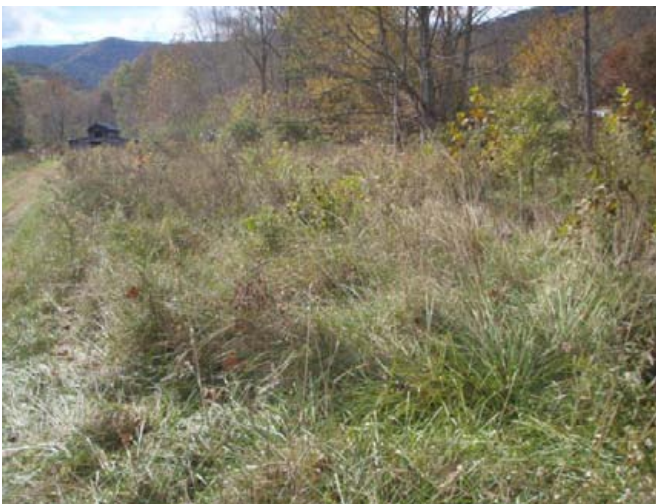
Sta. 6+50 to 8+00, right bank facing upstream, 29 October 2013.

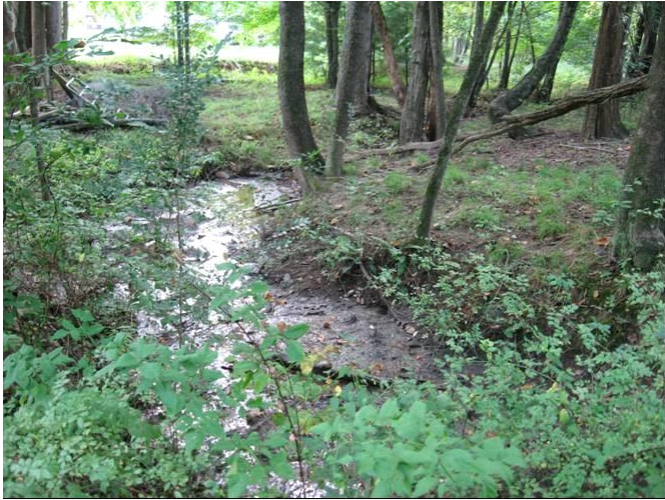
Photo Station 5

UT1 facing downstream, adjacent to small barn, 28 July 2009.

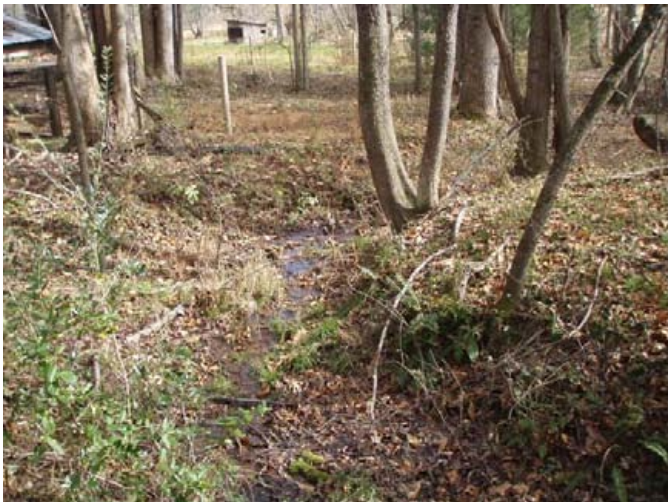
UT1 facing downstream, adjacent to small barn, 20 November 2012.

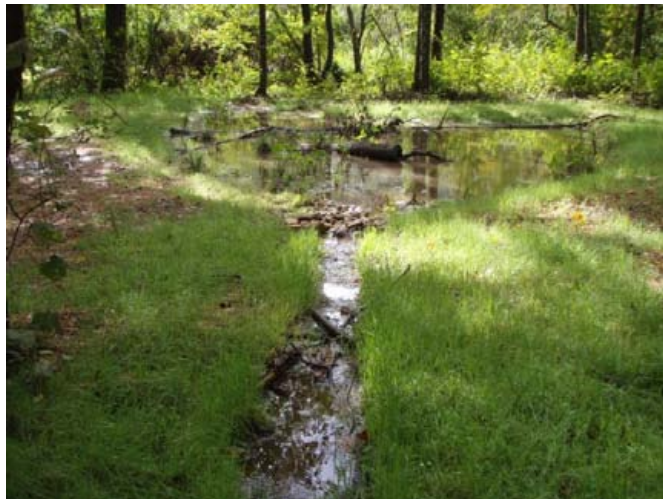
UT1 Priority I channel construction, above vernal pond, 5 September 2011.

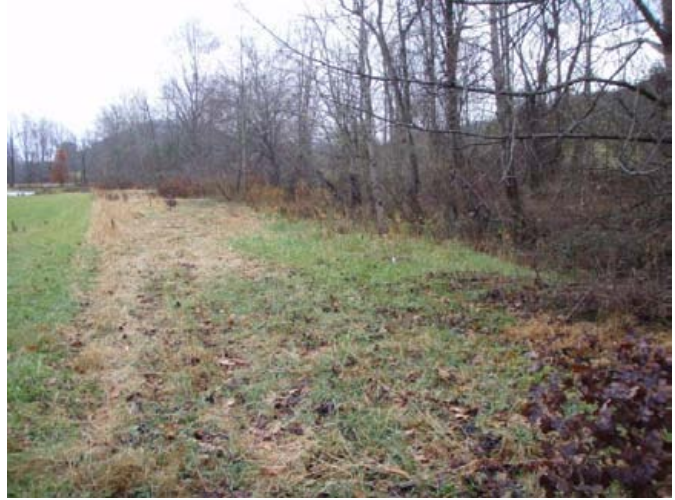
UT2 facing downstream, post invasive removal, 5 December 2011.

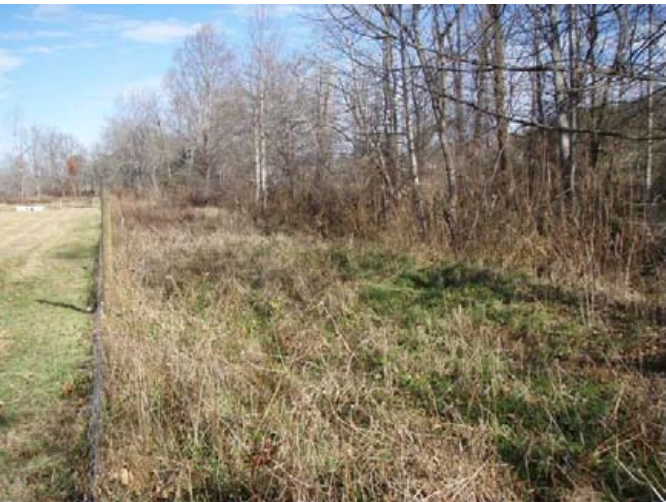
UT2 facing downstream, post invasive removal, 20 November 2012.

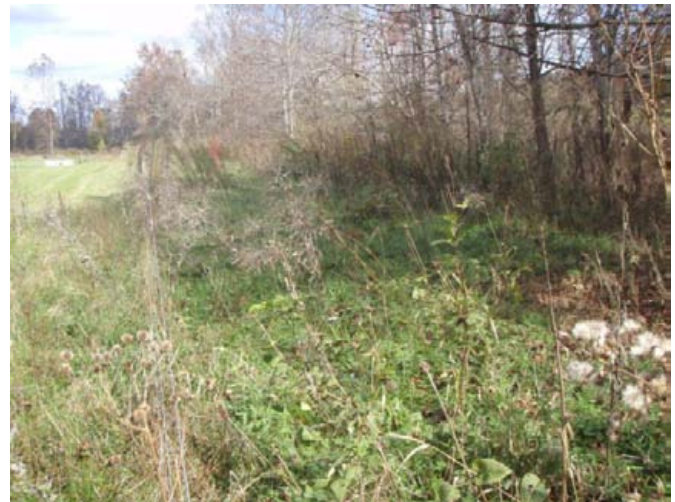
UT2 facing downstream, post invasive removal, 29 October 2013.

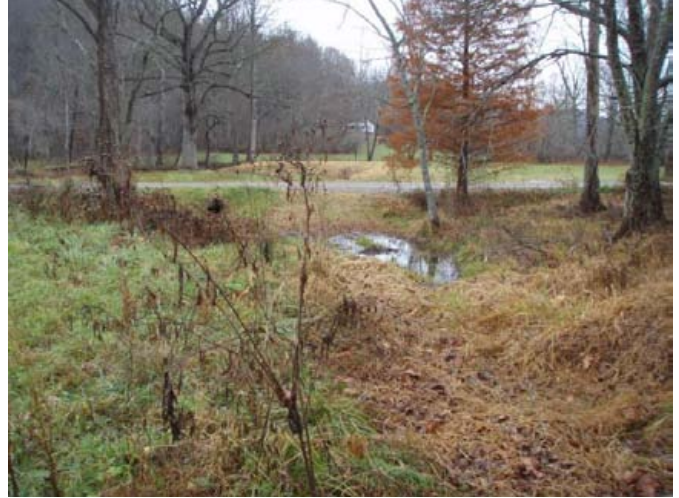
UT2 re-connected under Canterfield Lane to abandoned channel, sta. 0+00 to 0+50, 5 December 2011.

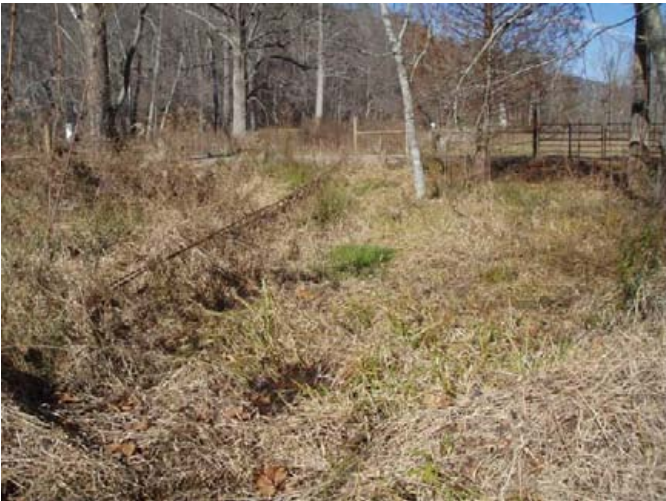
UT2 re-connected under Canterfield Lane to abandoned channel, sta. 0+00 to 0+50, 20 November 2012.

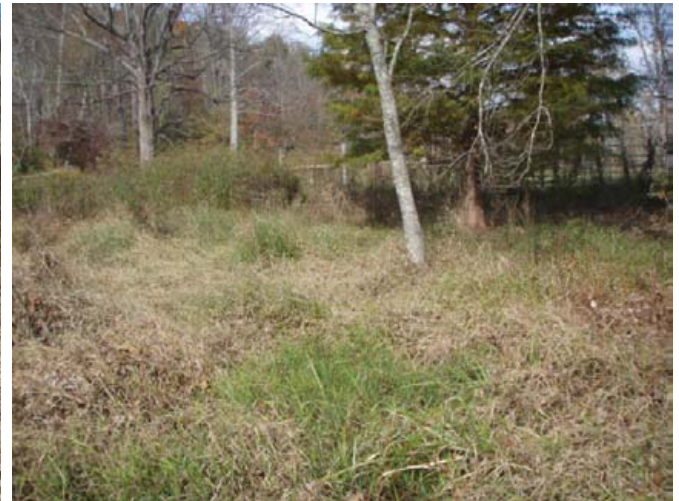
UT2 re-connected to abandoned channel, sta. 0+00 to 0+50, 29 October 2013.

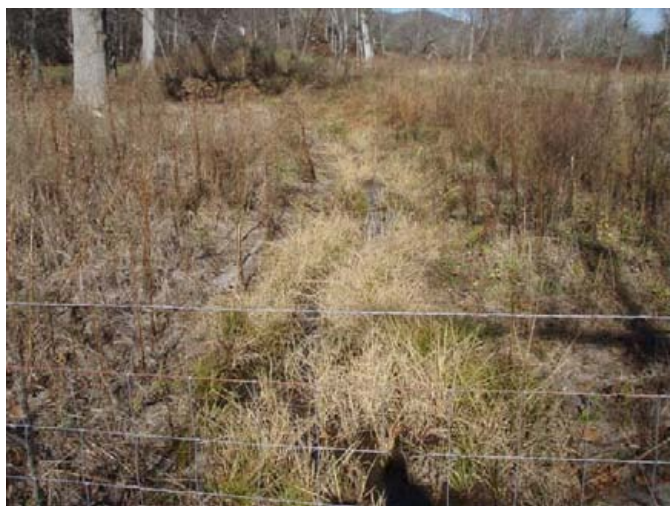
UT2 restored portion, east of Canterfield Lane, 20 November 2012.

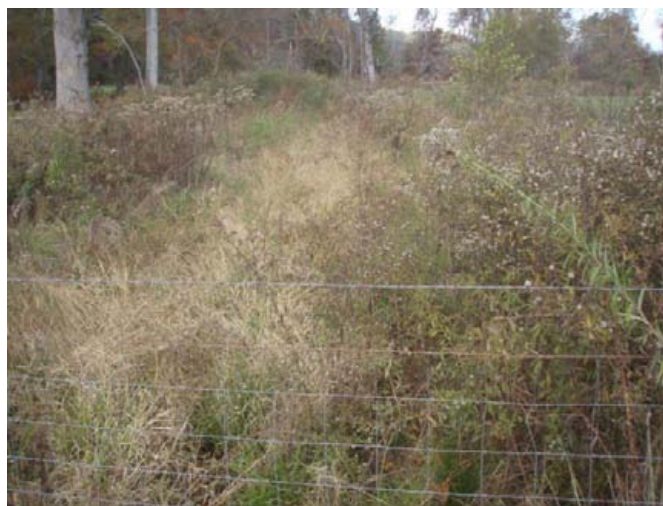
UT2 restored portion, east of Canterfield Lane, 29 October 2013.

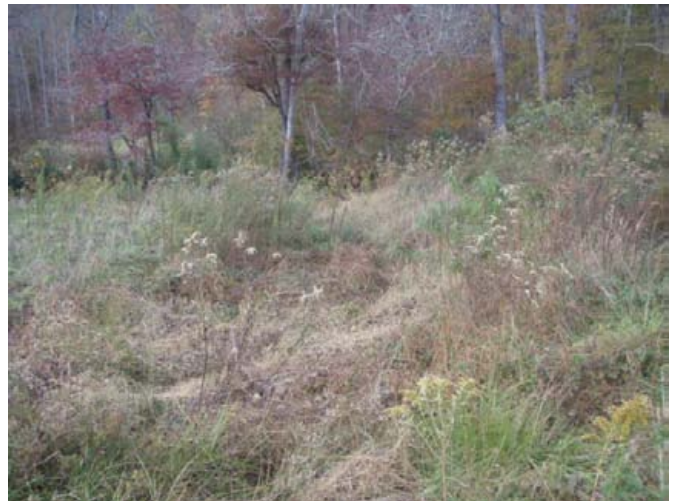
Lower portion of UT2, facing downstream, 29 October 2013.

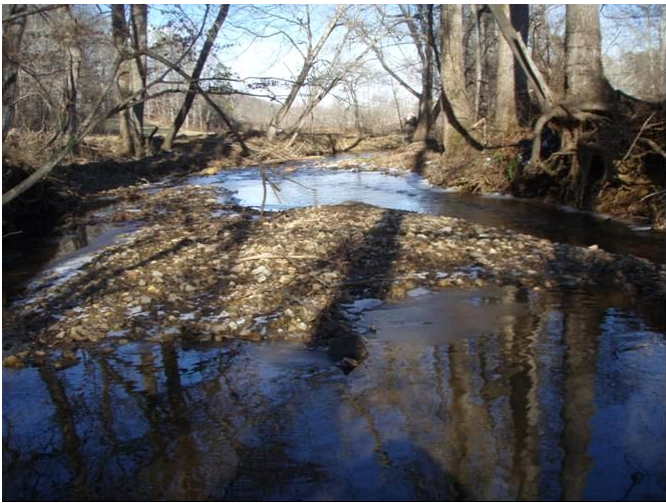
Photo Station 12

Mid channel aggradation, sta. 1+50 to 2+50, facing downstream.
22 January 2009.

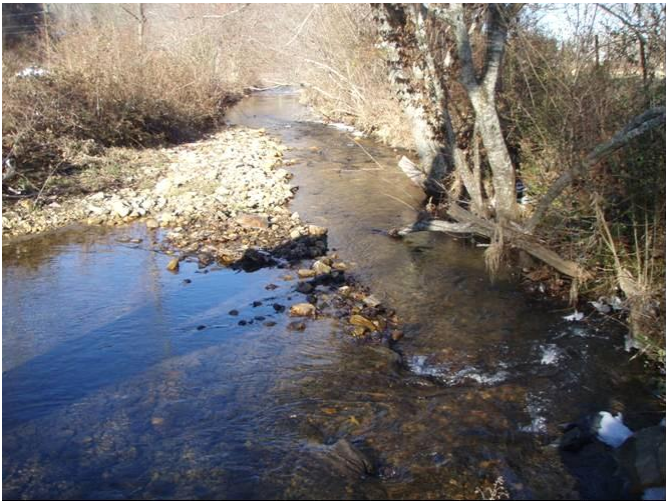
Photo Station 15

Bed aggradation and transverse bar, sta. 9+50 to 10+00, facing downstream, 22 January 2009.

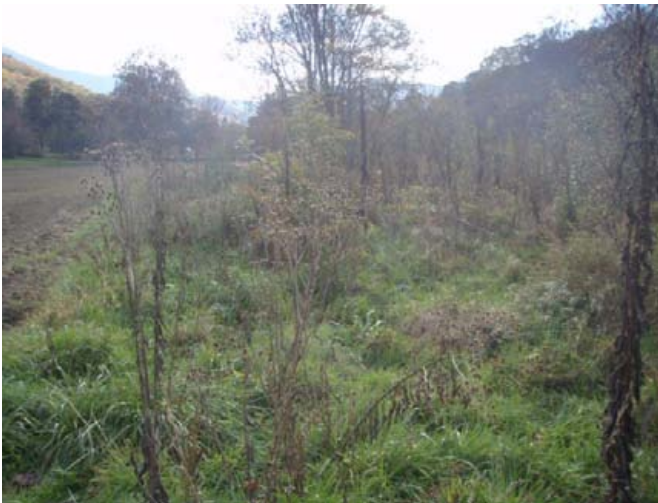
Left bank of Davis property, sta. 7+37, lower project boundary, facing upstream, 29 October 2013.

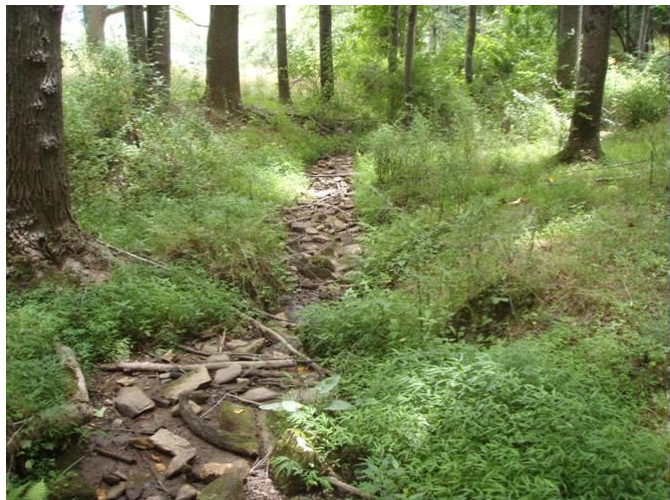
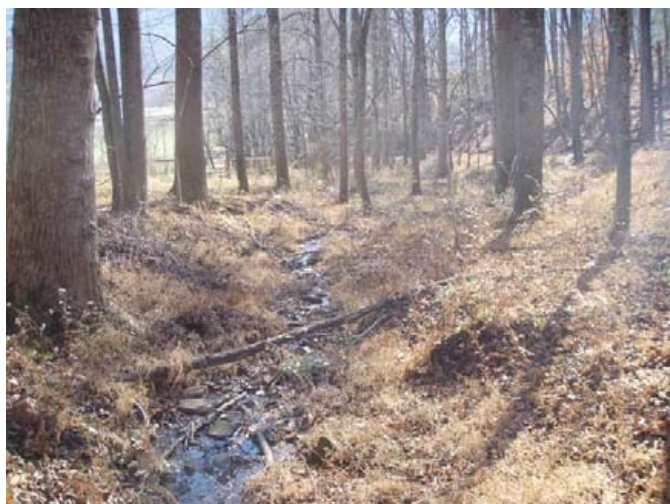
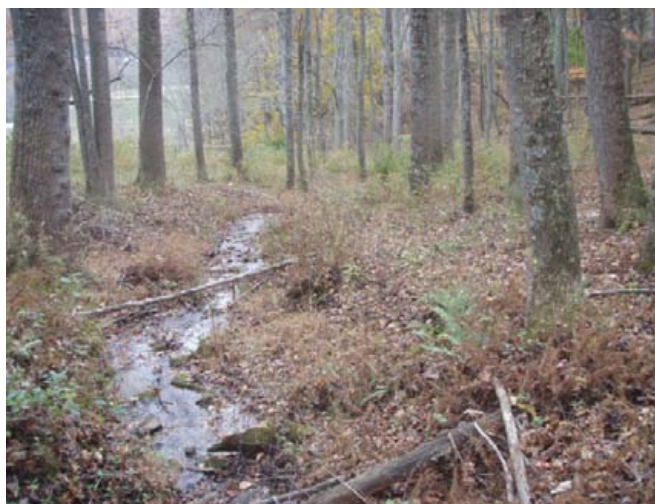
Photo Station 24

Upper portion of UT3 preservation, facing downstream, 25 July 2008.

Upper portion of UT3 preservation, facing downstream, 20 November 2012.

Upper portion of UT3 preservation, facing downstream, 29 October 2013.

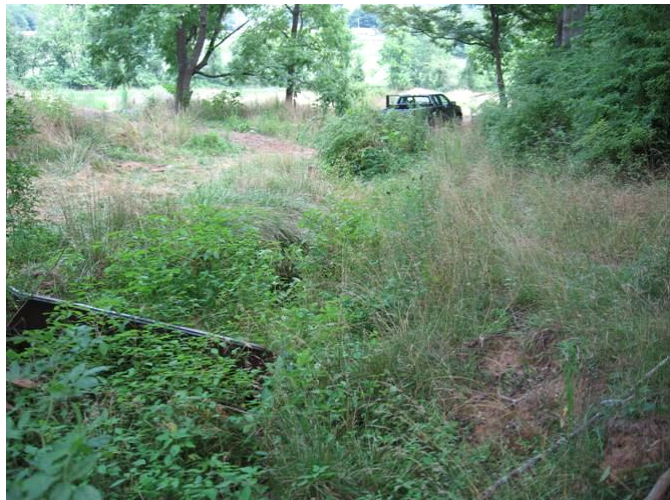
UT3 above ford, channel incision, facing downstream, 25 July 2008.

UT3 above ford, invasive removal, cattle exclusion, and bank shaping, facing upstream, 9 November 2011.

UT3 above ford, invasive removal, cattle exclusion, and bank shaping, facing upstream, 20 November 2012.

UT3 above ford, invasive removal, cattle exclusion, and bank shaping, facing upstream, 29 October 2013.

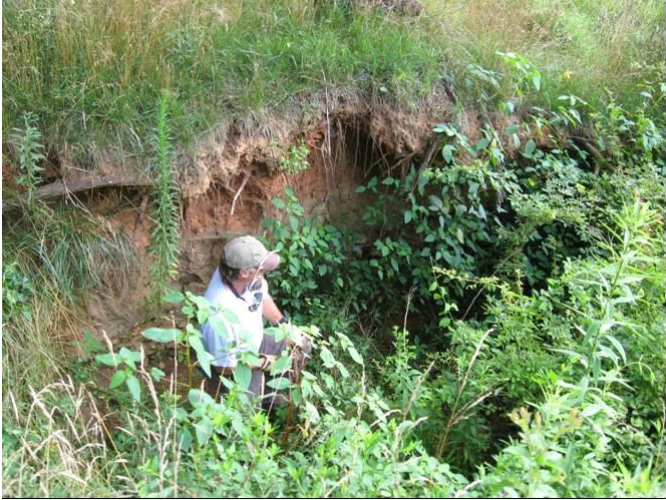
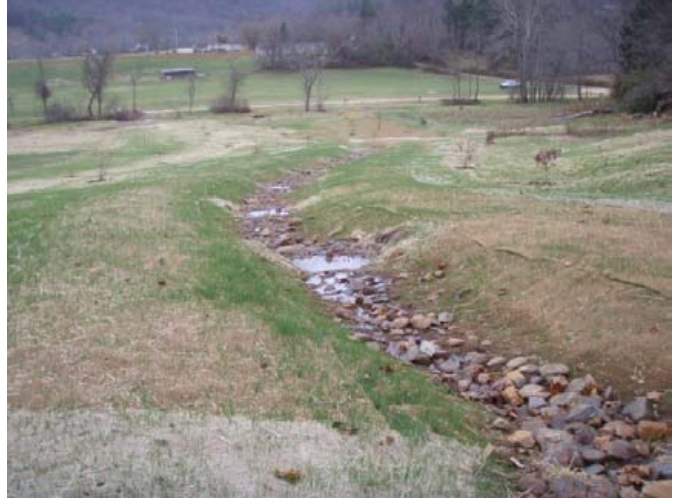
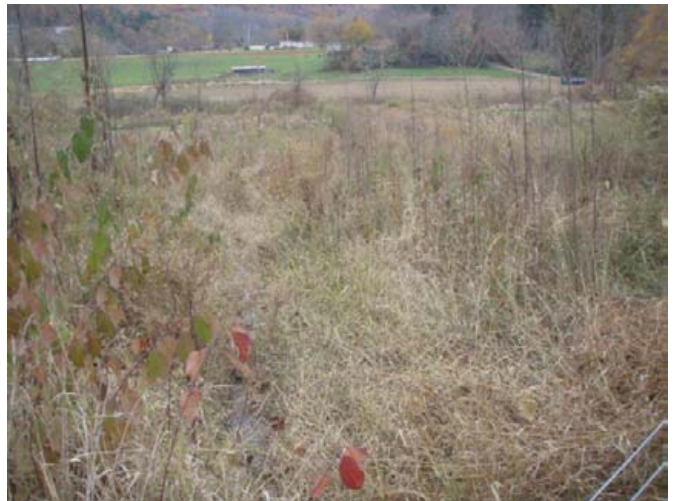
Photo Station 25

UT3 below ford, severe entrenchment and head cutting, 25 July 2008.

UT3 below ford, Priority I channel restoration, facing downstream, sta. 0+00, 15 November 2011.

UT3 below ford, Priority I channel restoration, facing downstream, sta. 0+00, 14 June 2012.

UT3 below ford, Priority I channel restoration, facing downstream, sta. 0+00, 29 October 2013.

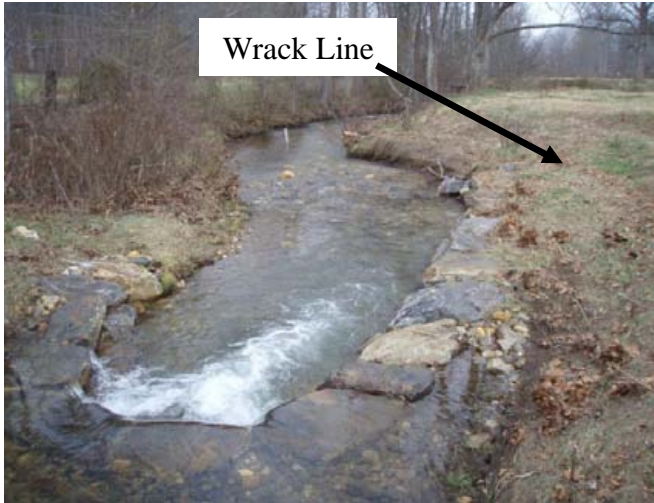
Photo 1 bankfull event on SHC, Bianculli property, sta. 6+00, 28 November 2011.

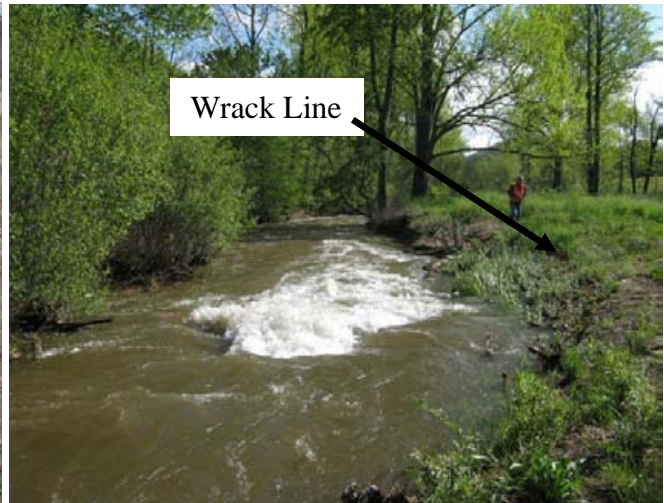
Photo 4 bankfull event on SHC, Bianculli property, sta. 6+00 06 May 2013.

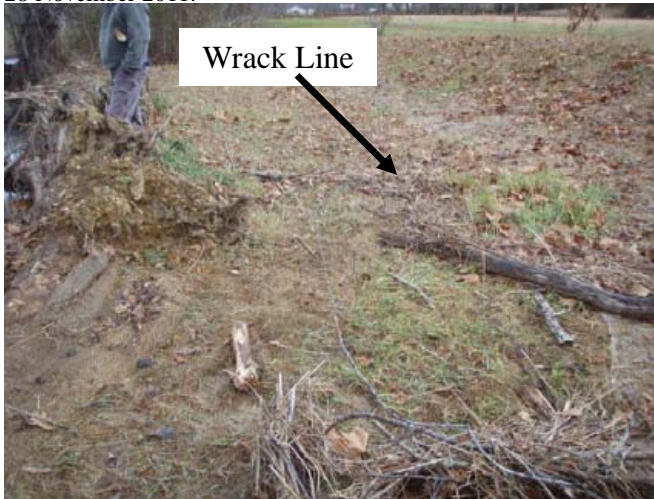
Photo 2 bankfull event on SHC, Roberson property, sta. 8+00 28 November 2011.

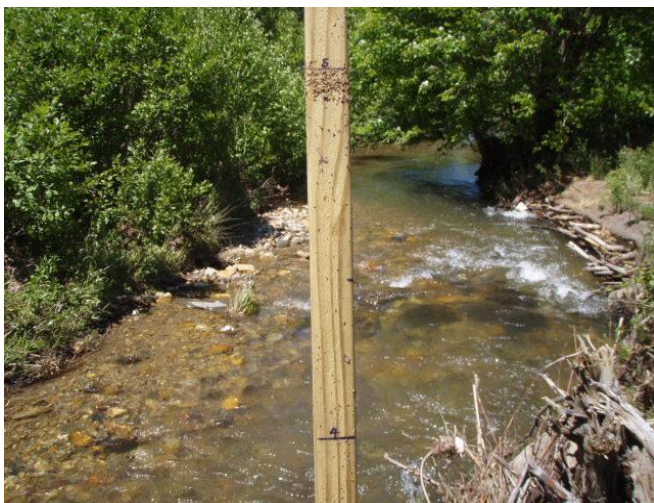
Simple crest gage verification of the 5 May 2013 bankfull event.

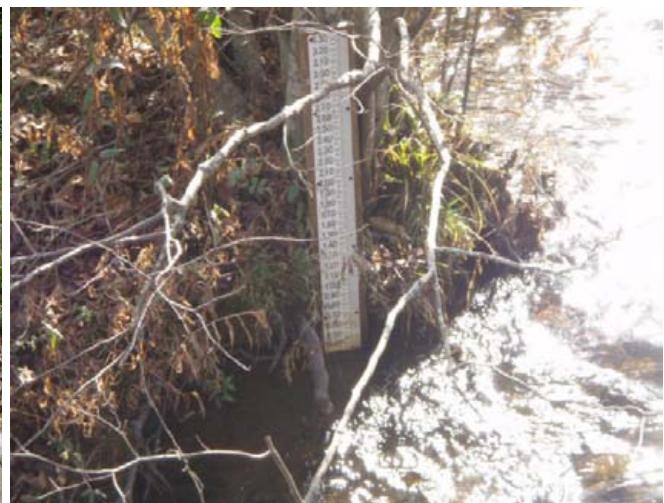
Stream gage plate, sta. 8+00, Mainstem 1 reach

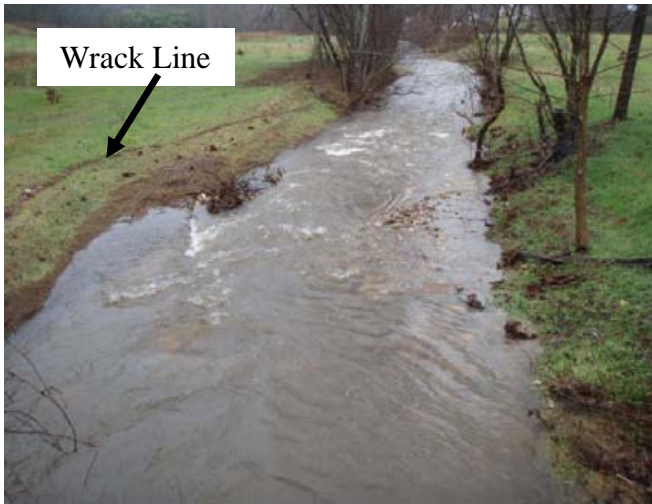
Photo 3 bankfull event on SHC, Davis property, sta. 0+50
28 November 2011.

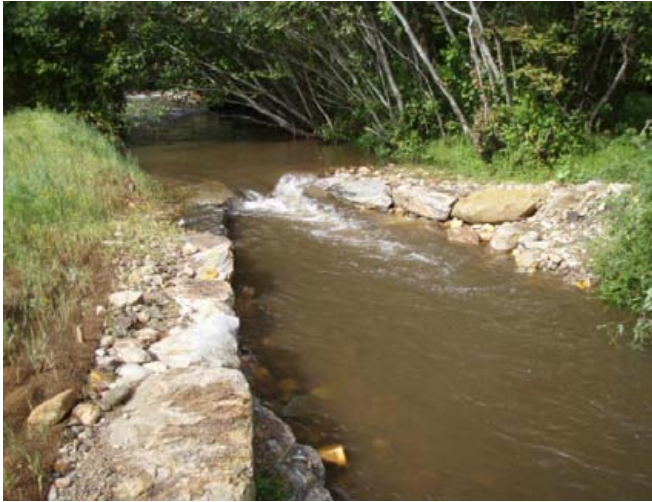
Problem Area 1

Rock vane after construction, sta. 1+50, facing upstream, 5 September 2011.

Rock vane, sta. 1+50, facing upstream, 20 November 2012.

Rock vane, sta. 1+50, facing upstream, 29 October 2013.

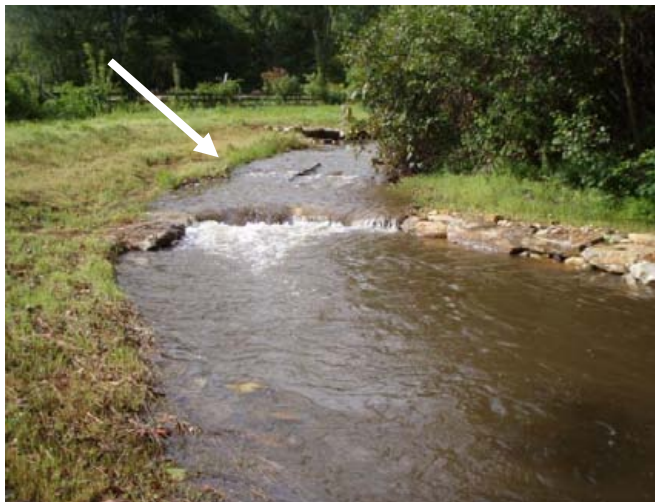
Problem Area 2

Right channel bank in stable condition, sta. 2+00, facing upstream, 5 September 2011.

Right channel bank instability, sta. 1+75 to 2+25, facing downstream, 20 November 2012.

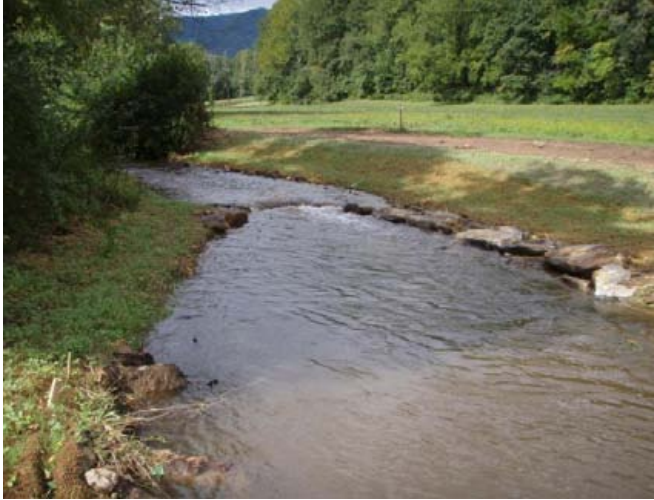
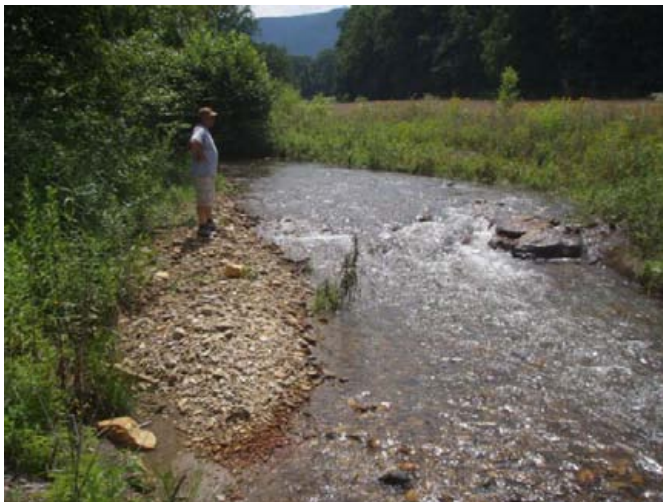
Problem Area 4

J-hook vane after construction, sta. 9+25, facing upstream, 5 September 2011.

Aggradation and bar formation below J-hook, sta. 9+25 to 9+50, after flood event, facing upstream, 5 December 2011.

Inner berm formation below J-hook, sta. 9+25 to 9+50, following 5 May 2013 flood event, facing upstream, 18 July 2013.

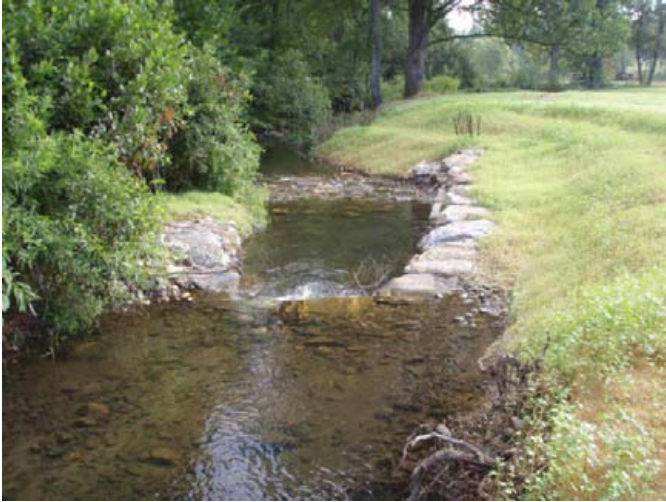
Problem Area 6

J-hook vane after construction, sta. 5+75, facing downstream, 14 August 2011.

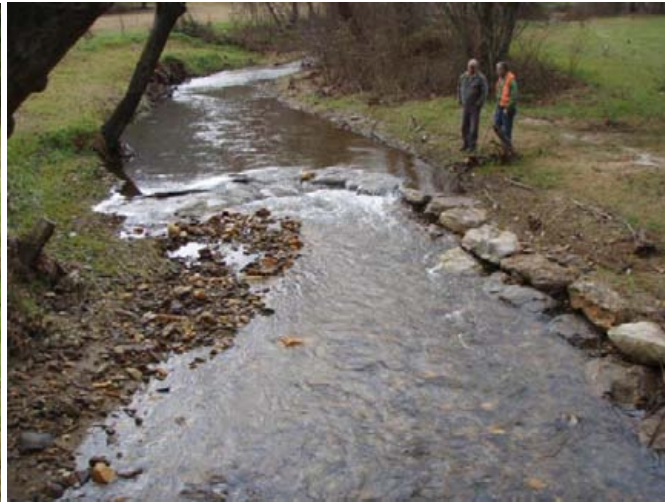
Problem Area 7

J-hook, sta. 12+75, after construction, facing upstream, 22 Sept 2011.

J-hook after 28 Nov 2011 flood event, aggradation in pool below J-hook, 5 December 2011.

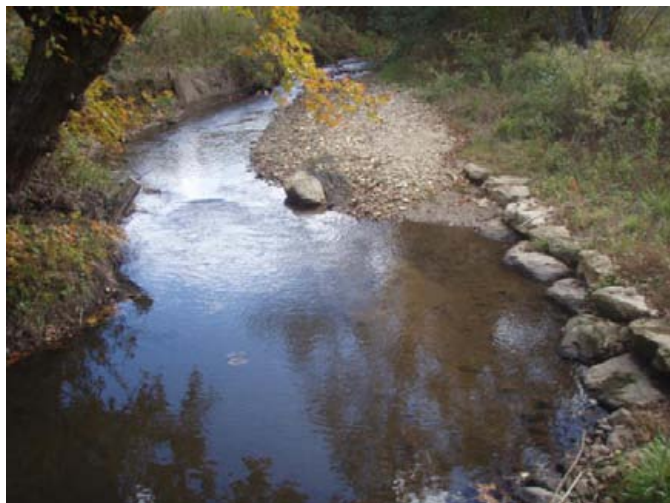
J-hook after 5 May 2013 flood event, aggradation above J-hook and scour pool below, 29 October 2013.

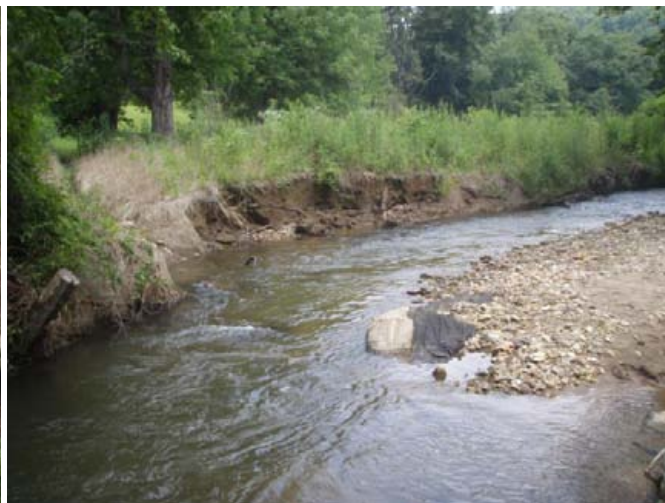
Right bank scour and erosion during 5 May 2013 flood event, facing upstream, sta. 12+50, 18 July 2013.

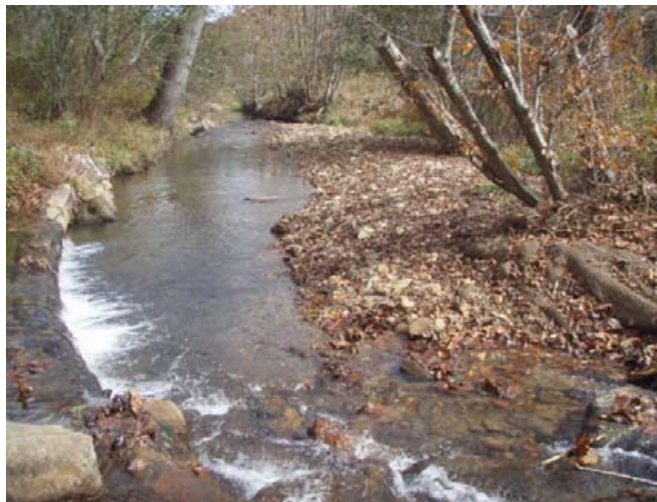
Problem Area 8

Aggradation below J-hook, sta. 4+00 to 4+50, following 5 May 2013 flood event, facing downstream, 29 October 2013.

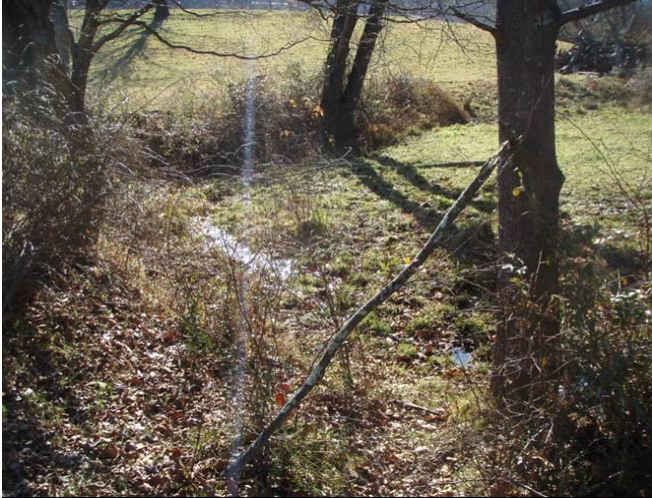
Wetland D, area of livestock access, facing upstream, 2009.
