Monitoring Year 3 Report

Upper South Hominy Mitigation Site, South Hominy Creek, French Broad River Basin, Buncombe County, North Carolina

EEP Project Number: 92632
Contract Number: D06082; Task Order: 08 FB05-1b-d

Data Collected: October 2014-November 2014
Submitted: February 2015

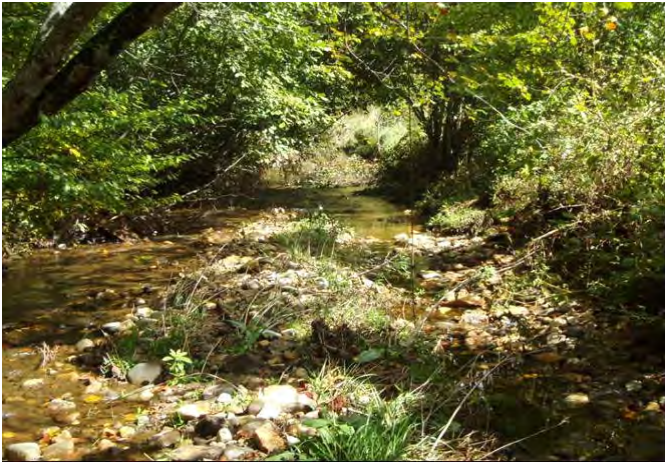
Photo Station 1

Mid channel bar, sta. 0+50, facing downstream, pre-construction.
30 September 2008.

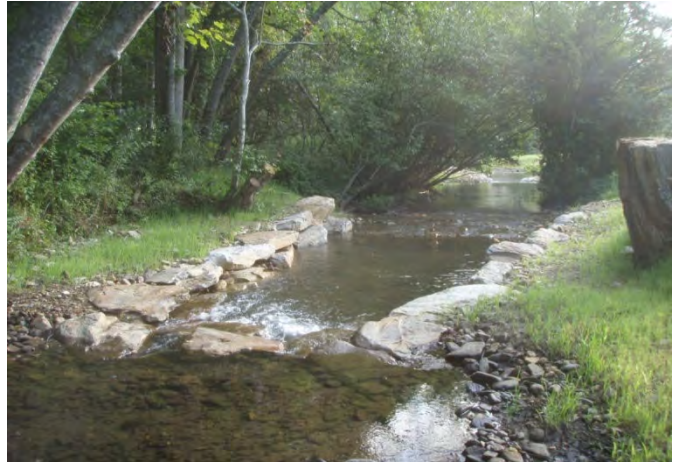
Cross vane, sta. 0+50, facing downstream, 14 August 2011.

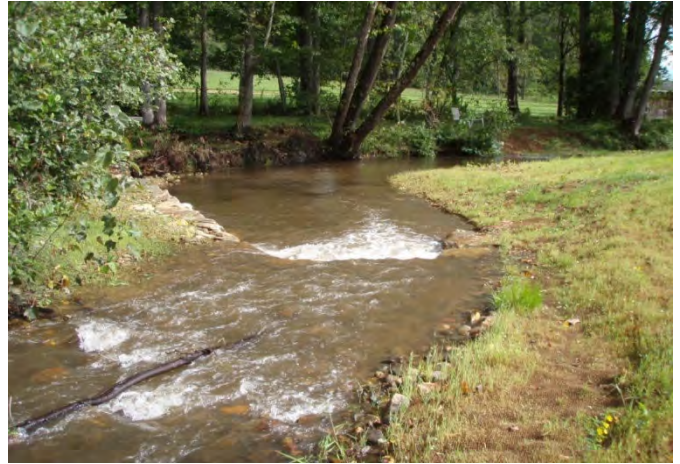
J-hook, sta. 2+50, facing downstream, 5 September 2011.

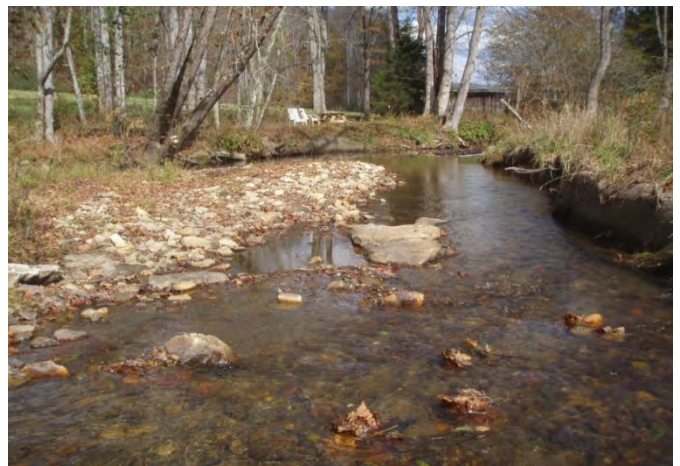
J-hook, sta. 2+50, facing downstream, 29 October 2013.

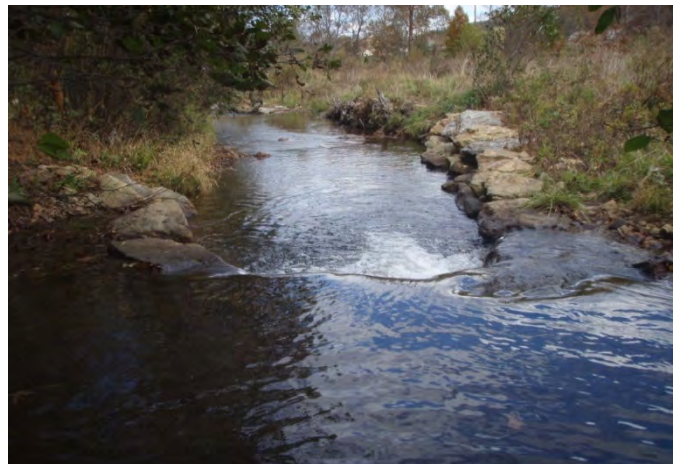
J-hook, sta. 5+00, facing downstream, 29 October 2013.

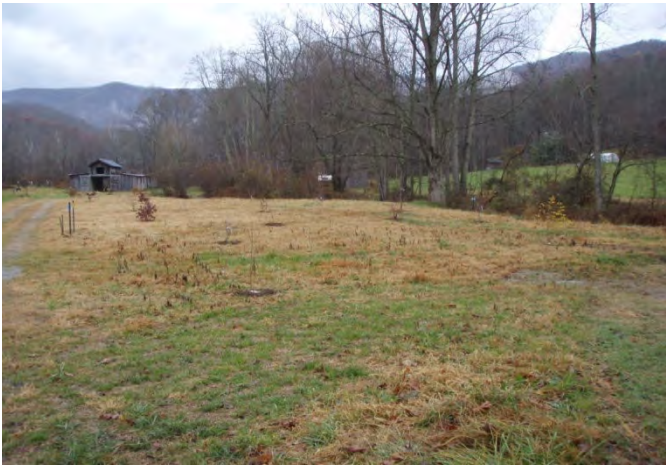
Photo Station 4

Sta. 6+50 to 8+00, right bank facing upstream, 5 December 2011.

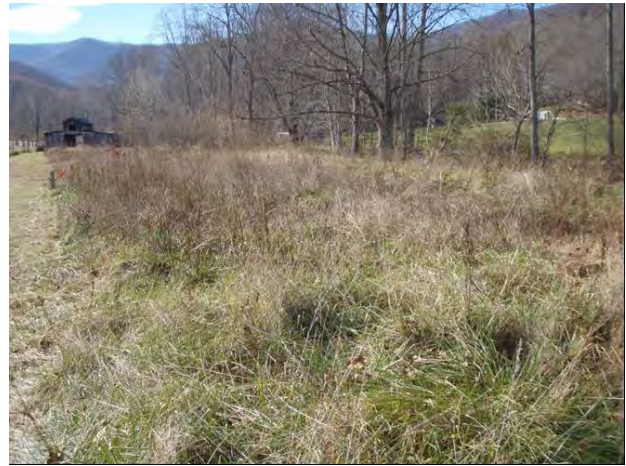
Sta. 6+50 to 8+00, right bank facing upstream, 20 November 2012.

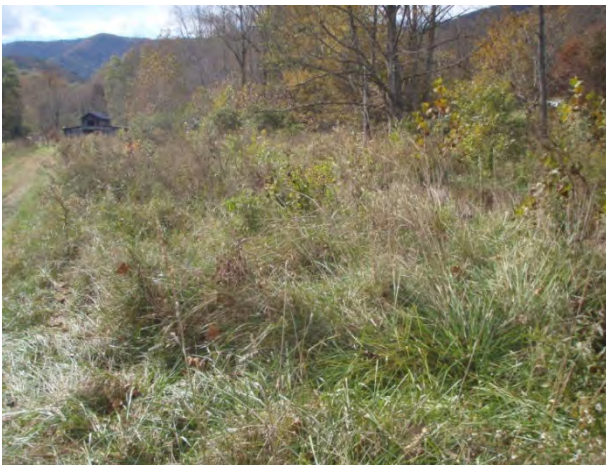
Sta. 6+50 to 8+00, right bank facing upstream, 29 October 2013.

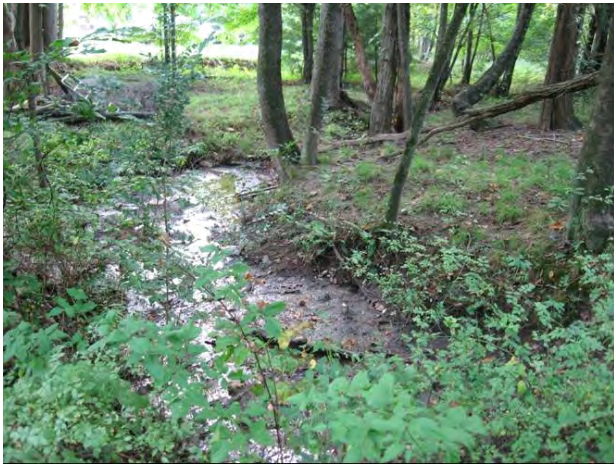
Photo Station 5

UT1 facing downstream, adjacent to small barn, 28 July 2009.

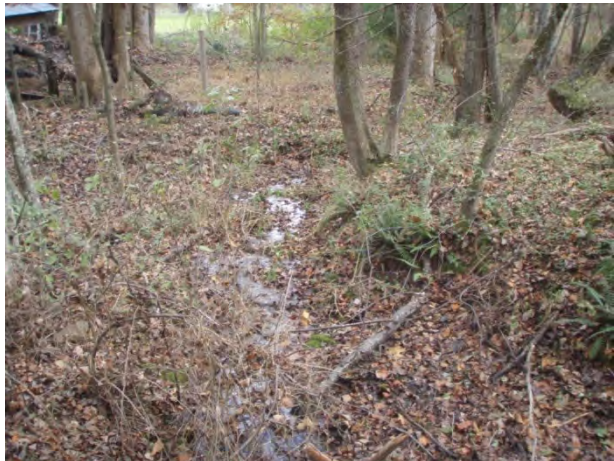
UT1 facing downstream, adjacent to small barn, 29 October 2013.

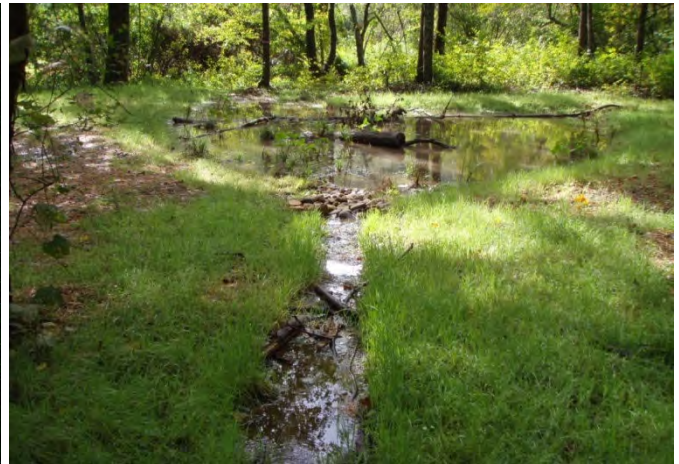
UT1, above vernal pond, 5 September 2011.

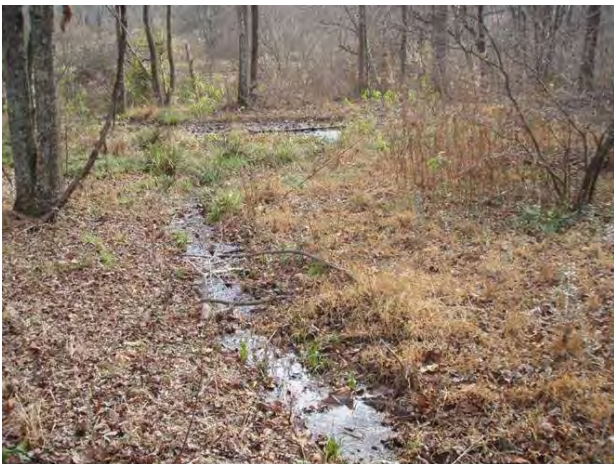
UT1 Priority I construction, above vernal pond, 20 November 2012.

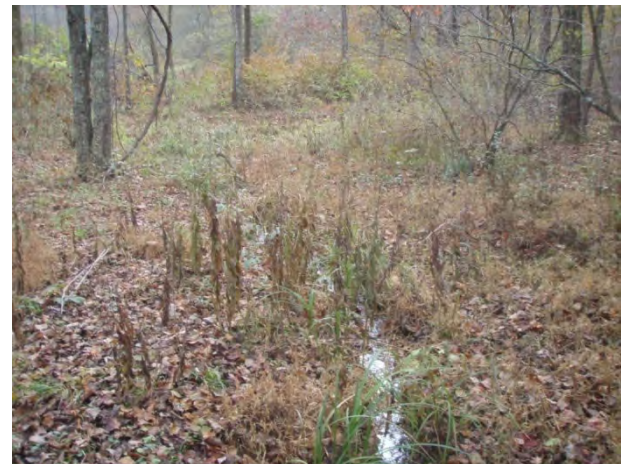
UT1 Priority I construction, above vernal pond, 29 October 2013.

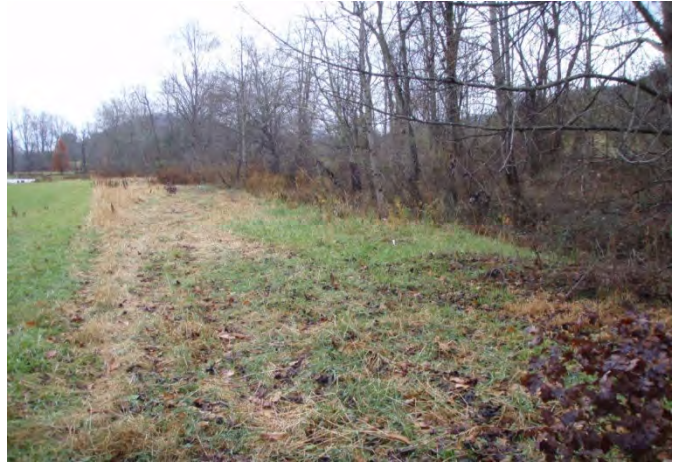
UT2 facing downstream, post invasive removal, 5 Dec 2011.

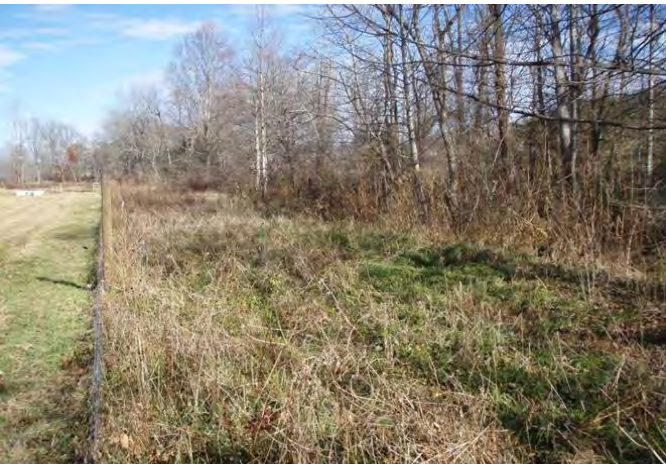
UT2 facing downstream, post invasive removal, 20 Nov 2012.

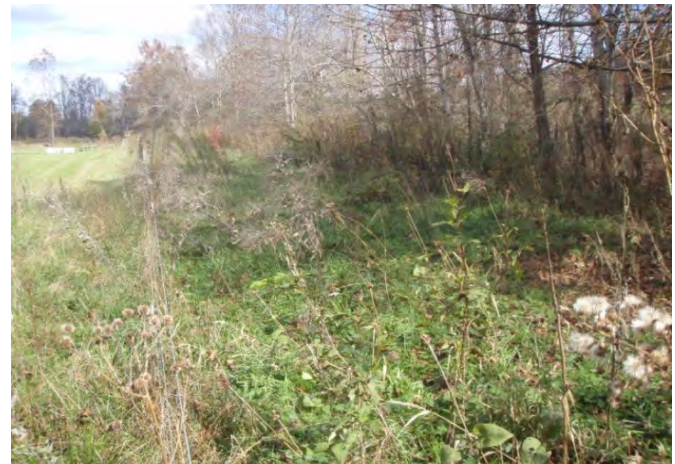
UT2 facing downstream, post invasive removal, 29 Oct 2013.

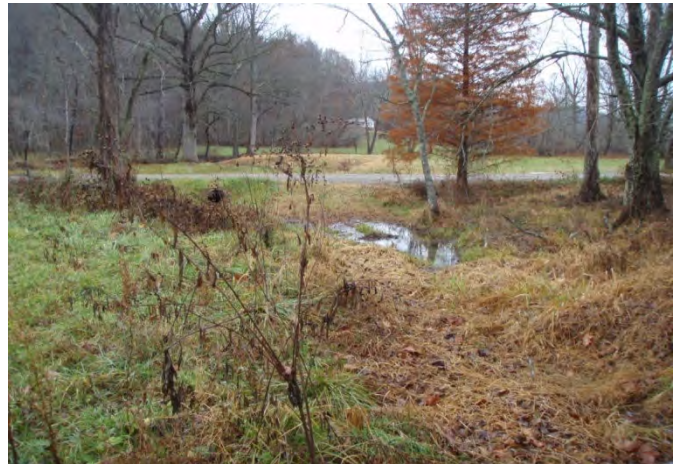
UT2 re-connected under Canterfield Lane to abandoned channel, sta. 0+00 to 0+50, 5 December 2011.

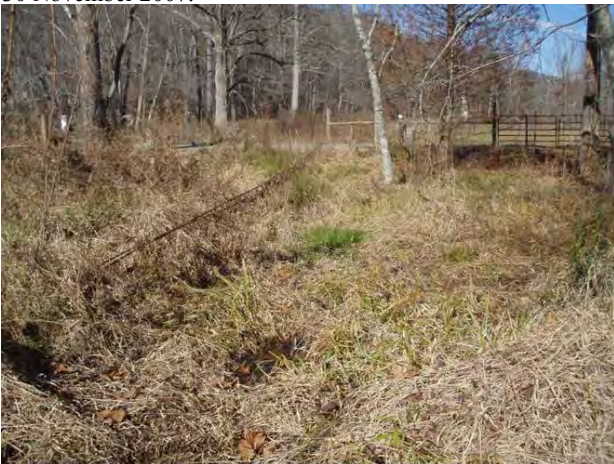
UT2 re-connected under Canterfield Lane to abandoned channel, sta. 0+00 to 0+50, 20 November 2012.

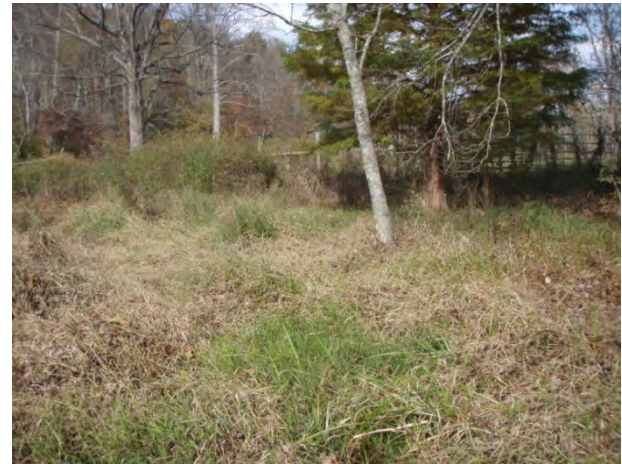
UT2 re-connected to abandoned channel, sta. 0+00 to 0+50, 29 October 2013.

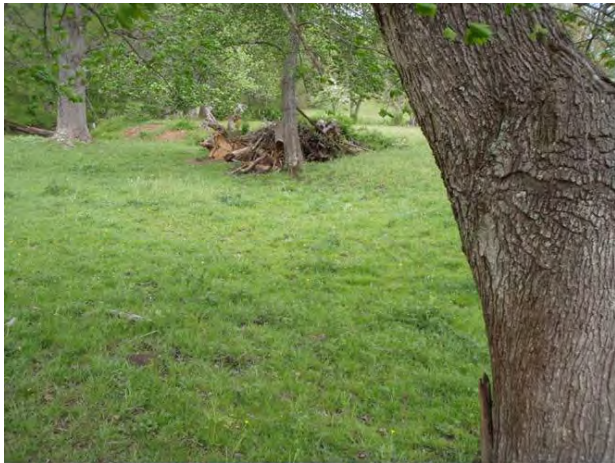
Abandoned UT2 channel east of Canterfield Lane, 26 April 2010.

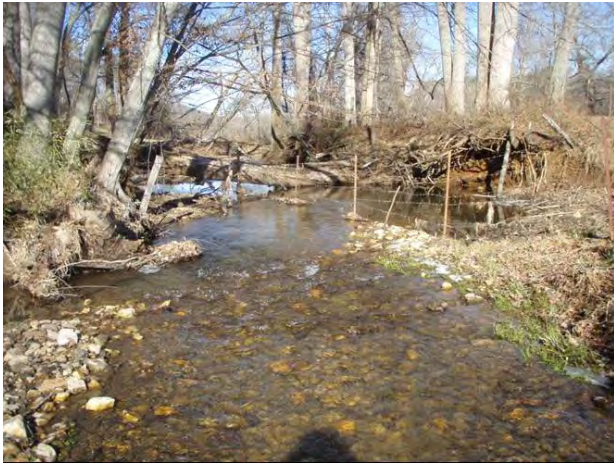
Photo Station 11

Livestock access right bank, sta. 1+00 to 1+50, facing downstream. 22 January 2009.

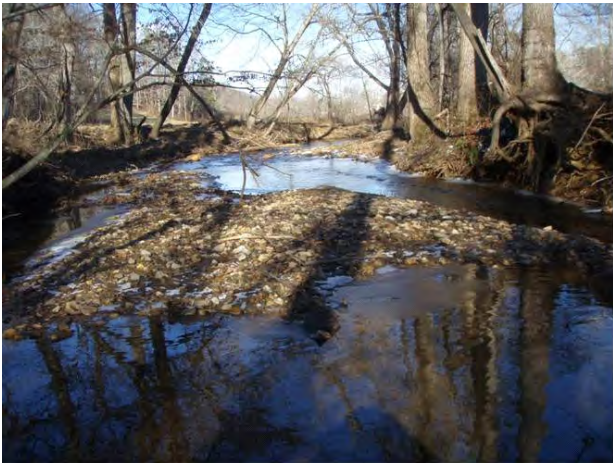
Photo Station 12

Mid channel aggradation, sta. 1+50 to 2+50, facing downstream. 22 January 2009.

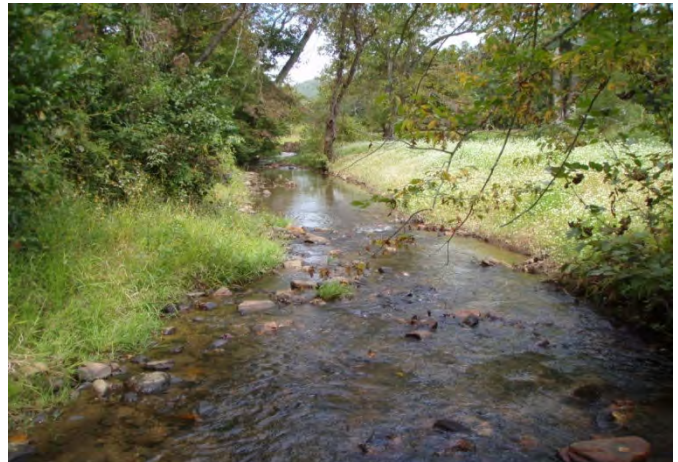
Fence and invasive removal, bank sloping, sta. 5+00, facing downstream, 22 September 2011.

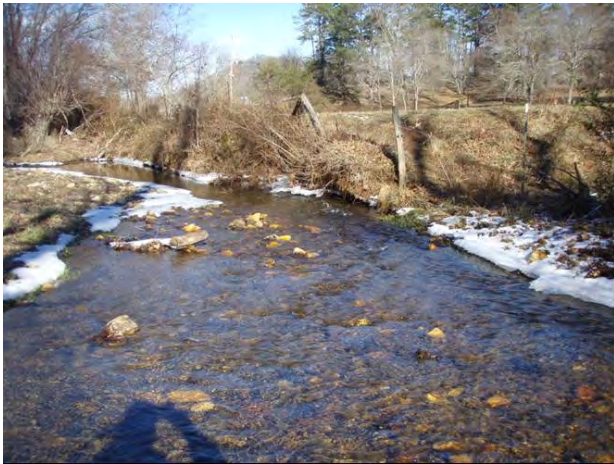
Photo Station 14

Outside meander bend bank stress, sta. 7+25 to 8+00, facing downstream, 22 January 2009.

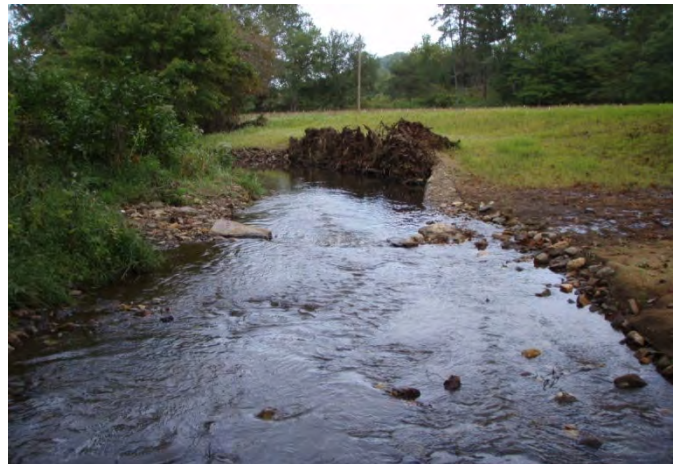
Log vane, root wad, and bank shaping, sta. 7+25 to 8+00, 22 September 2011.

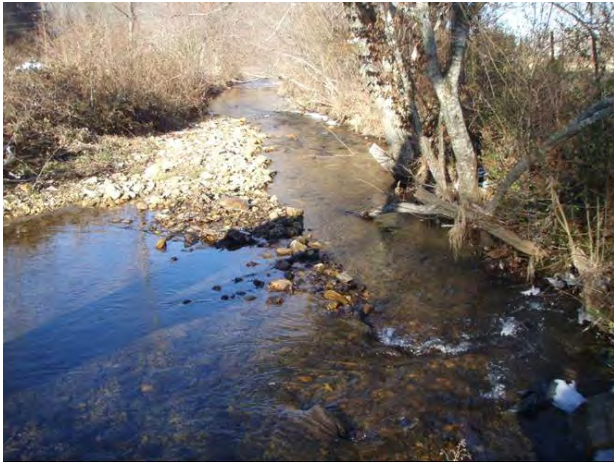
Photo Station 15

Bed aggradation and transverse bar, sta. 9+50 to 10+00, facing downstream, 22 January 2009.

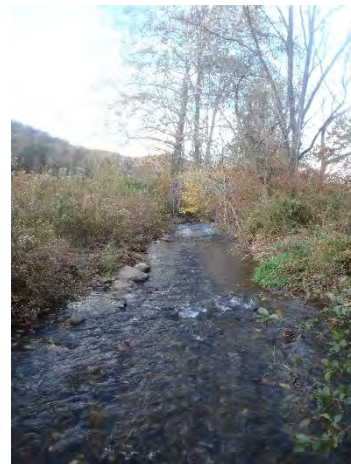
Cross vane, riffle construction, and bank shaping, sta. 6+75, 12 Nov 2014.

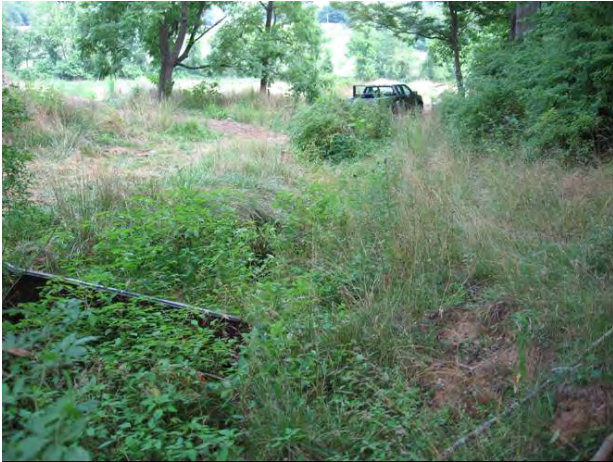
UT3 above ford, channel incision, facing downstream, 25 July 2008.

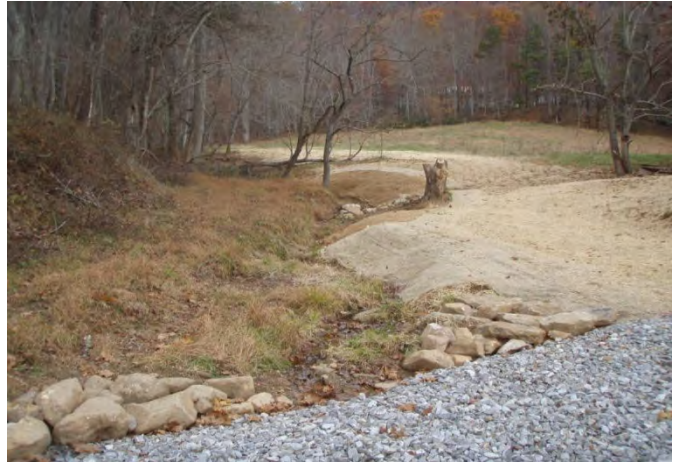
UT3 above ford, invasive removal, cattle exclusion, and bank shaping, facing upstream, 9 November 2011.

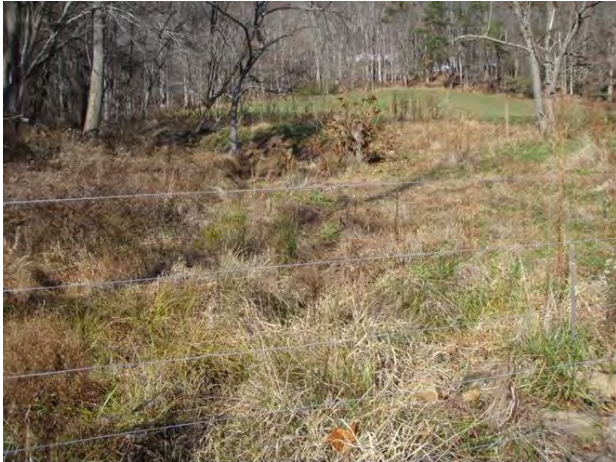
UT3 above ford, invasive removal, cattle exclusion, and bank shaping, facing upstream, 20 November 2012.

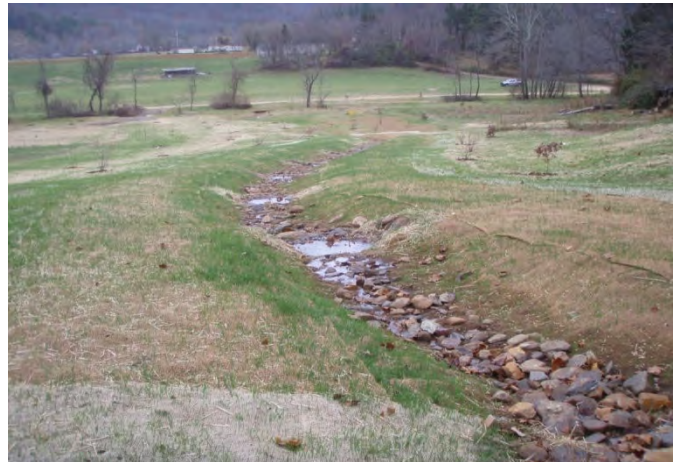
UT3 below ford, Priority I channel restoration, facing downstream, sta. 0+00, 15 November 2011.

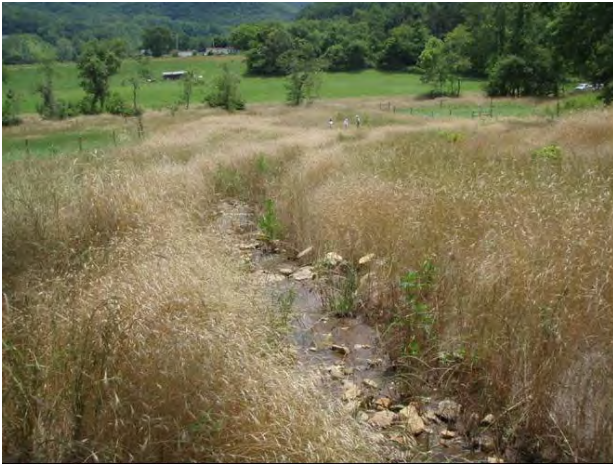
UT3 below ford, Priority I channel restoration, facing downstream, sta. 0+00, 14 June 2012.

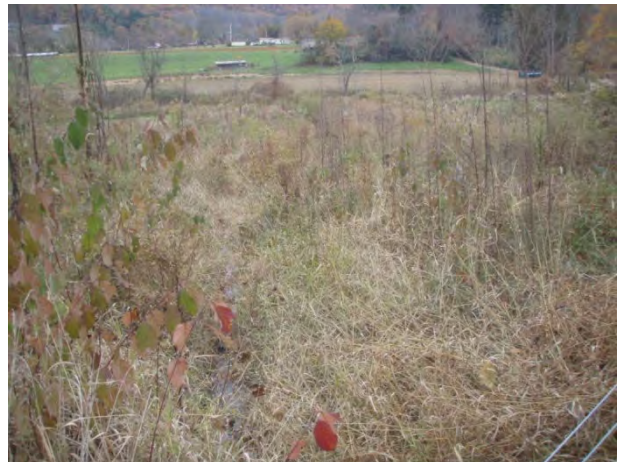
UT3 below ford, Priority I channel restoration, facing downstream, sta. 0+00, 29 October 2013.

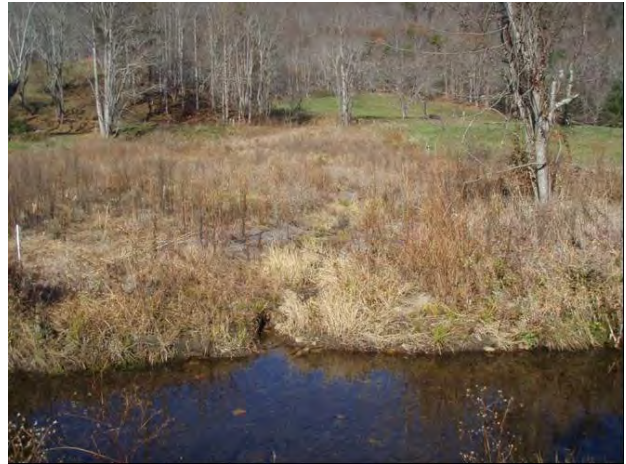
UT3 lower at confluence with SHC, Priority I restoration, facing upstream, 20 November 2012.

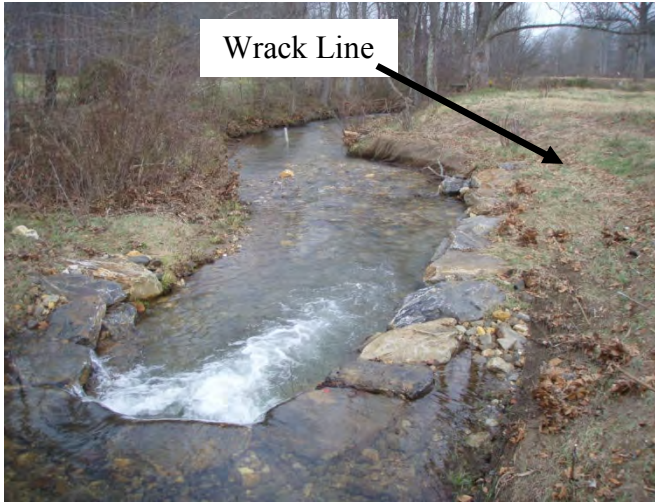
Photo 1 bankfull event on SHC, Bianculli property, sta. 6+00, 28 November 2011.

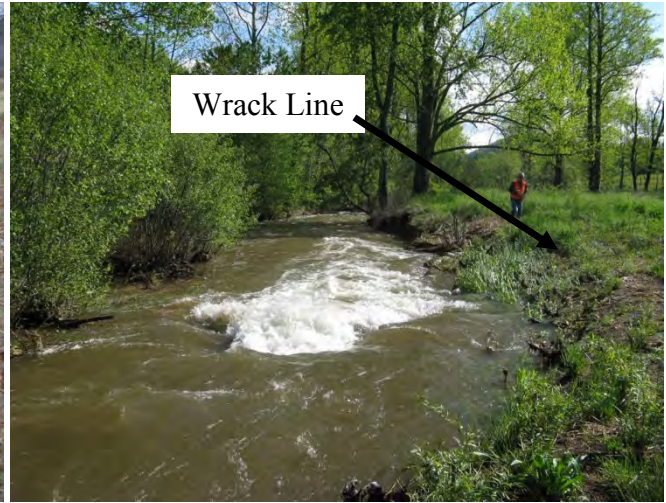
Photo 4 bankfull event on SHC, Bianculli property, sta. 6+00 06 May 2013.

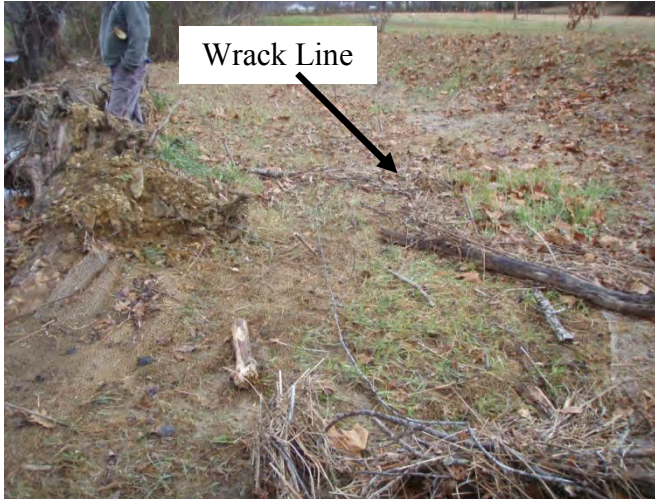
Photo 2 bankfull event on SHC, Roberson property, sta. 8+00 28 November 2011.

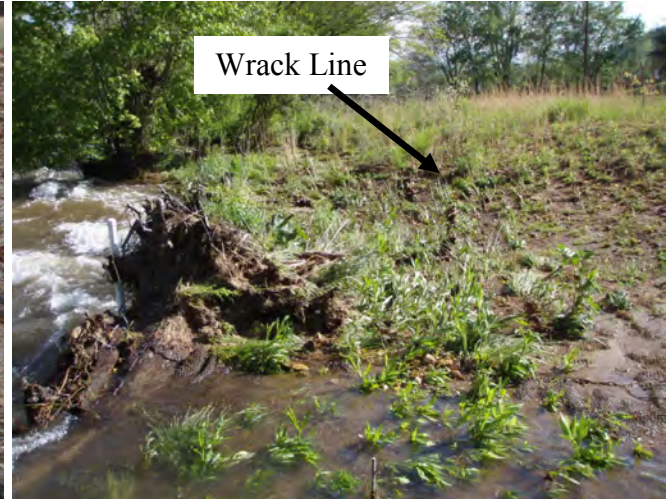
Photo 5 bankfull event on SHC, Roberson property, sta. 8+00 06 May 2013

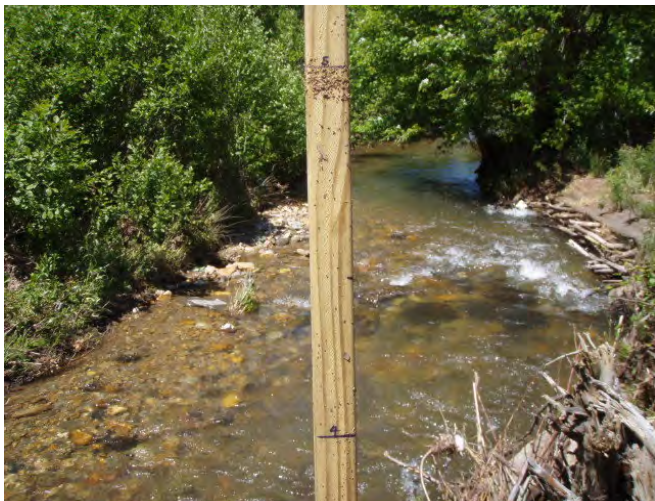
Simple crest gage verification of the 5 May 2013 bankfull event.

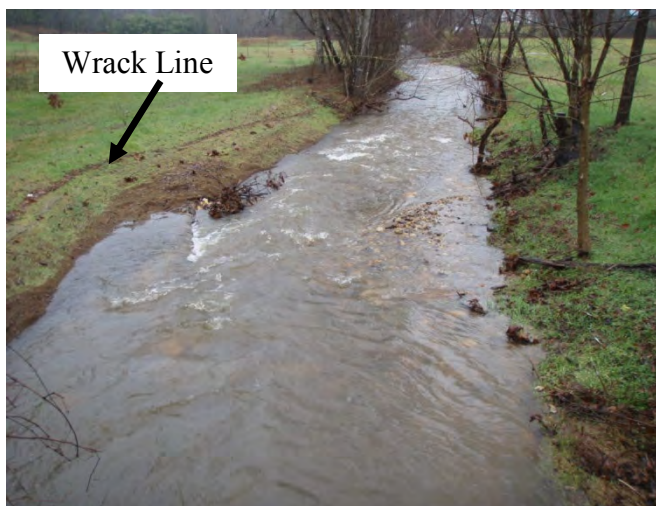
Photo 3 bankfull event on SHC, Davis property, sta. 0+50
28 November 2011.

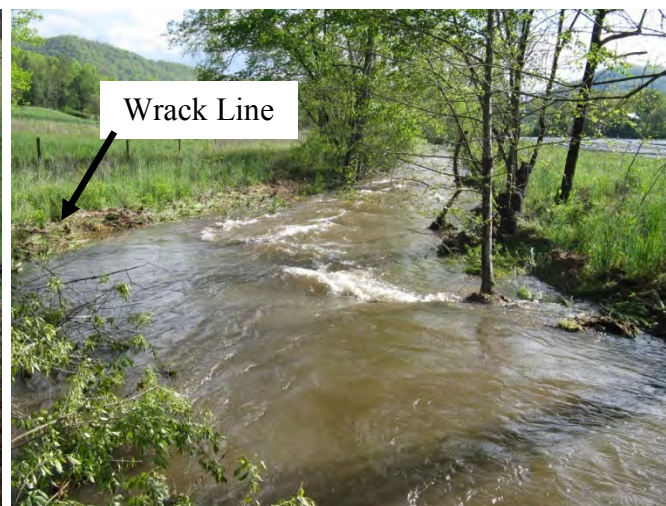
Photo 6 bankfull event on SHC, Davis property, sta. 0+50
06 May 2013.

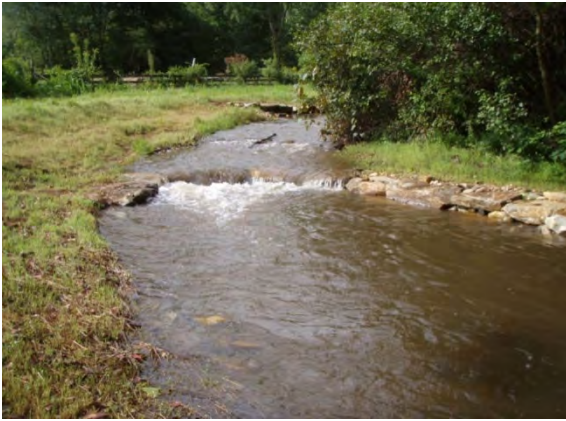
Problem Area 2

Right channel bank in stable condition, sta. 2+00, facing upstream, 5 September 2011.

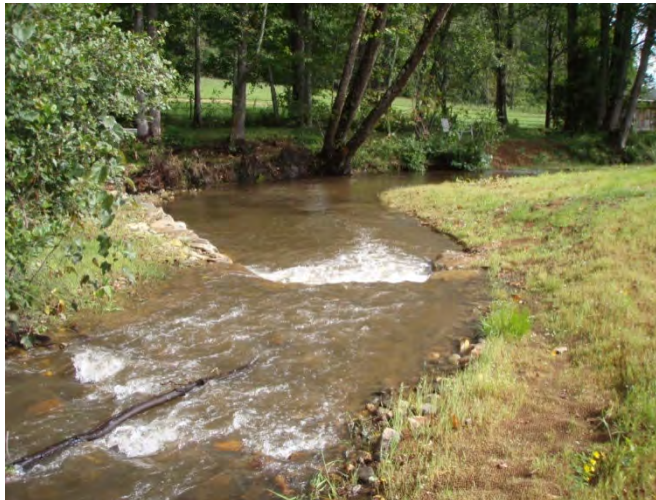
Problem Area 3

J-hook and meander post construction, sta. 2+50, facing downstream, 5 September 2011.

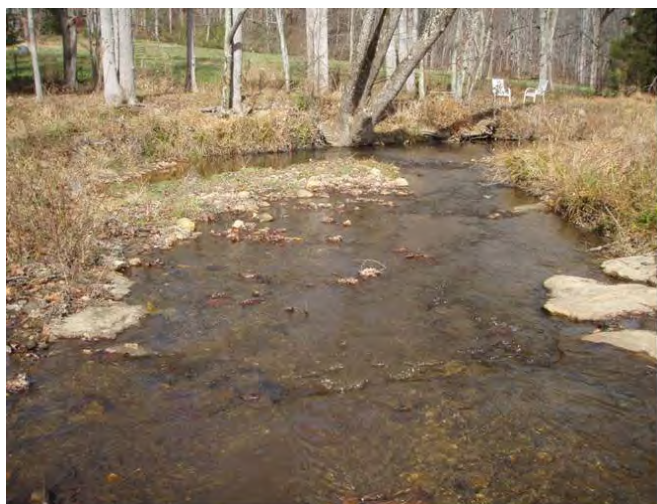
Aggradation and bar formation in meander below J-hook, sta. 2+50, facing downstream, 20 November 2012.

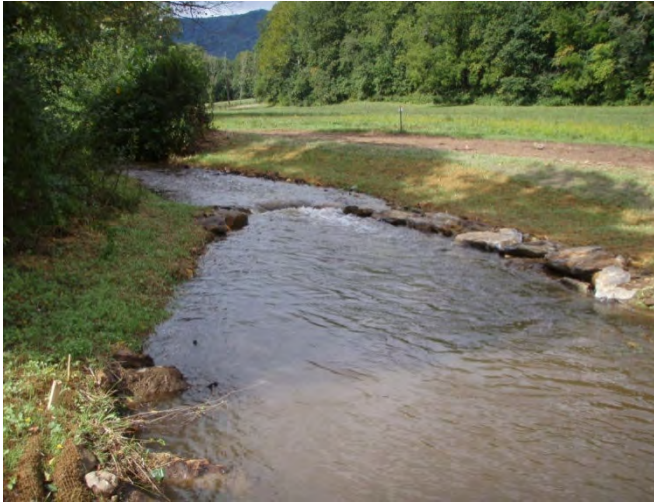
Problem Area 4

J-hook vane after construction, sta. 9+25, facing upstream, 5 September 2011.

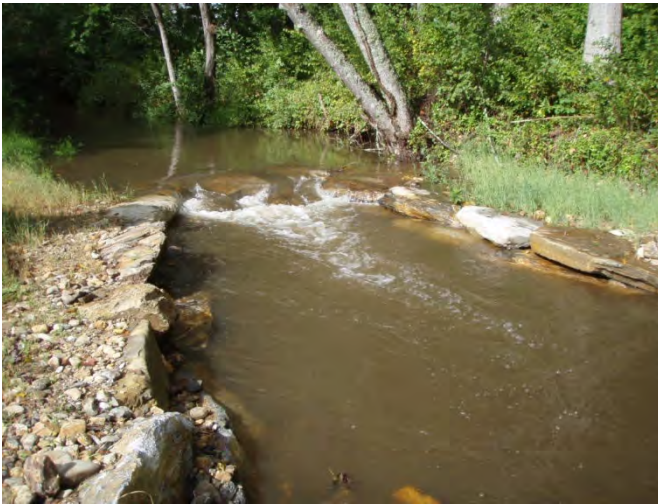
Problem Area 5

Cross vane after construction, facing upstream, sta. 0+50
14 Aug 2011.

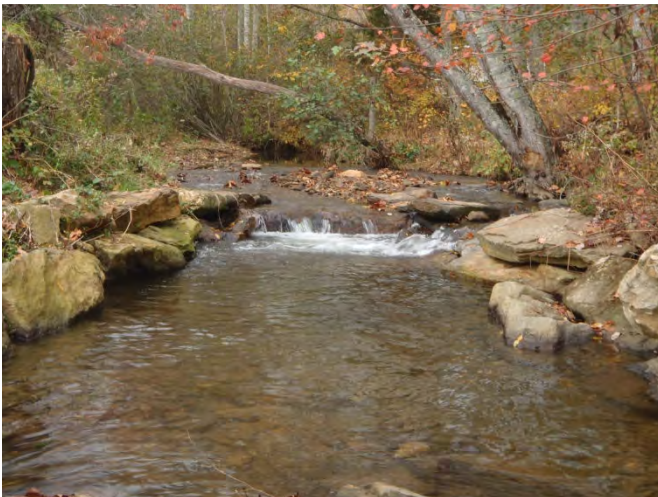
No longer considered a problem during MY3 (2014) field surveys
28 October 2014

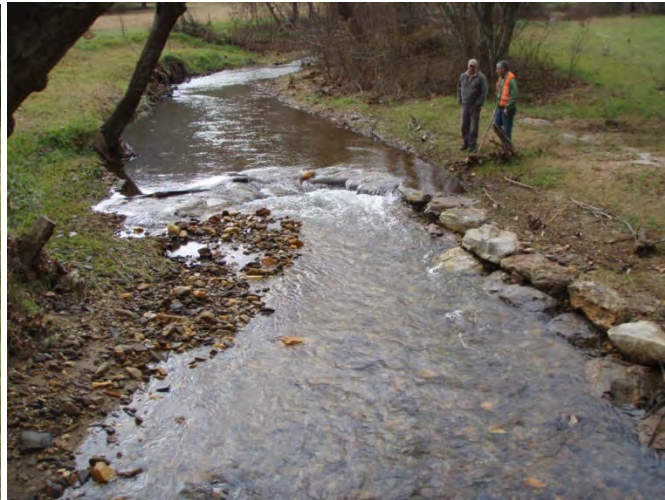
J-hook after 28 Nov 2011 flood event, aggradation in pool below J-hook, 5 December 2011.

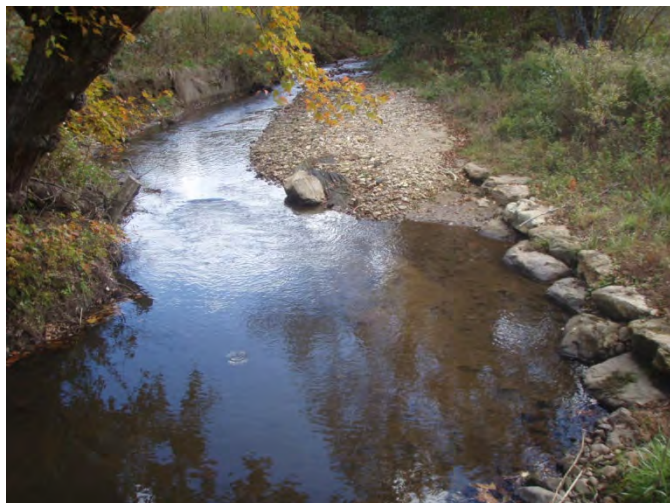
J-hook after 5 May 2013 flood event, aggradation above J-hook and scour pool below, 29 October 2013.

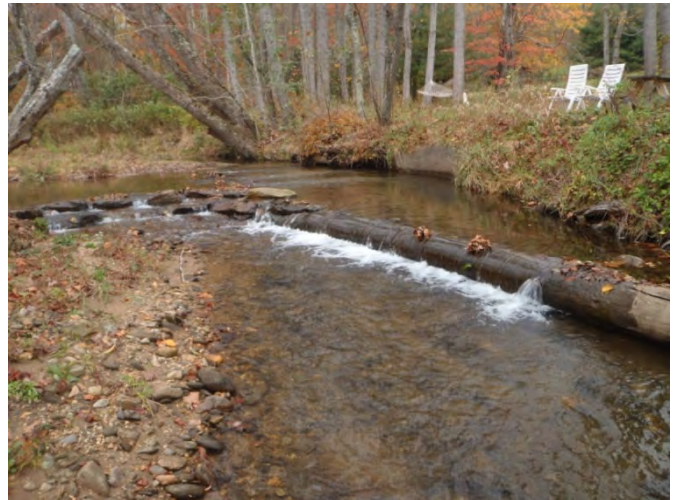
Aggradation below J-hook, sta 4+00 to 4+50, facing upstream, 28 October 2014

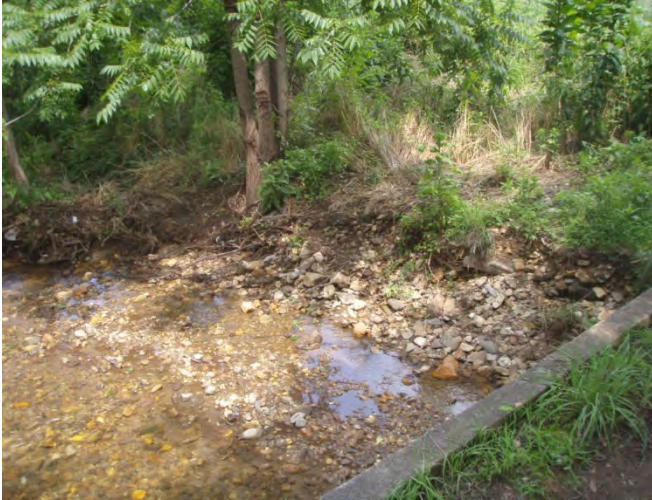
Problem Area 9

Right bank scour during 5 May 2013 flood event, sta. 0+00 to 0+20, facing downstream, 18 July 2013.

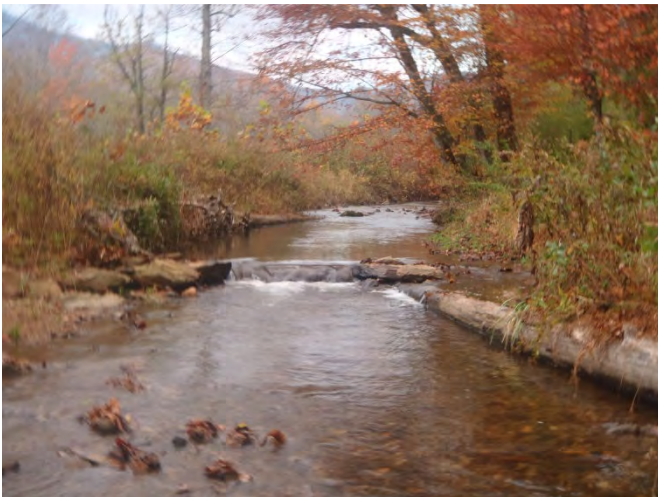
PA-09 was no longer considered a problem during MY3 (2014) surveys, 28 October 2014

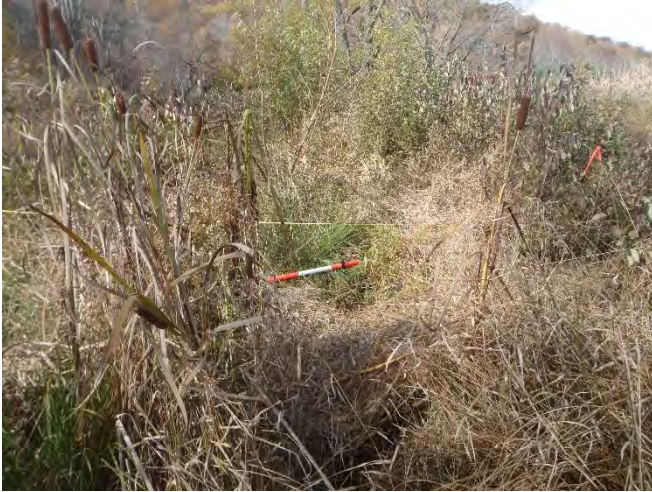
Problem Area 10

Aggradation due to low flow velocity and dense herbaceous vegetation, sta. 0+00 to 2+00 UT-3 Upper Davis Reach, facing upstream, 28 October 2014.

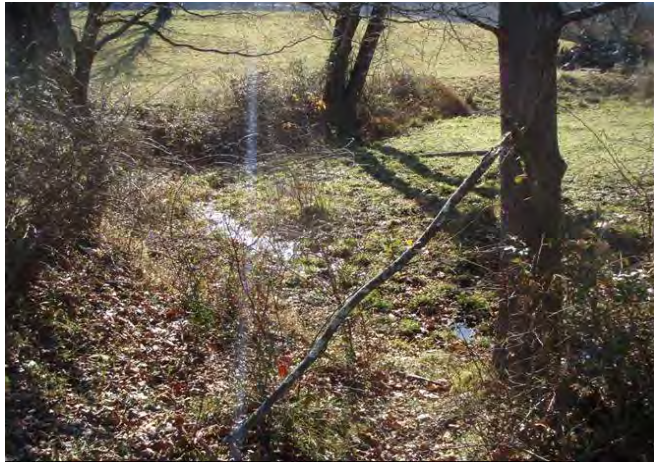
Wetland D, area of livestock access, facing upstream, 2009. September 2011.

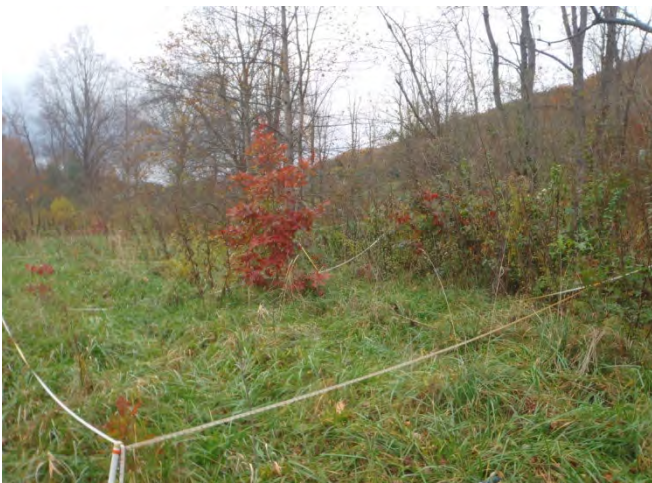
Vegetation plot 1, UT2 facing downstream (0,0), 11 Nov 2014, MY3

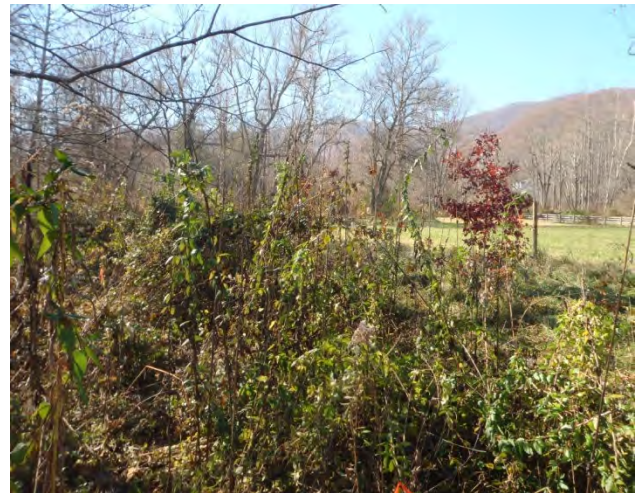
Vegetation plot 1, UT2 facing upstream (10,10), 11 Nov 2014, MY3.

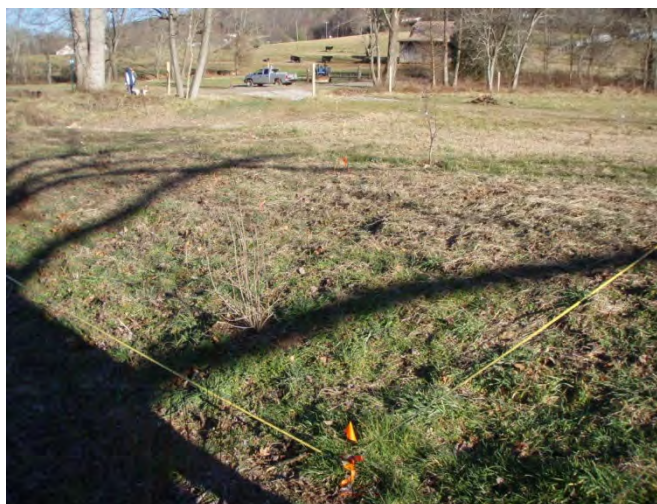
Vegetation plot 2, SHC facing downstream (0,0), 2 Feb 2012, MY0.

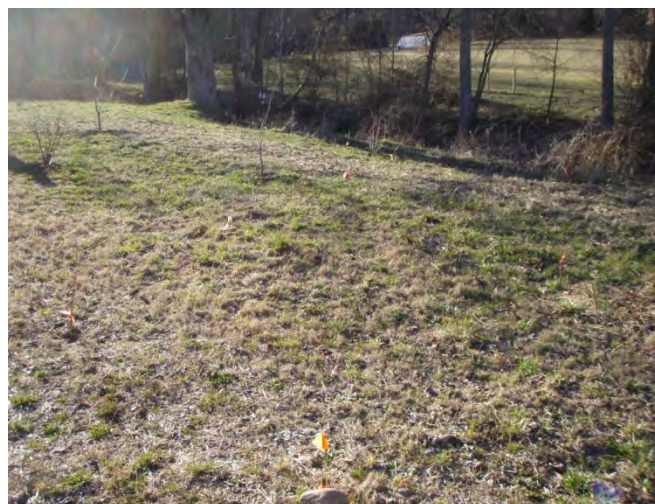
Vegetation plot 2, SHC facing upstream (10,10), 2 Feb 2012, MY0.

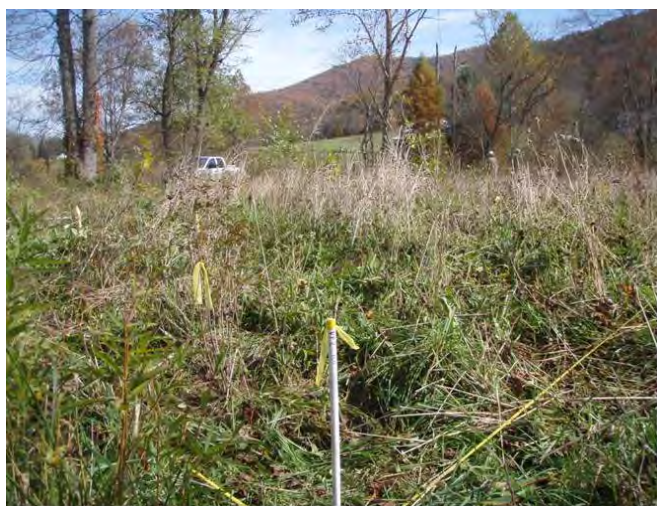
Vegetation plot 2, SHC facing downstream (0,0), 23 October 2012, MY1.

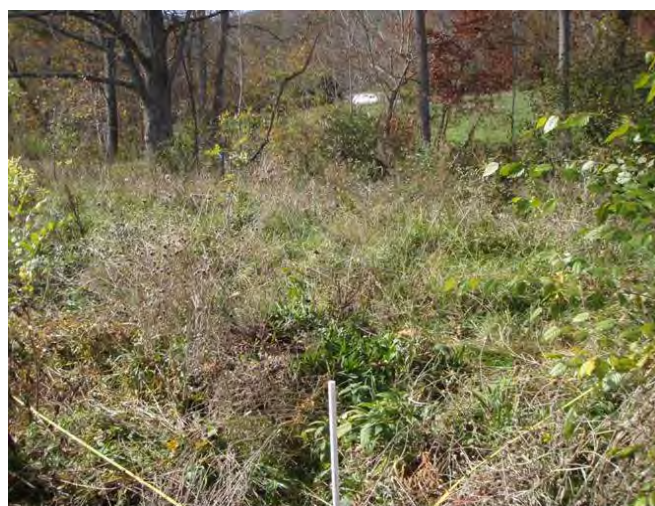
Vegetation plot 2, SHC facing upstream (10,10), 23 October 2012, MY1.

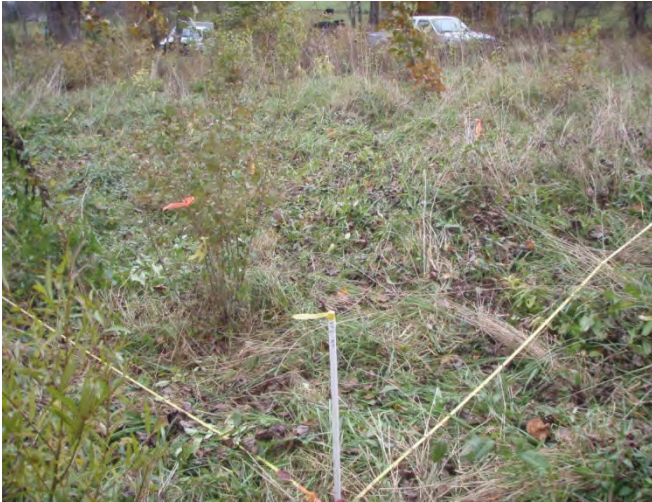
Vegetation plot 2, SHC facing downstream (0,0), 6 Nov 2013, MY2.

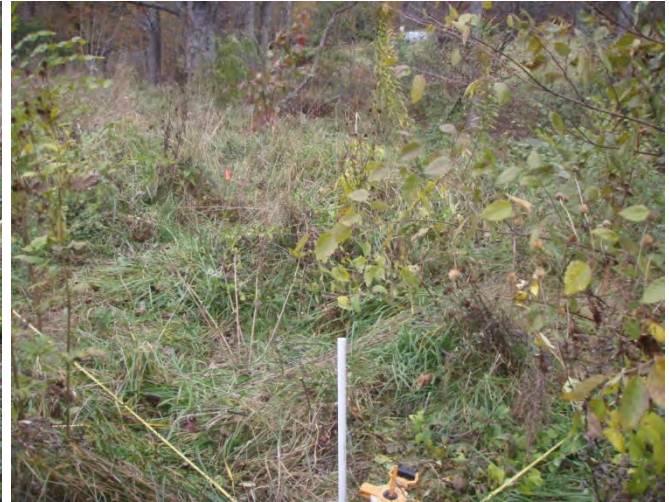
Vegetation plot 2, SHC facing upstream (10,10), 6 Nov 2013 MY2.

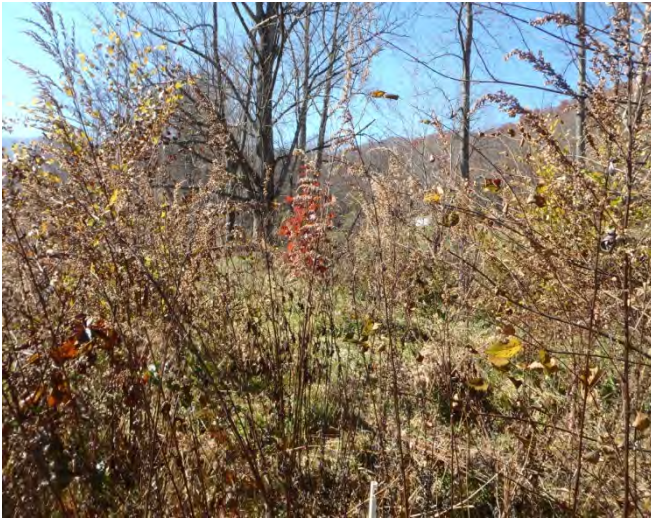
Vegetation plot 2, SHC facing downstream (0,0), 11 Nov 2014, MY3.

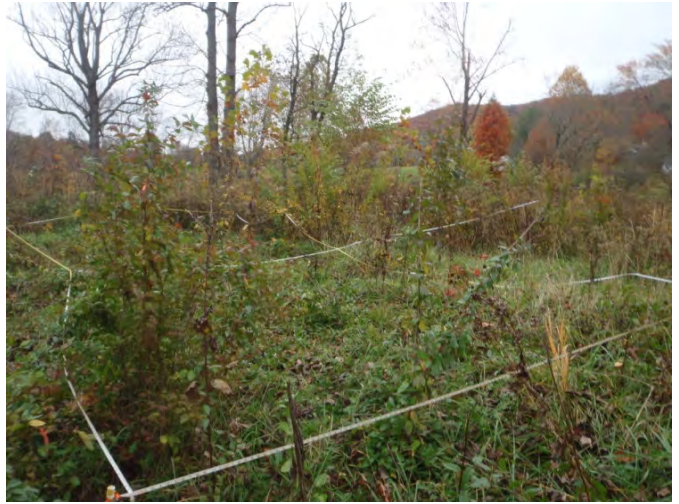
Vegetation plot 2, SHC facing upstream (10,10), 11 Nov 2014 MY3.

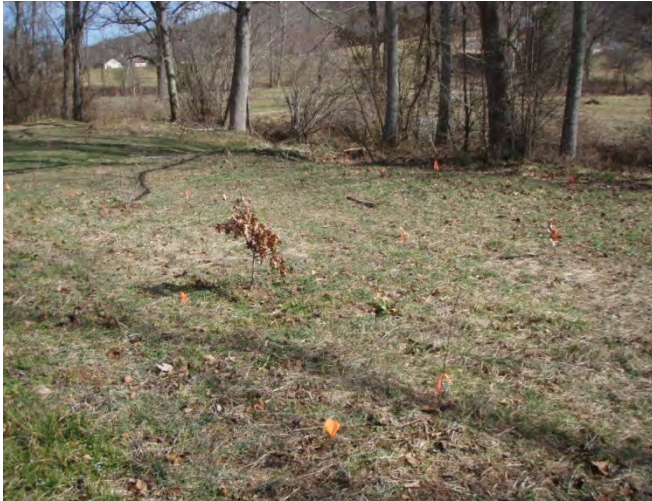
Vegetation plot 3, SHC facing downstream (0,0), 2 Feb 2012, MY0.

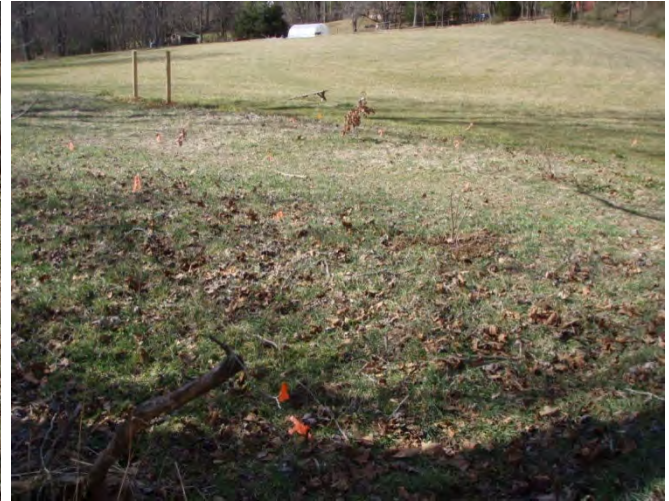
Vegetation plot 3, SHC facing upstream (10,10), 2 Feb 2012, MY0.

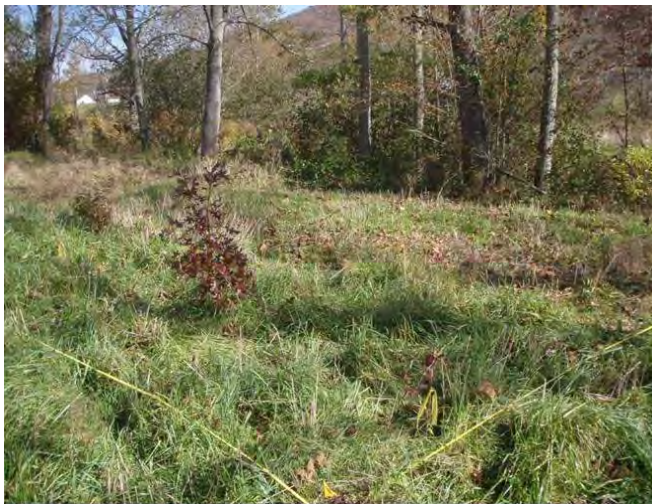
Vegetation plot 3, SHC facing downstream (0,0), 23 October 2012, MY1.

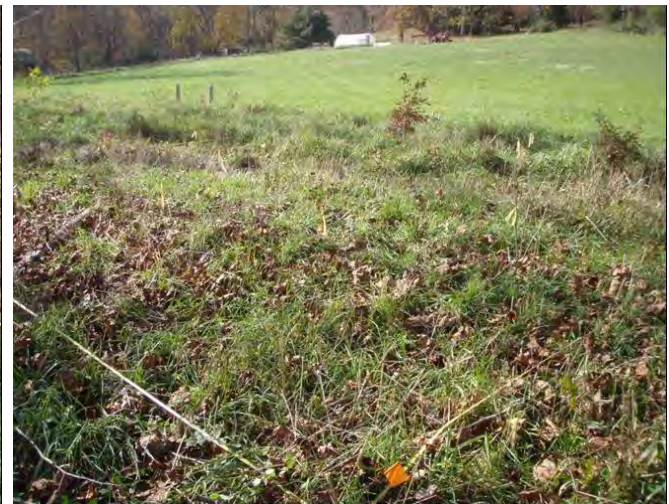
Vegetation plot 3, SHC facing upstream (10,10), 23 October 2012, MY1.

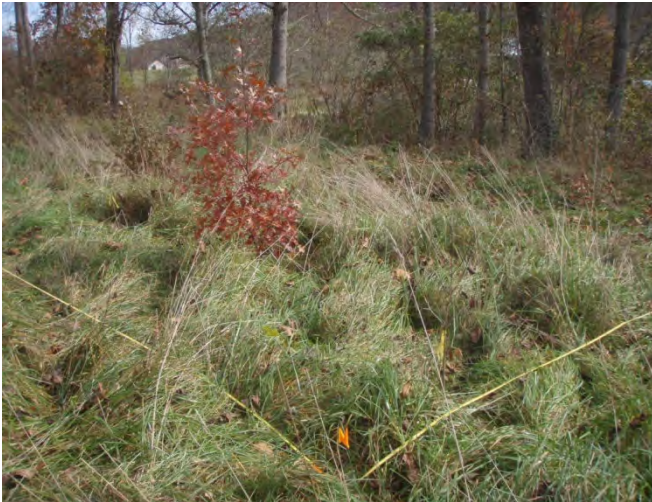
Vegetation plot 3, SHC facing downstream (0,0), 6 Nov 2013, MY2.
