Monitoring Year 3 Report

Upper South Hominy Mitigation Site, South Hominy Creek, French Broad River Basin, Buncombe County, North Carolina

EEP Project Number: 92632
Contract Number: D06082; Task Order: 08 FB05-1b-d

Data Collected: October 2014-November 2014
Submitted: February 2015

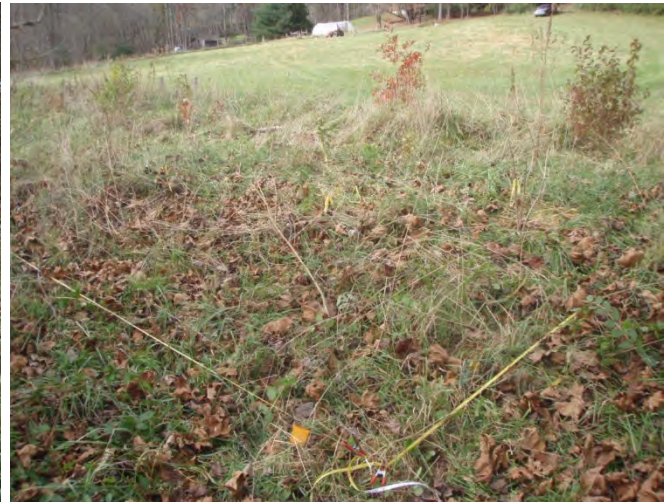
Vegetation plot 3, SHC facing upstream (10,10), 6 Nov 2013, MY2.

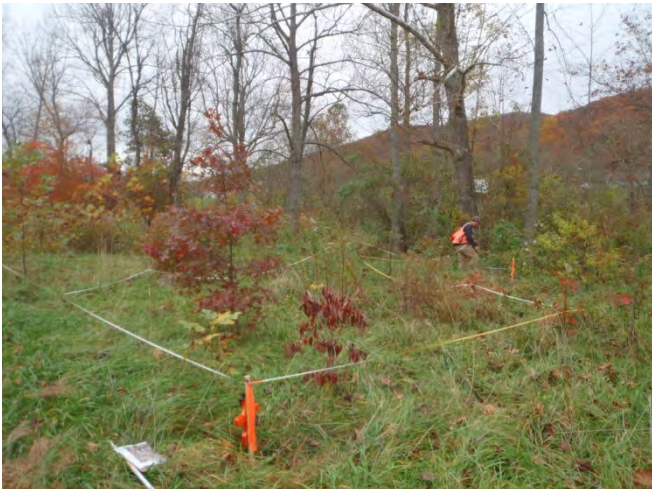
Vegetation plot 3, SHC facing downstream (0,0), 11 Nov 2014, MY3.

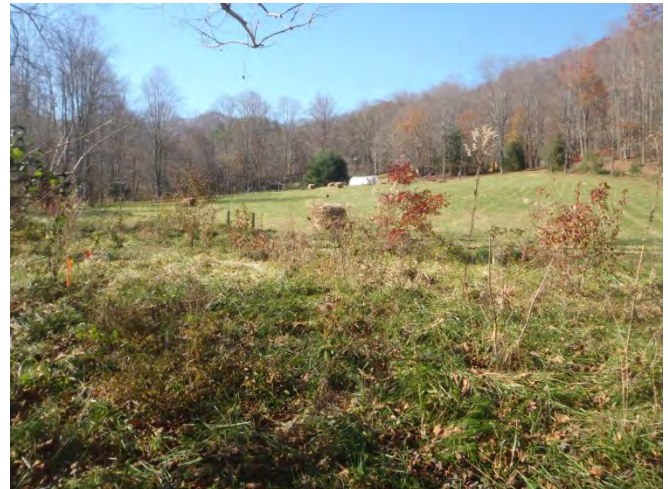
Vegetation plot 3, SHC facing upstream (10,10), 11 Nov 2014, MY3.

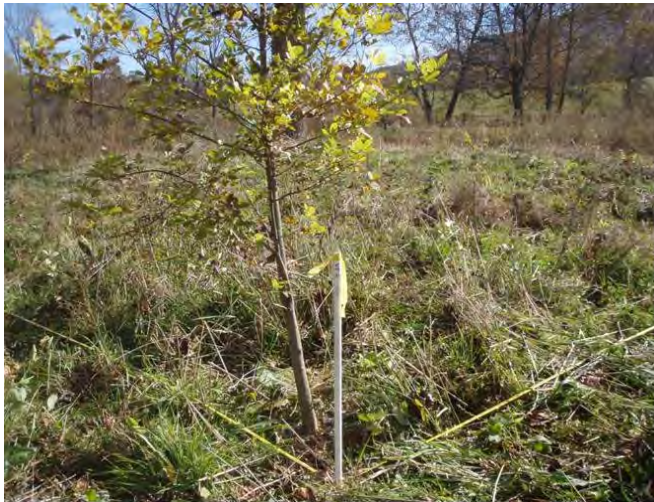
Vegetation plot 4, SHC facing downstream (0,0), 23 October 2012, MY1.

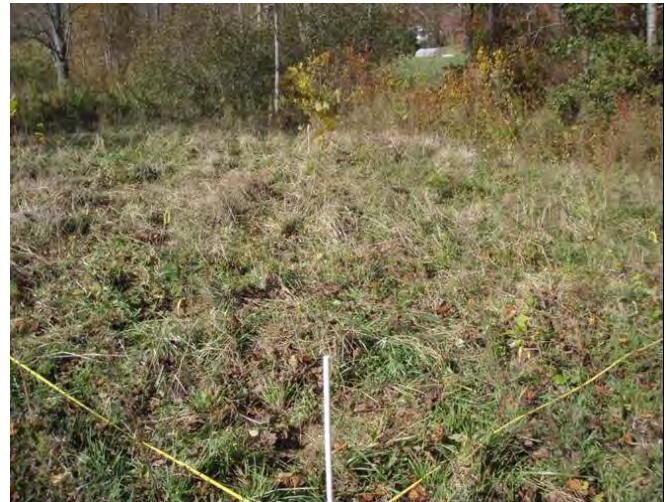
Vegetation plot 4, SHC facing upstream (10,10), 23 October 2012, MY1.

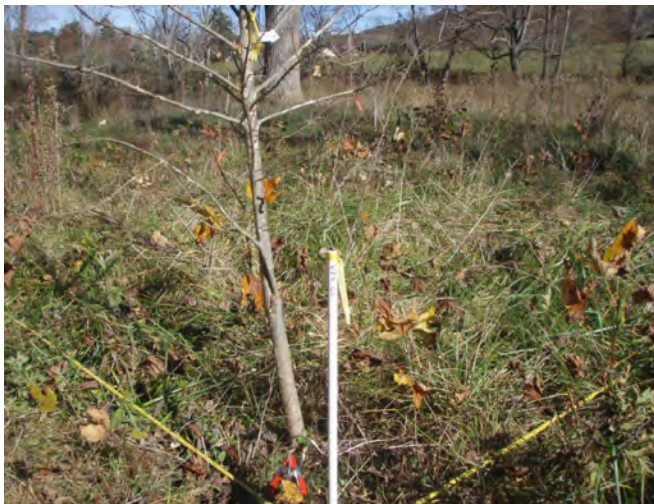
Vegetation plot 4, SHC facing downstream (0,0), 6 Nov 2013, MY2.

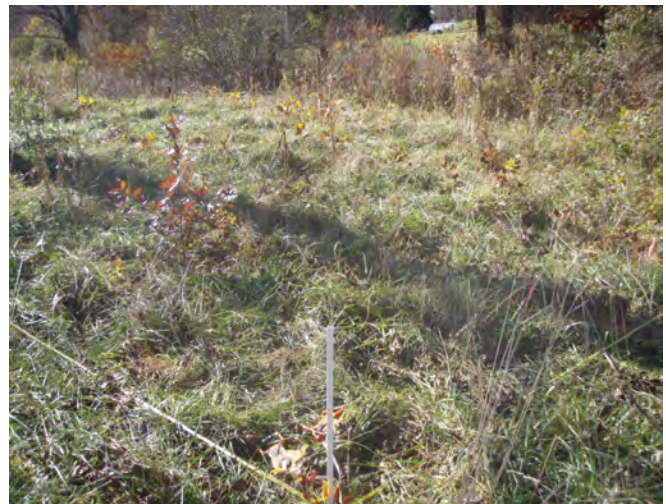
Vegetation plot 4, SHC facing upstream (10,10), 6 Nov 2013, MY2.

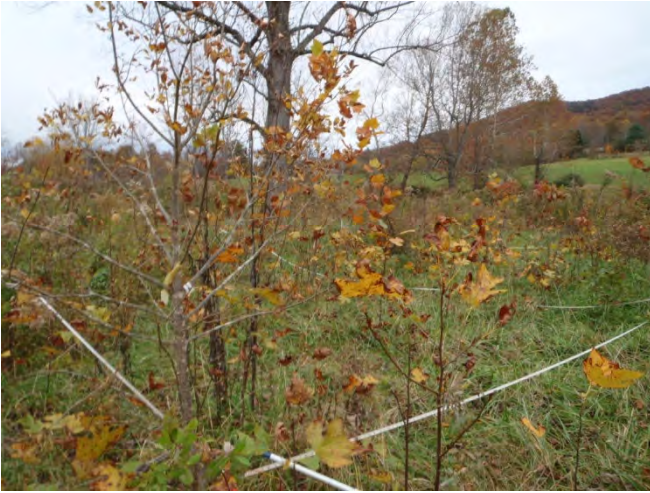
Vegetation plot 4, SHC facing downstream (0,0), 11 Nov 2014, MY3.

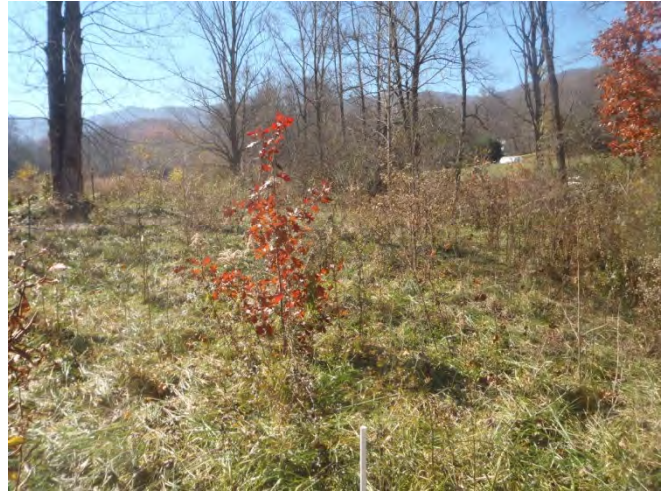
Vegetation plot 4, SHC facing upstream (10,10), 11 Nov 2014, MY3.

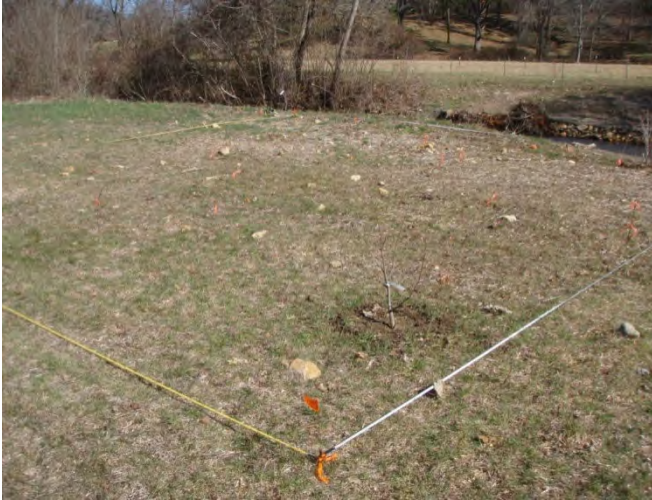
Vegetation plot 5, SHC facing downstream (0,0), 2 Feb 2012, MY0.

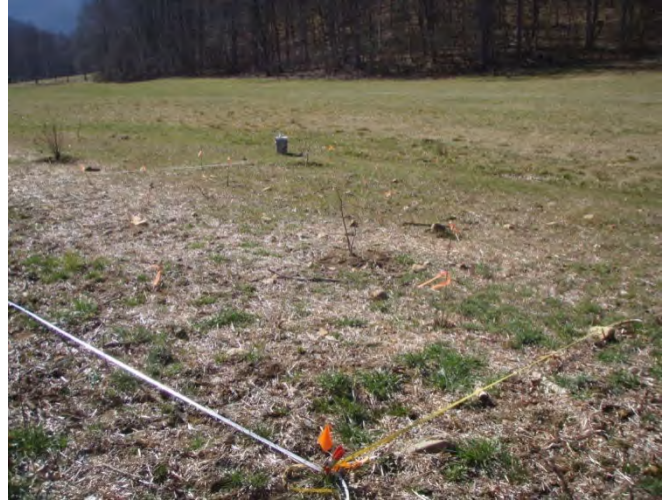
Vegetation plot 5, SHC facing upstream (10,10), 2 Feb 2012, MY0.

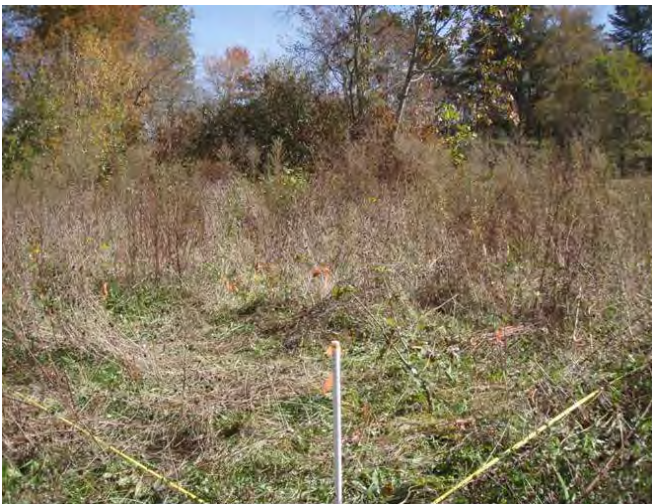
Vegetation plot 5, SHC facing downstream (0,0), 23 October 2012, MY1.

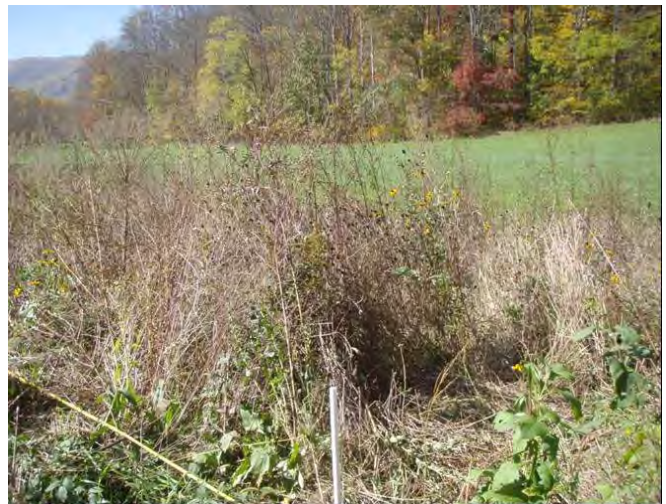
Vegetation plot 5, SHC facing upstream (10,10), 23 October 2012, MY1.

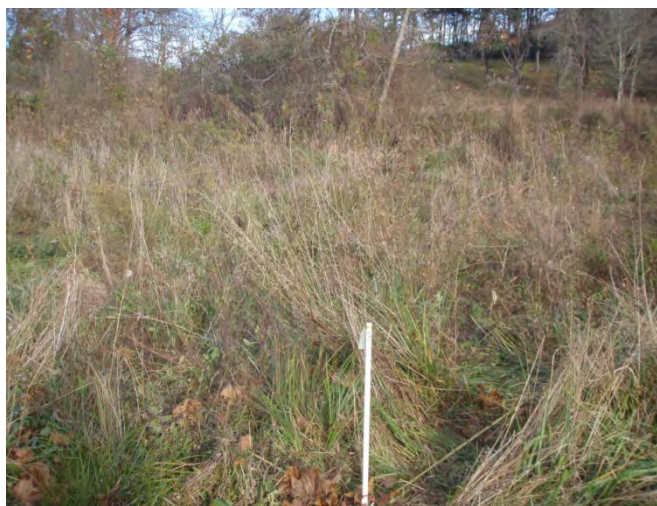
Vegetation plot 5, SHC facing downstream (0,0), 6 Nov 2013, MY2.

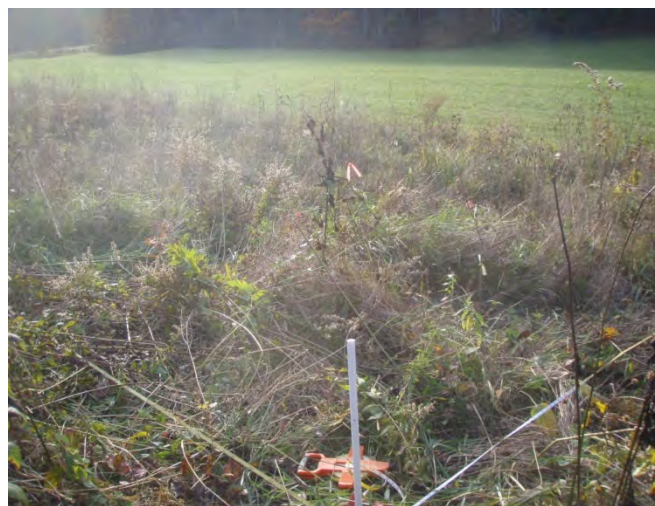
Vegetation plot 5, SHC facing upstream (10,10), 6 Nov 2013, MY2.

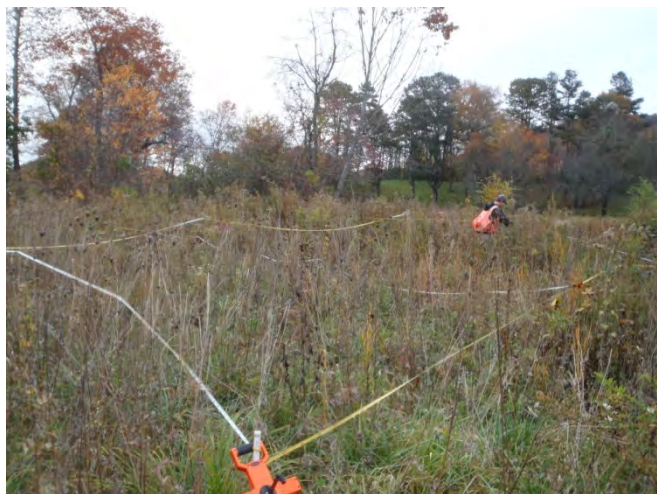
Vegetation plot 5, SHC facing downstream (0,0), 11 Nov 2014, MY3.

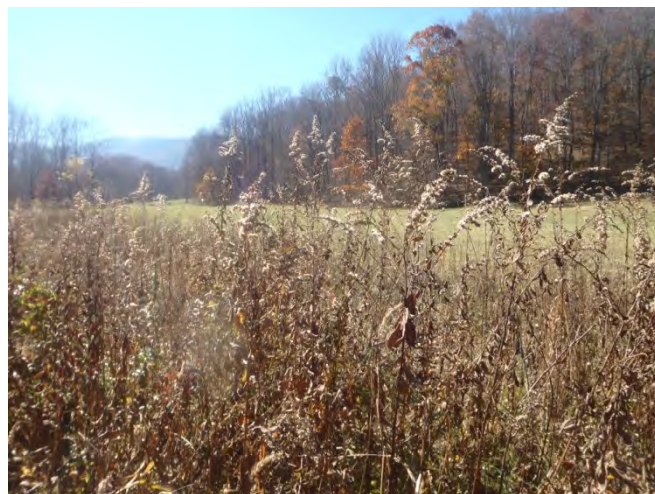
Vegetation plot 5, SHC facing upstream (10,10), 11 Nov 2014, MY3.

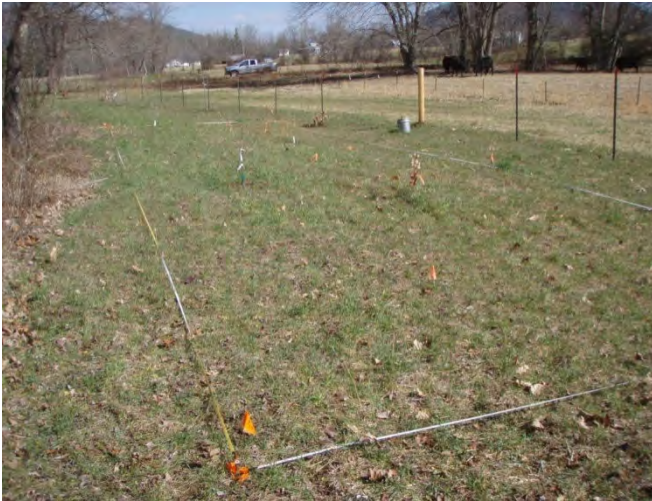
Vegetation plot 6, SHC facing downstream (0,5), 2 Feb 2012, MY0.

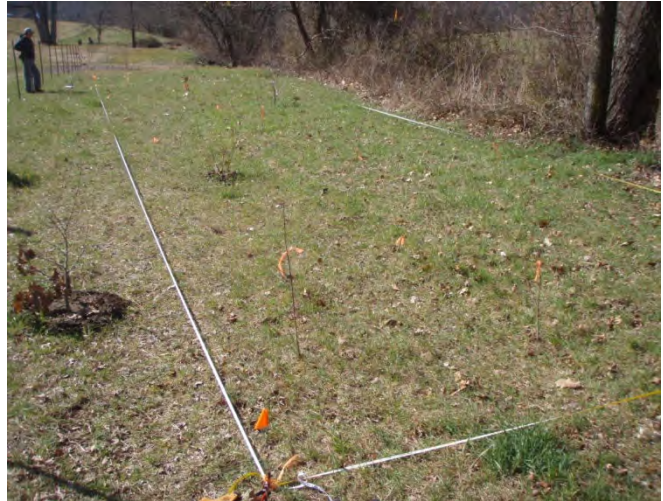
Vegetation plot 6, SHC facing upstream (20,0), 2 Feb 2012, MY0.

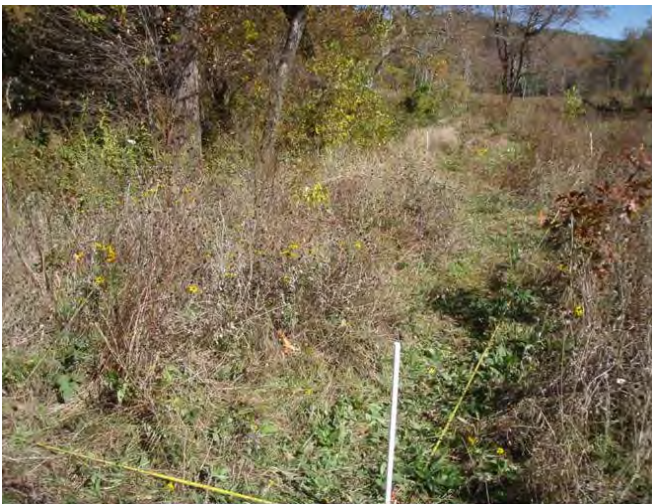
Vegetation plot 6, SHC facing downstream (0,0), 23 October 2012, MY1.

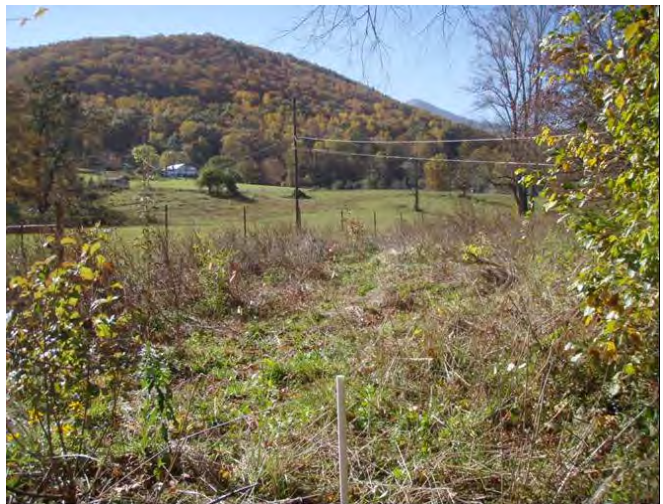
Vegetation plot 6, SHC facing upstream (20,5), 23 October 2012, MY1.

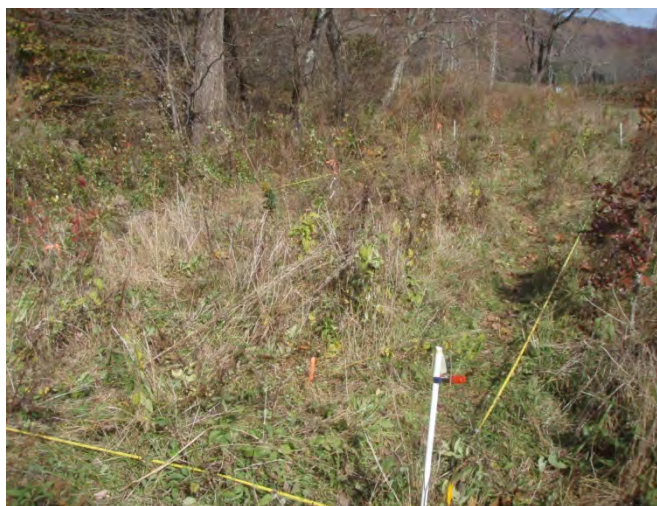
Vegetation plot 6, SHC facing downstream (0,0), 6 Nov 2013, MY2.

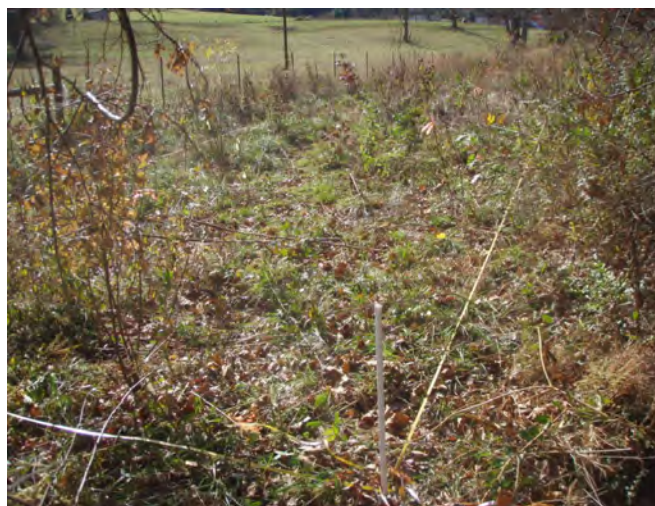
Vegetation plot 6, SHC facing upstream (20,5), 6 Nov 2013, MY2.

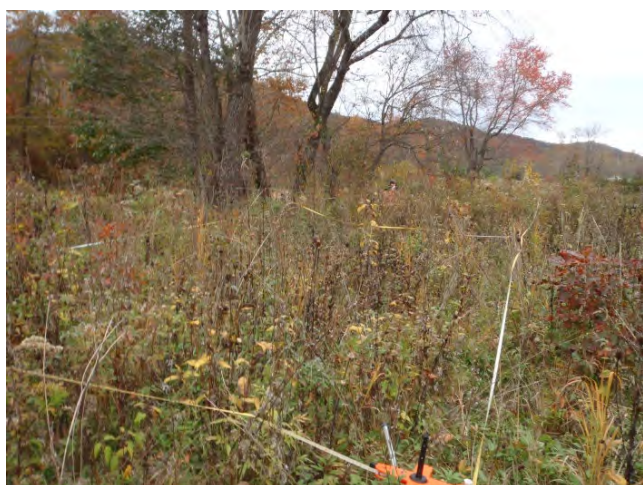
Vegetation plot 6, SHC facing downstream (0,0), 11 Nov 2014, MY3.

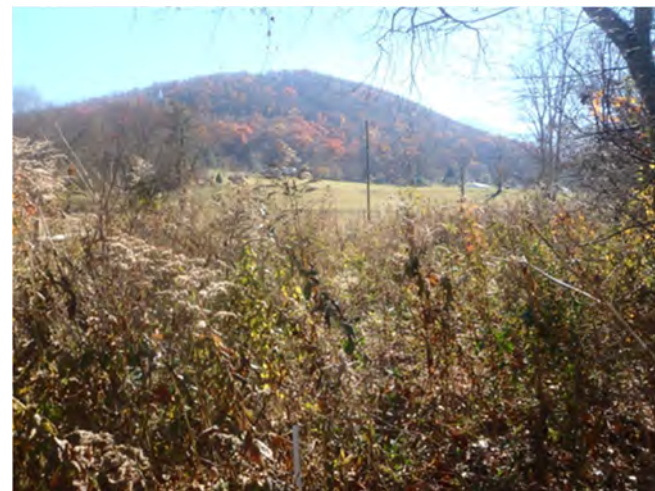
Vegetation plot 6, SHC facing upstream (10,10), 11 Nov 2014, MY3.

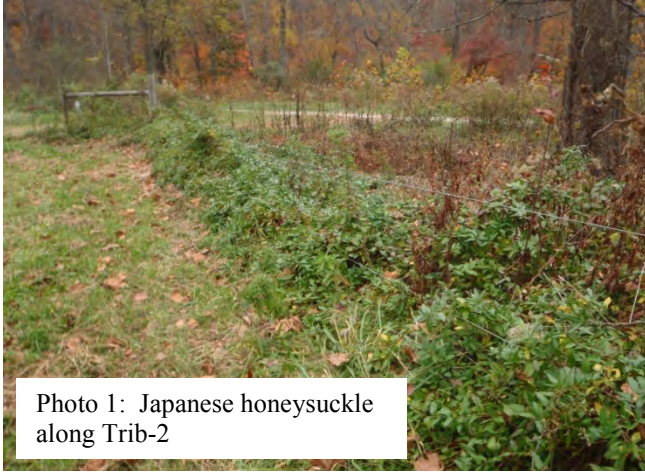
MY1-MY3 Vegetation Problem Areas Upper South Hominy Mitigation Site (EEP project number 92632)			
Feature/Issue	Station Number/Range	Probable Cause	Photo Number
Dense Japanese Honeysuckle	UT-2	Invasive	2
Dense Japanese Honeysuckle	UT-2	Invasive	1
Dense Japanese Honeysuckle	Mainstem 1 Sta. 7+25 to 8+00	Invasive	--
Dense Bamboo	Mainstem 2 Sta. 1+00 to 1+75	Invasive	3
Dense Japanese Honeysuckle	Mainstem 2 Sta. 4+25 to 5+50	Invasive	--
Dense Japanese Honeysuckle	Mainstem 2 Sta. 8+25 to 9+75	Invasive	--
Dense Japanese Honeysuckle	Mainstem 2 Sta. 11+00 to 12+00	Invasive	--
Dense Japanese Honeysuckle	Mainstem 3 0+00 to 1+00	Invasive	--
Dense Japanese Honeysuckle	Mainstem 3 4+25 to 5+50	Invasive	--

Photo 1: Japanese honeysuckle along Trib-2
