Monitoring Year 4 (2015) Report

Upper South Hominy Mitigation Site, South Hominy Creek, French Broad River Basin, Buncombe County, North Carolina

DMS Project Number: 92632
Contract Number: D06082; Task Order: 08 FB05-1b-d

Data Collected: April - November 2015
Submitted: December 2015

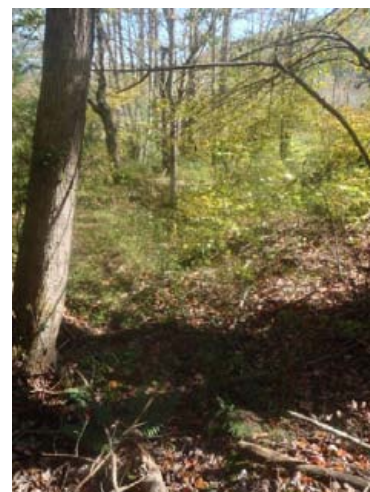
UT1 facing downstream, adjacent to small barn, 14 October 2015.

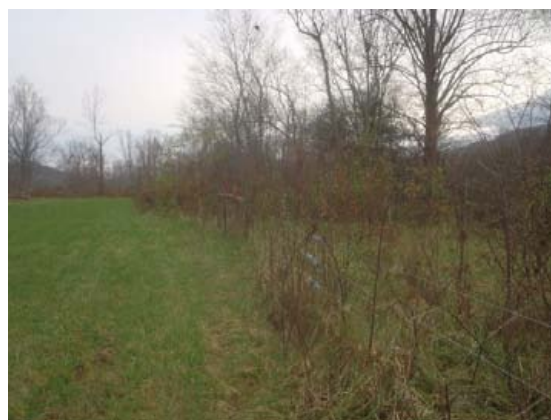
UT2 facing downstream, post invasive removal, 17 Nov 2015.

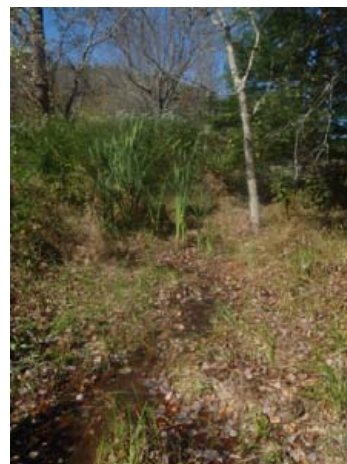
UT2 re-connected under Canterfield Lane to abandoned channel, sta. 0+00 to 0+50, 15 October 2015.

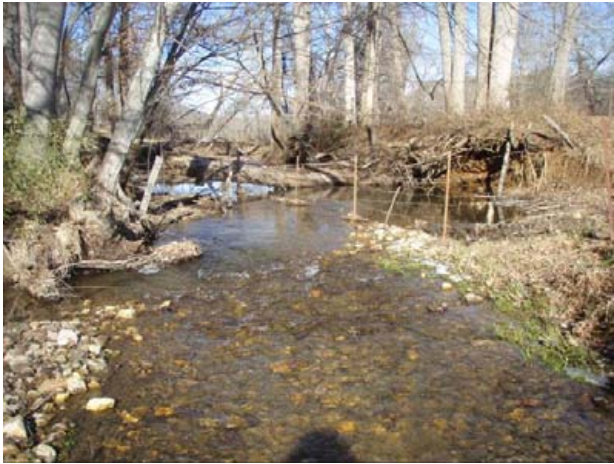
Livestock access right bank, sta. 1+00 to 1+50, facing downstream.
22 January 2009.

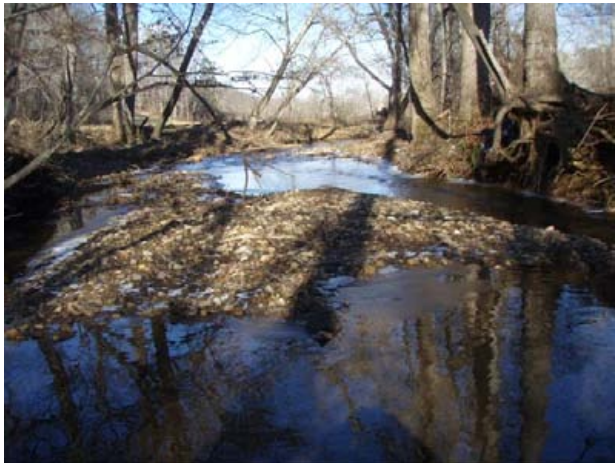
Mid channel aggradation, sta. 1+50 to 2+50, facing downstream. 22 January 2009.

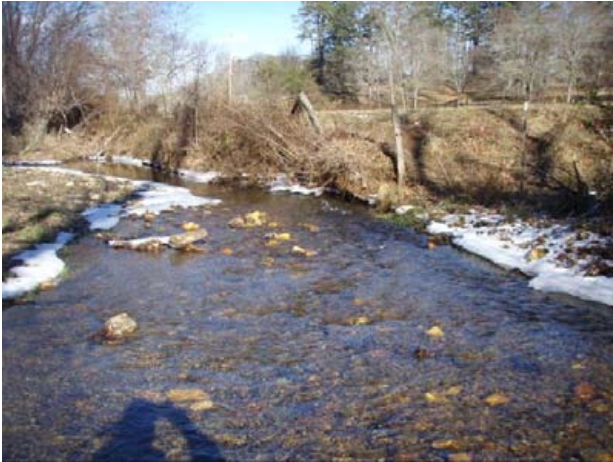
Outside meander bend bank stress, sta. 7+25 to 8+00, facing downstream, 22 January 2009.

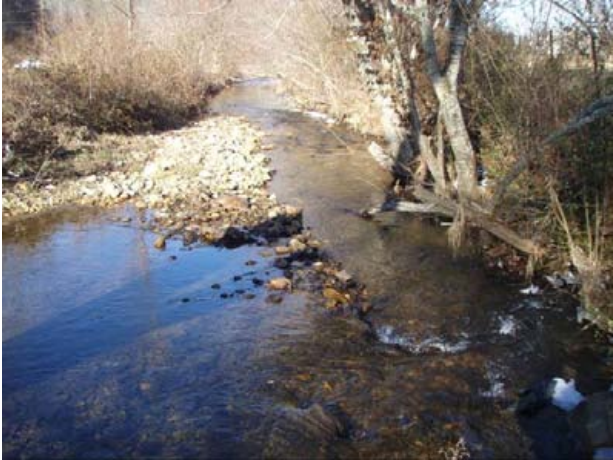
Bed aggradation and transverse bar, sta. 9+50 to 10+00, facing downstream, 22 January 2009.

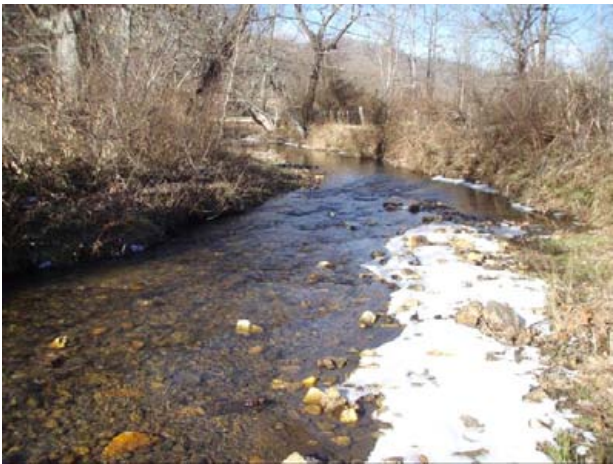
Lower portion of enhancement II, sta. 11+50 to 12+00, facing downstream, 22 January 2009.

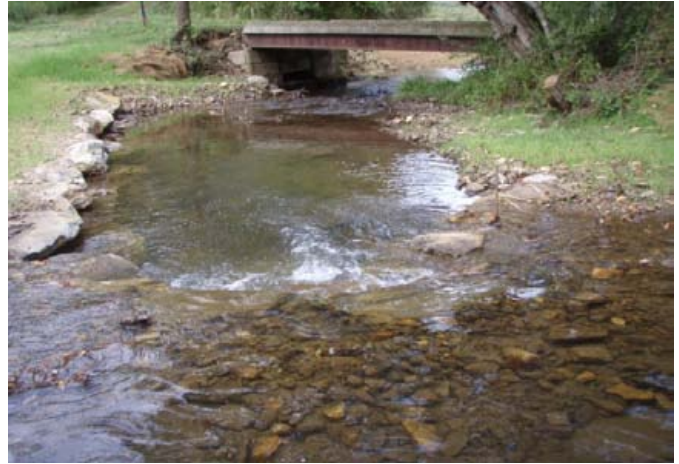
J-hook sta. 12+75, lower end of Bura/Roberson properties, 22 September 2011.

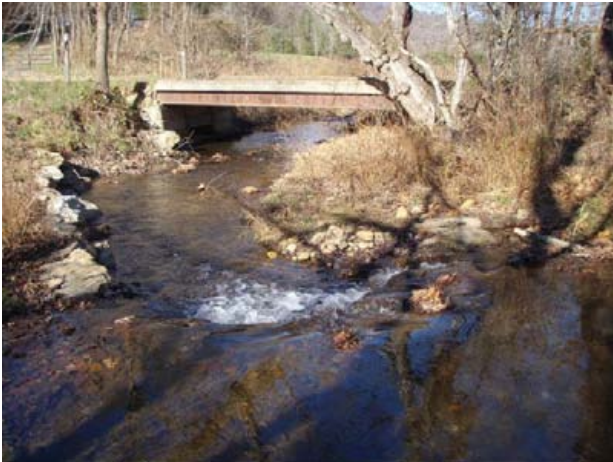
J-hook sta. 12+75, lower end of Bura/Roberson properties, 20 November 2012.

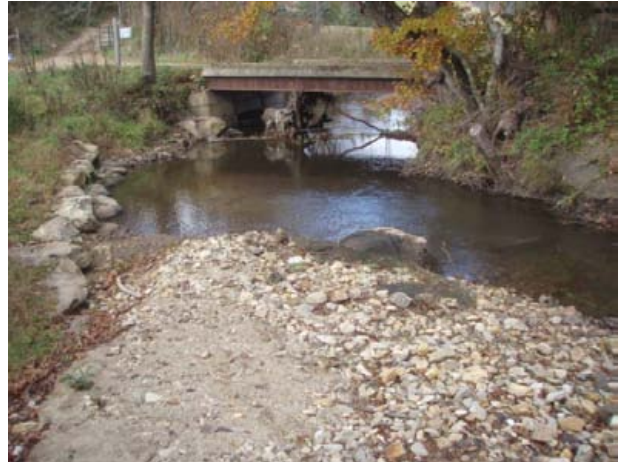
J-hook sta. 12+75, lower end of Bura/Roberson properties, 29 October 2013.

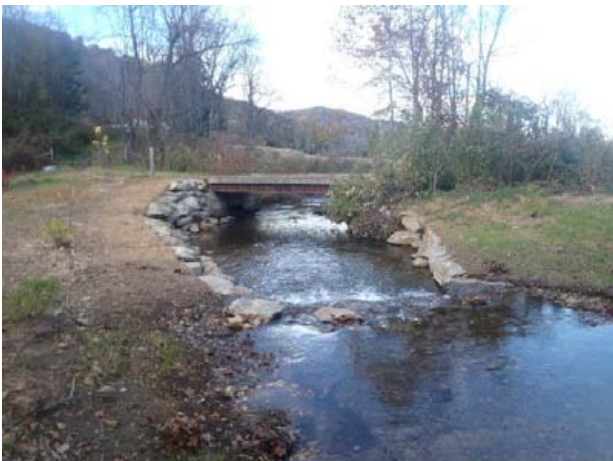
J-hook sta. 12+75, lower end of Bura/Roberson properties, 12 Nov 2014.

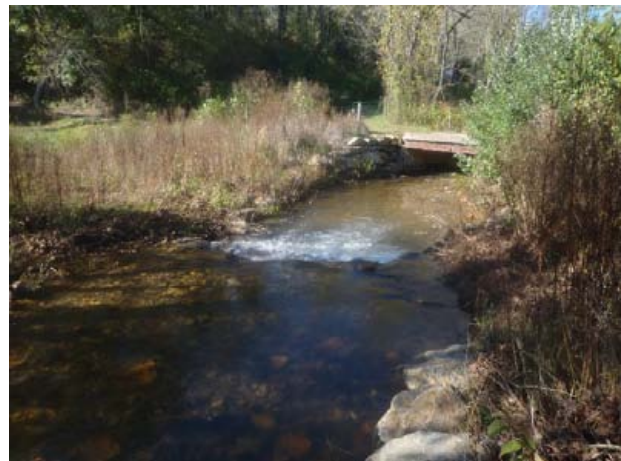
J-hook sta. 12+75, lower end of Bura/Roberson properties, 14 Oct 2015.

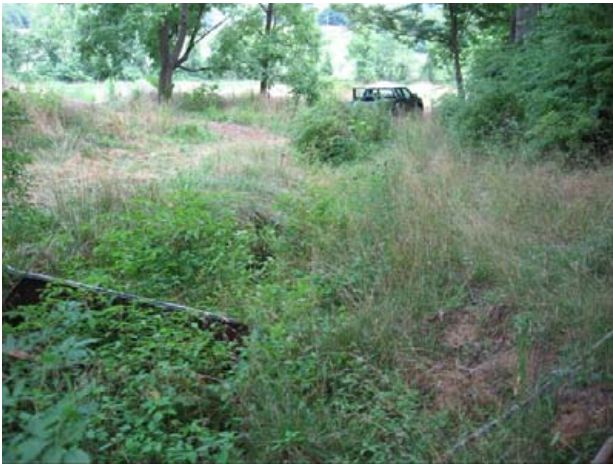
Photo Station 24

UT3 above ford, channel incision, facing downstream, 25 July 2008.

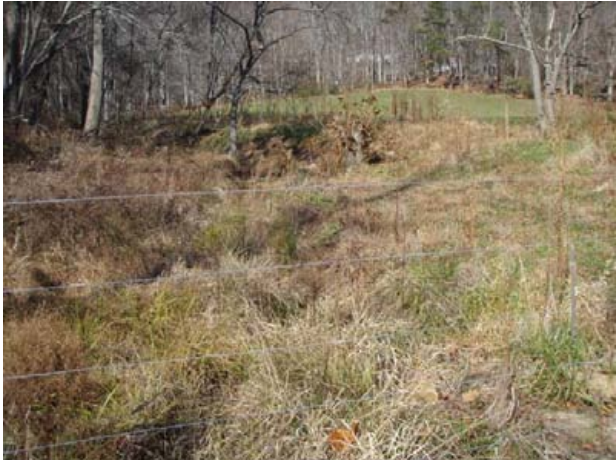
UT3 above ford, invasive removal, cattle exclusion, and bank shaping, facing upstream, 20 November 2012.

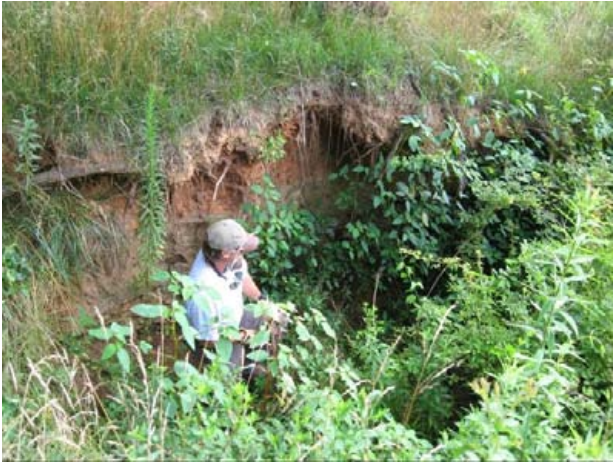
UT3 below ford, severe entrenchment and head cutting, 25 July 2008.

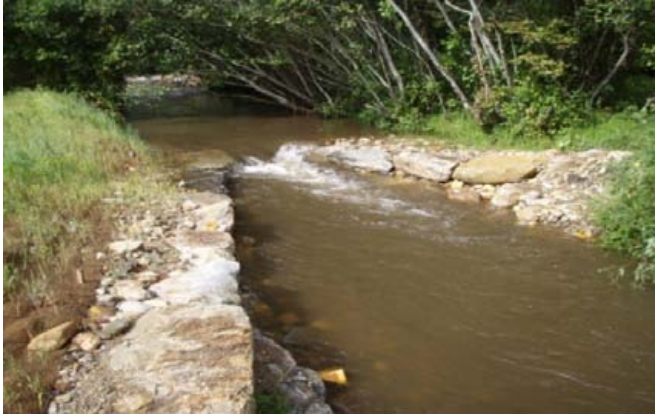
Problem Area 1

Rock vane after construction, sta. 1+50, facing upstream, 5 September 2011.

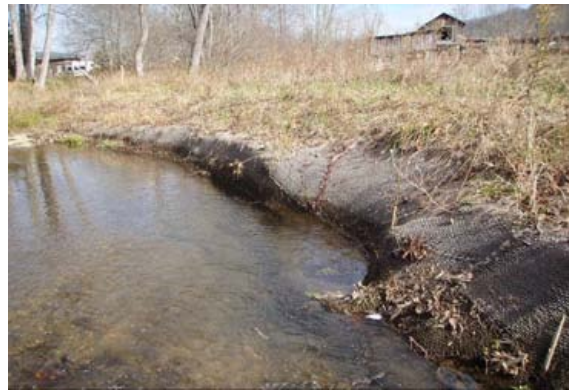
Right channel bank instability, sta. 1+75 to 2+25, facing downstream, 20 November 2012.

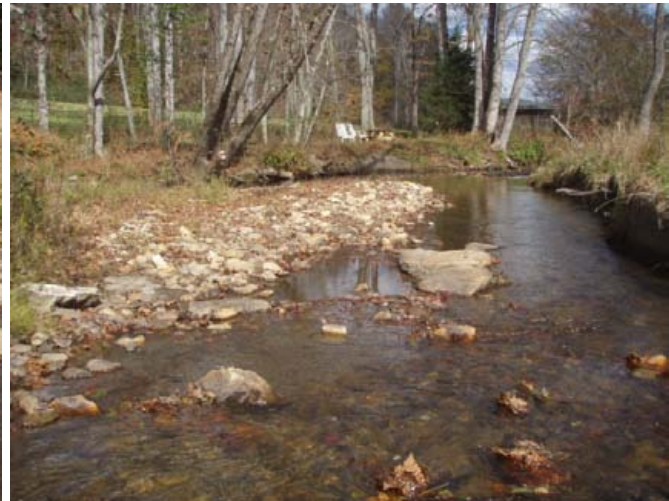
Aggradation and thalweg movement following 5 May 2013 flood, sta. 2+50, facing downstream, 29 October 2013.

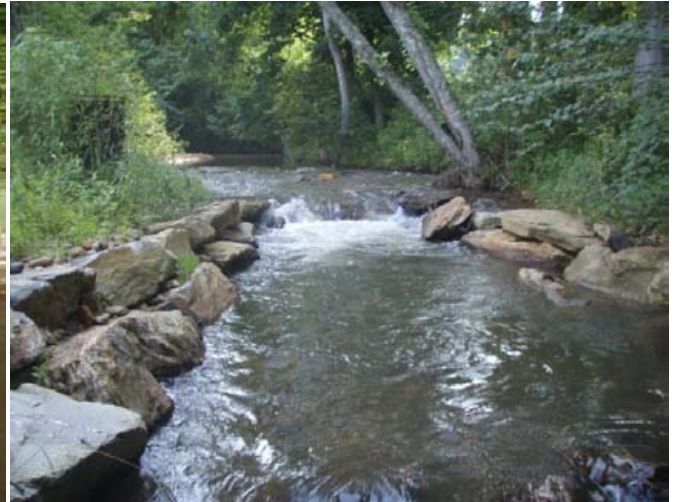
Cross vane after 5 May 2013 flood event, facing upstream,
sta. 0+50, 18 July 2013.

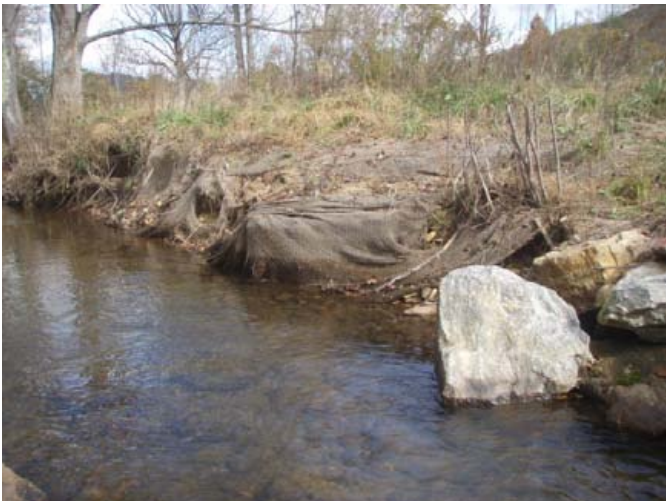
Right bank scour and erosion, sta. 6+25, facing downstream, occurred during the 5 May 2013 flood event, 29 October 2013.

Right bank repairs performed summer 2015, sta. 6+25, facing downstream, 14 October 2015. No longer considered a problem during MY4 (2015) field surveys.

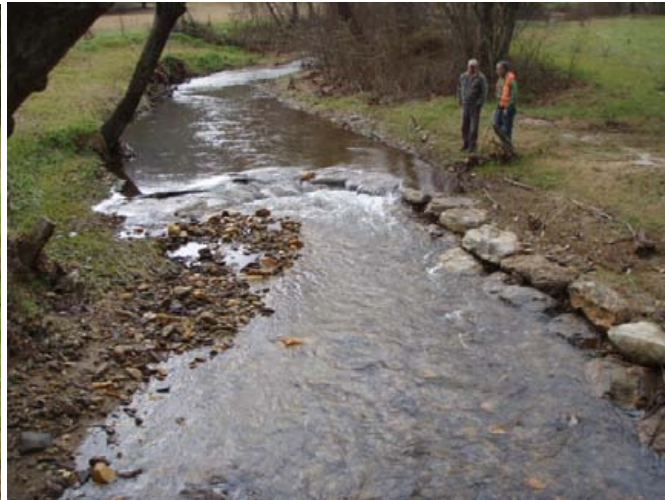
J-hook after 28 Nov 2011 flood event, aggradation in pool below J-hook, 5 December 2011.

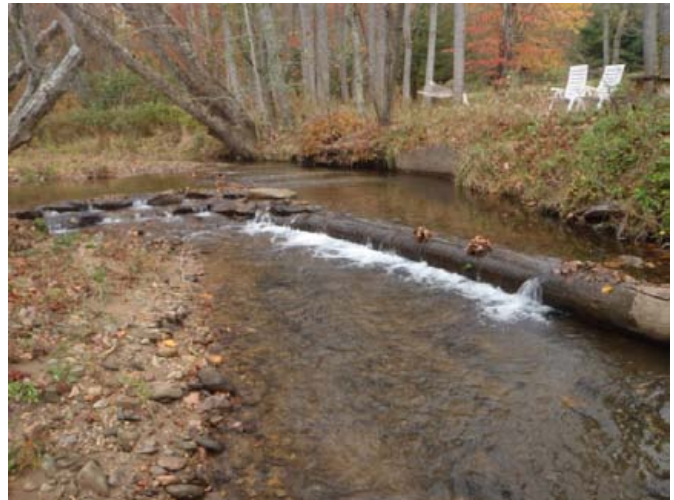
Aggradation below J-hook, sta 4+00 to 4+50, facing upstream, 28 October 2014

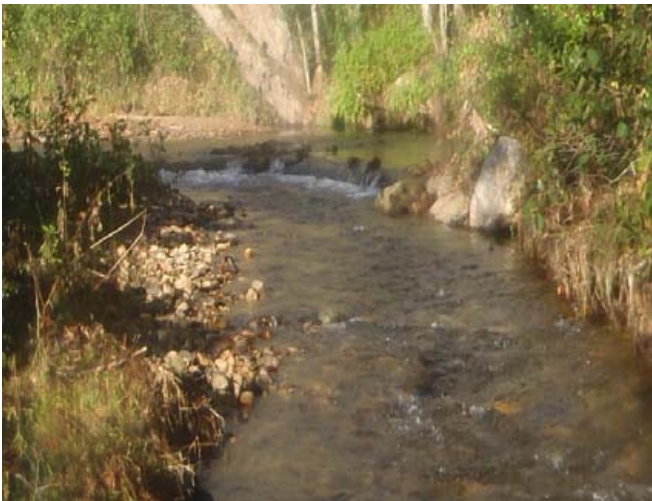
Area below J-hook, sta. 4+00 to 4+50, facing upstream, 15 October 2015. No longer considered a problem during MY4 (2015) field surveys.

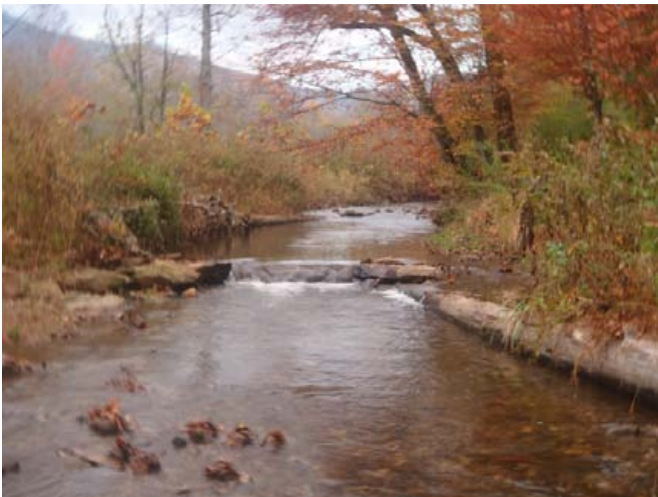
PA-09 was no longer considered a problem during MY3 (2014) surveys, 28 October 2014

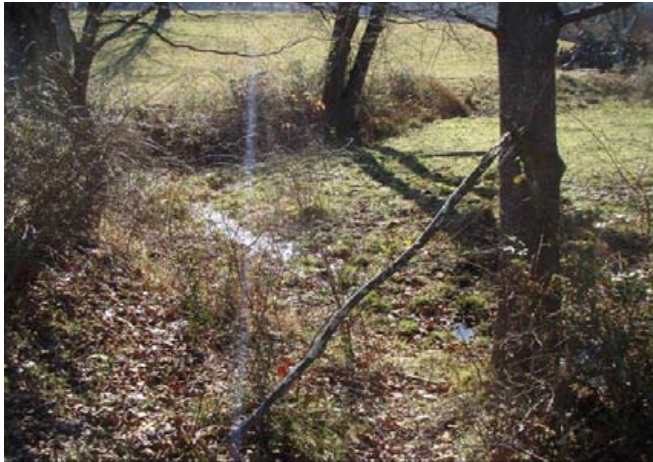
Roberson Property, Wetland D (Wetland Station 4)

Wetland D, area of livestock access, facing upstream, 2009.

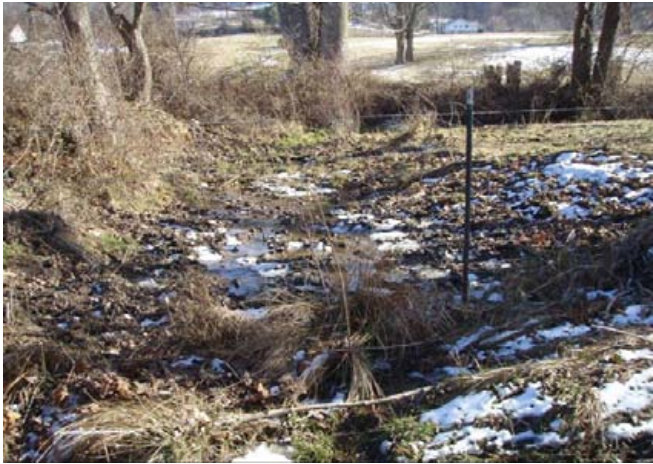
Wetland Station 5

Lower portion of Wetland D, livestock impacts, facing upstream, 2009.

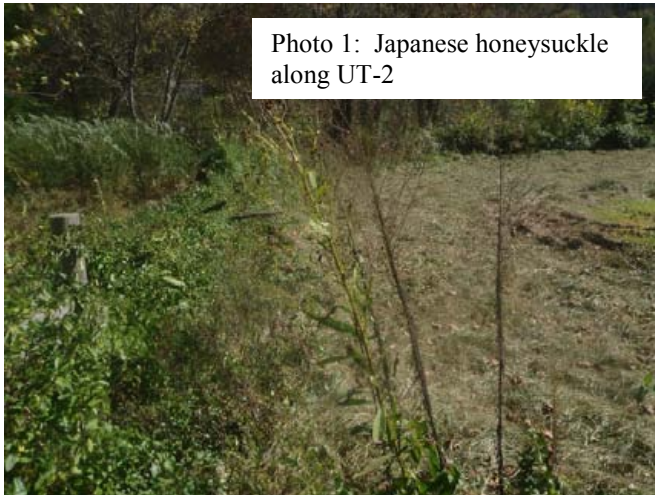
Photo 1: Japanese honeysuckle along UT-2

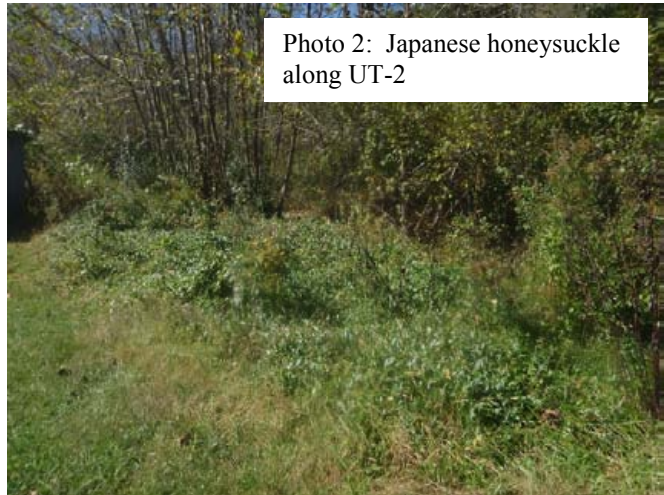
Photo 2: Japanese honeysuckle along UT-2

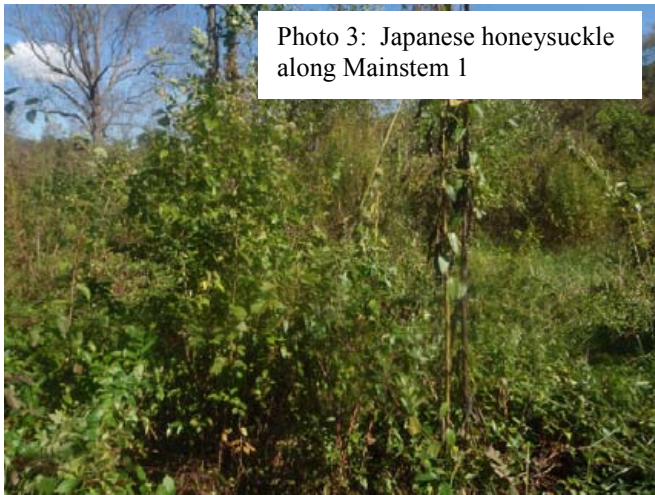
Photo 3: Japanese honeysuckle along Mainstem 1

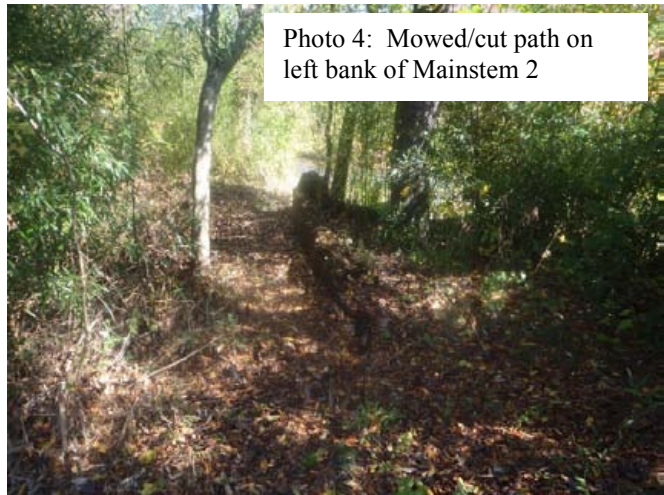
Photo 4: Mowed/cut path on left bank of Mainstem 2

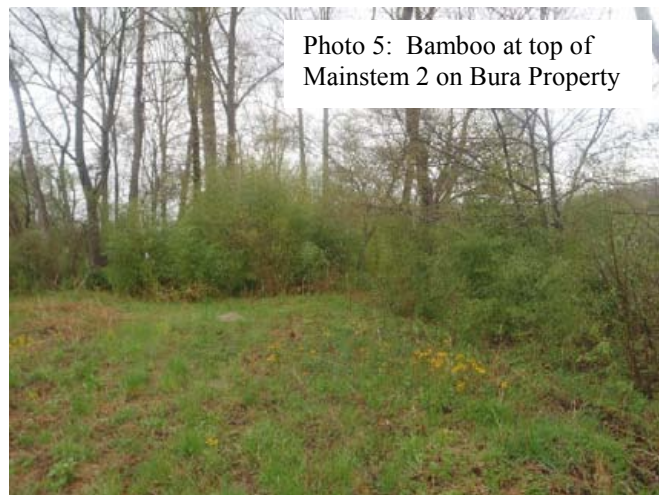
Photo 5: Bamboo at top of Mainstem 2 on Bura Property
