**UT to Barnes Creek
Stream and Wetland Restoration Project
Project No. 397
2009 Monitoring Report: Year 4 of 5**

November 2009 (Revised May 2010)

Prepared by: Jordan, Jones & Goulding
9101 Southern Pine Blvd., Suite 160
Charlotte, NC 28273

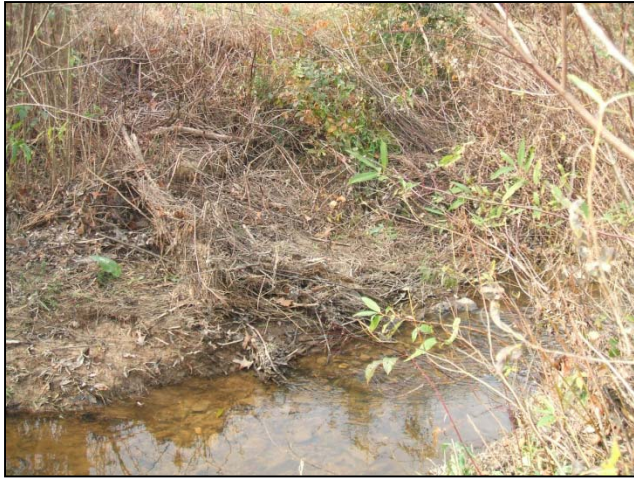
T-1 View Downstream
Tributary (11/2009)

Based on current monitoring data and the visual inspection, the channel is impacted by beaver activity. Three beaver dams were located along the channel with inundation levels above the top of bank. Fine sediment deposition is occurring throughout the reach due to the stagnant flow conditions. The average bankfull width (13.70 ft) of the surveyed cross-sections is lower than the proposed 14.40 ft, and the average surveyed mean bankfull depth is 1.0 ft compared to the proposed 0.7 ft. The surveyed bankfull widths and depths lead to an average Width/Depth ratio of 17.6, which typifies a Rosgen C-type stream. The average water surface slope and the average bankfull slope were very slightly different for the surveyed reach, 0.0085 ft/ft and 0.0091 ft/ft, respectively. This is most likely due to the inundated conditions occurring onsite during the longitudinal survey.

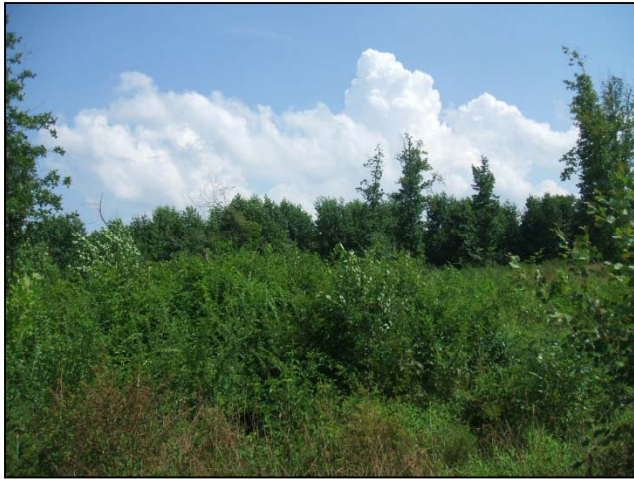
E-1 View East (8/2009)

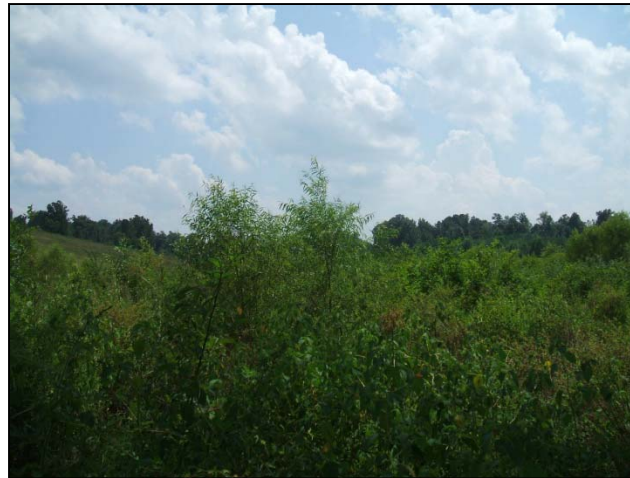
E-3 View Southwest (8/2009)
