# UT to Cane Creek Stream Restoration Site

2008 Annual Monitoring Report (Year 2)

Alamance County  
EEP Project No. 69  
Design Firm: Stantec Consulting Services, Inc.

May 2009

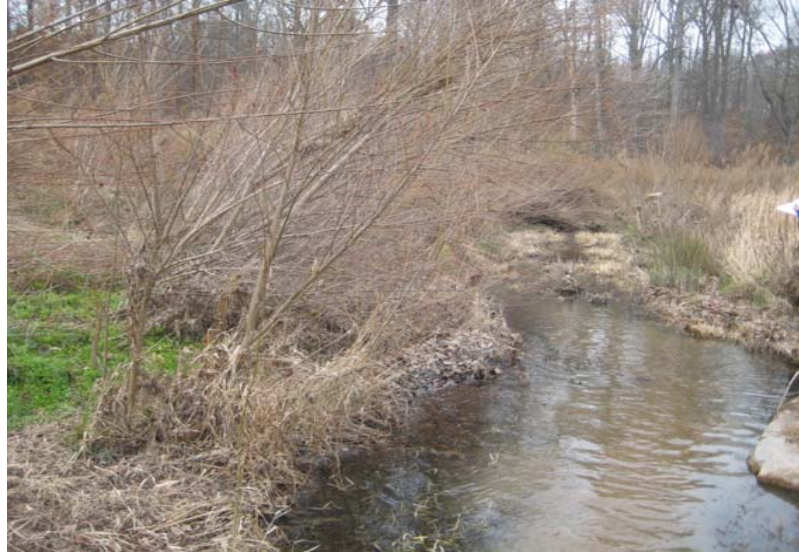
Photo of XS-1, looking in the downstream direction

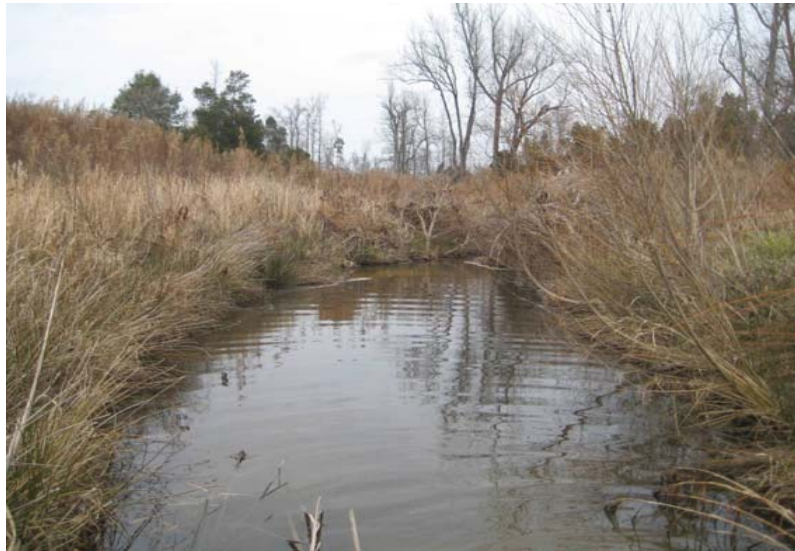
Photo of XS-2, looking in the downstream direction

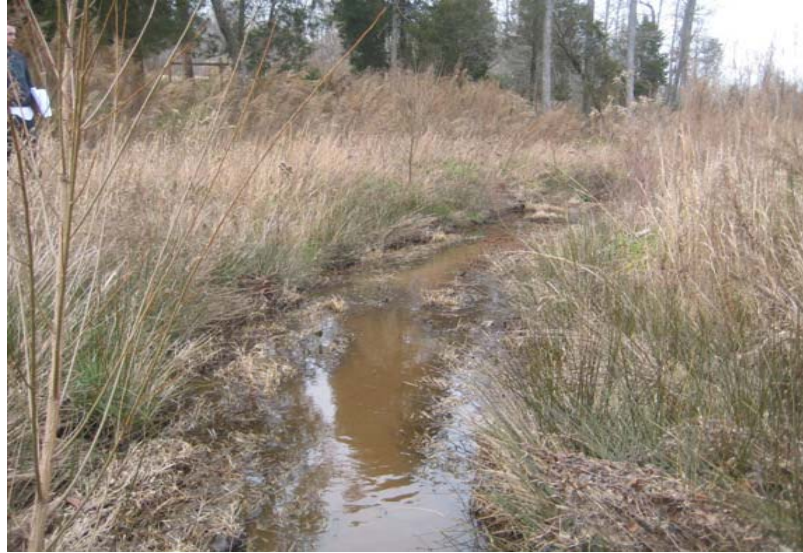
Photo of XS-3, looking in the downstream direction

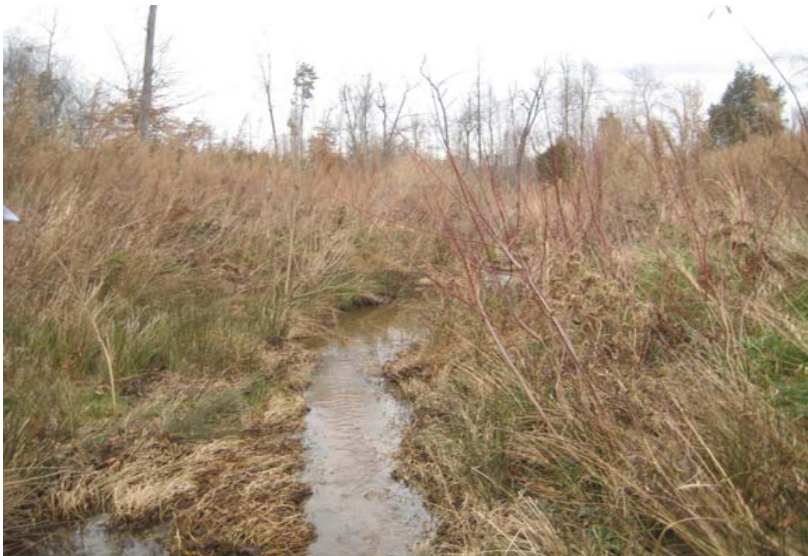
Photo of XS-4, looking in the downstream direction

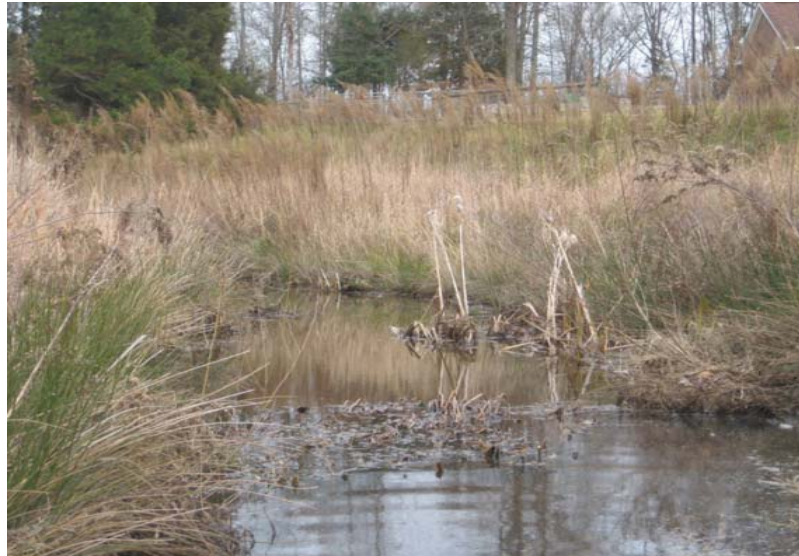
Photo of XS-5, looking in the downstream direction
