**Upper UT to Cane Creek (Pickard)
Restoration Site
Alamance County, North Carolina
EEP Project #395**

MY-04 Monitoring Report

Data Collected: September, 2012

Submitted: January, 2013

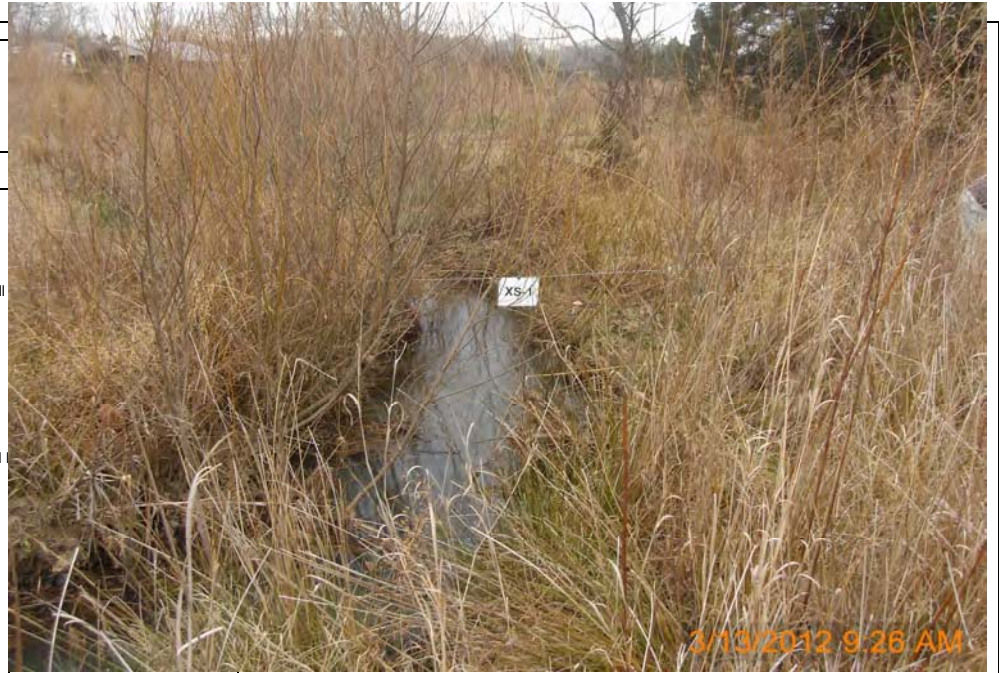
Cross Section 1

Photo of XS-1, looking in the downstream direction

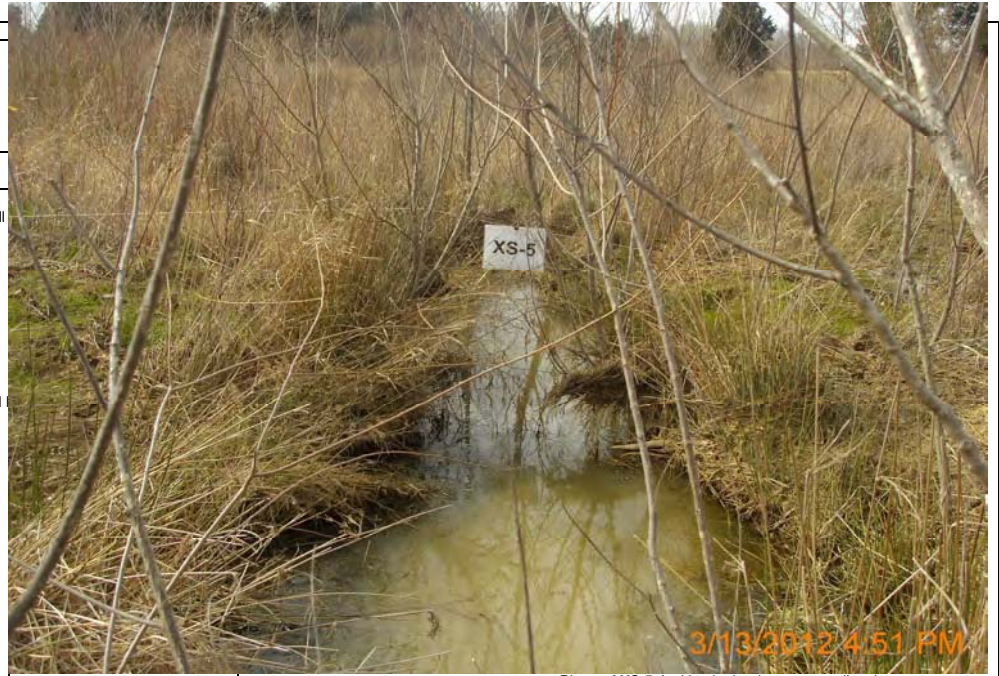
Cross Section 5

Photo of XS-5, looking in the downstream direction

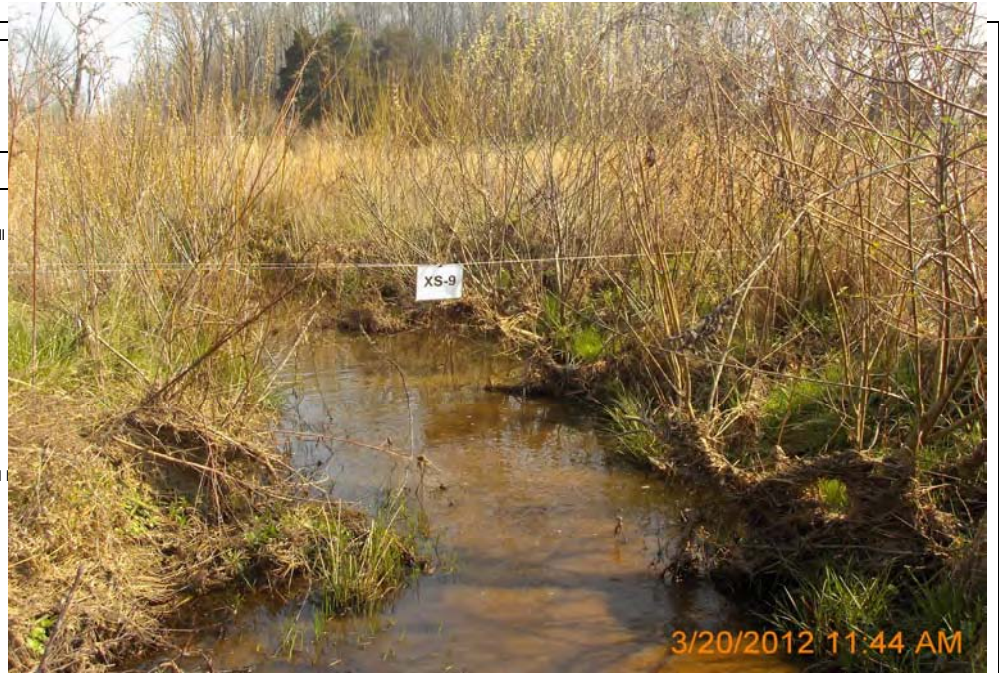
Cross Section 9

Photo of XS-9, looking in the downstream direction

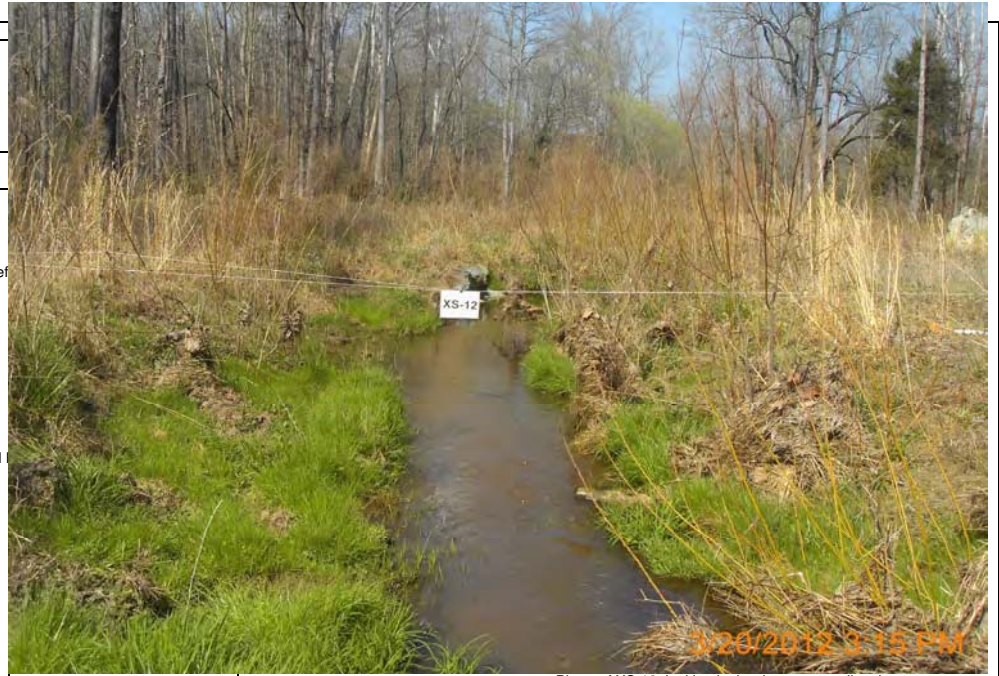
Cross Section 12

Photo of XS-12, looking in the downstream direction
