UT to Clarke Creek Stream and Wetland Restoration Site Annual Final Monitoring Report

DMS # 92500
DENR Contract # 005363
USACE Action ID # SAW-2010-00471
DWR Project # 11-0409
SCO # 09-07763-01
DLR (Land Quality) Project # MECK-2012-034

Monitoring Report Year 4 of 5
Mecklenburg County, North Carolina

UT to Clarke Creek Stream and Wetland Restoration
DMS Project #92500

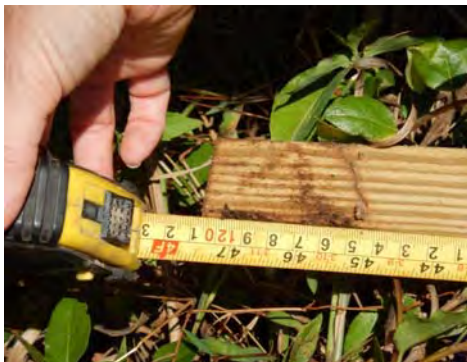
Photo 3: 10/18/17 - Crest Gauge reading on on UT to Clarke Creek.

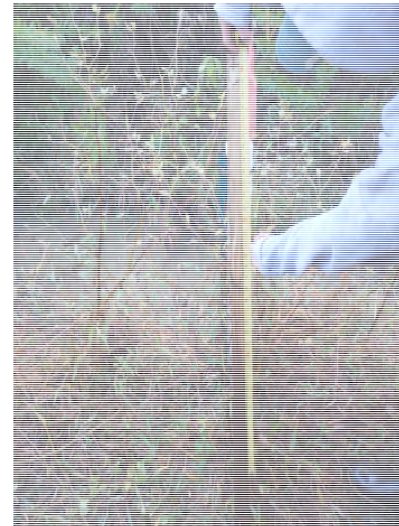
Photo 4: 10/19/17 - Crest Gauge reading on on UT1.
