UT to Mill Swamp - Monitoring Report Fourth Monitoring Measurement Third Year of Credit Release

**Onslow County, North Carolina
NCDMS Project ID Number - 95019**

Project Info: Credit Release Year: 3 of 7 (Fourth site measurement since construction)
Year of Data Collection: 2016
Year of Completed Construction: 2013
Submission Date: January 2017

Report Prepared and Submitted by Michael Baker Engineering, Inc.

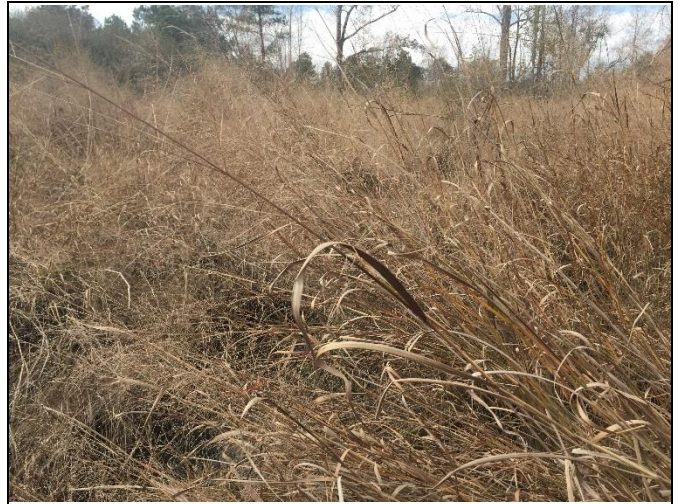
Photo Point 2 – Log Jam

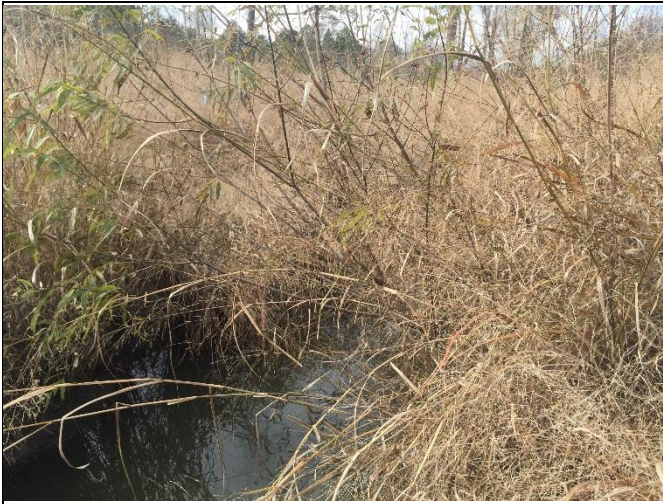
Photo Point 3 – Log Jam

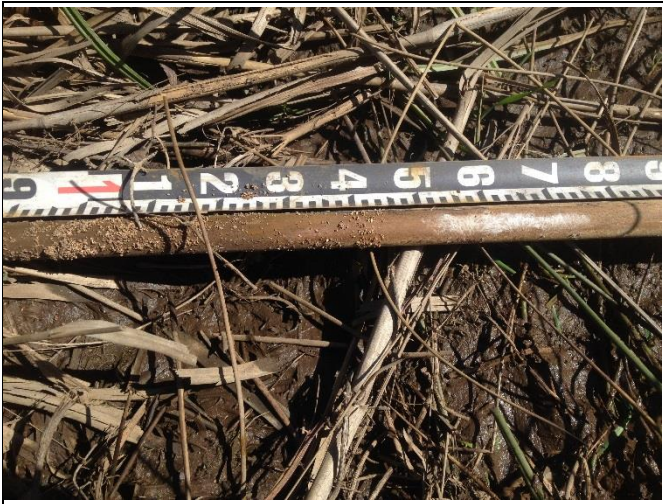
The Site was found to have had at least two post-construction above bankfull events based on the crest gauge readings during Year 3.

Crest gauge reading, 1.44 feet – February 5, 2016 storm

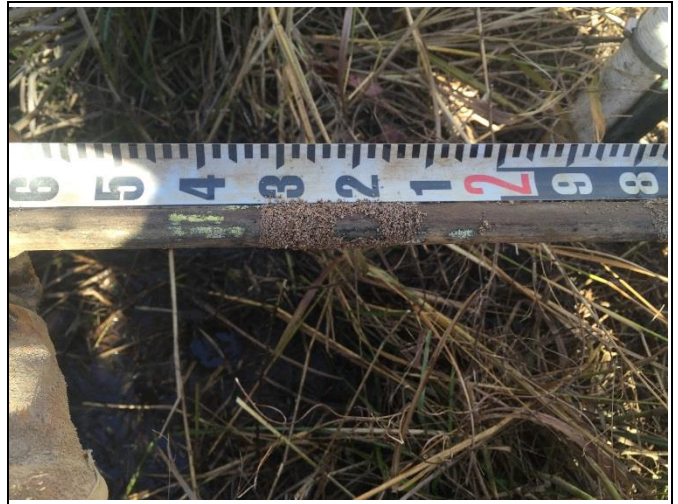
Crest gauge reading, 2.32 feet – October 8, 2016 (Hurricane Matthew)

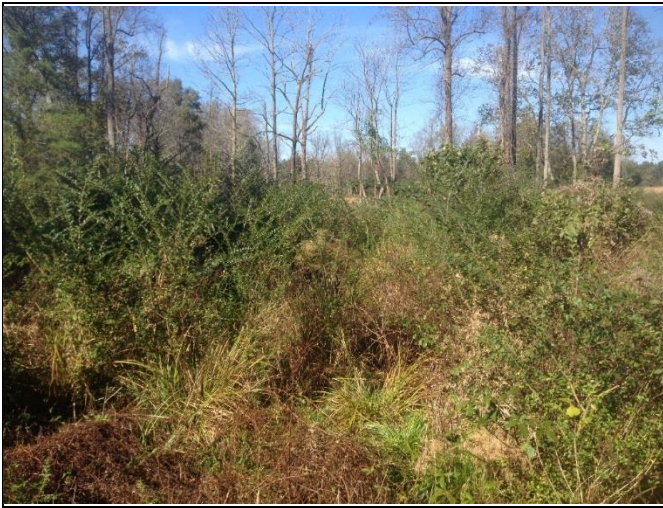
Privet Area #2 11/15/2015

Invasive species areas of concern were observed, documented and treated accordingly during Year 3. Following Year 3 monitoring, four areas (Areas 1, 2, 3, 4) of Chinese privet, totaling approximately 1.48 acres or 9.7

percent of the total planted area within UT1c (15.2 acres) were found to contain the invasive species. To control areas of invasive species, these areas were treated in October and November 2016 by mechanical removal and the use of the herbicide Glyphosate.

Table 6b. Vegetation Problem Areas (VPAs)			
UT to Mill Swamp Restoration Project: DMS Project ID No. 95019			
Feature Issue	Problem Area Number (as shown on CCPV)	Suspected Cause	Photo Number
Invasive/Exotic Populations	#1 (See CCPV)	<i>Ligustrum sinense</i> (Treated 11/22/2016)	3,4,5,6
Invasive/Exotic Populations	#2 (See CCPV)	<i>Ligustrum sinense</i> (Treated 11/22/2016)	1,2
Invasive/Exotic Populations	#3 (See CCPV)	<i>Ligustrum sinense</i> (Treated 10/14/2016)	None
Invasive/Exotic Populations	#4 (See CCPV)	<i>Ligustrum sinense</i> (Treated 10/14/2016)	None

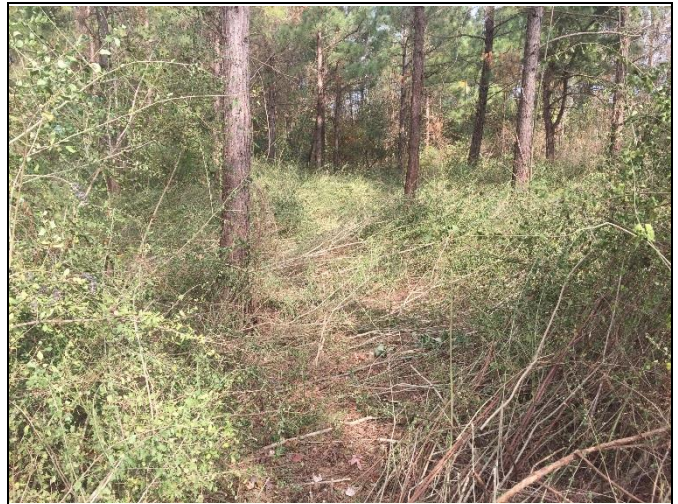
Privet Area #1 11/22/2016

Invasive species areas of concern were observed and documented accordingly during Year 3. During, Year 3 monitoring, four areas (Areas 1, 2, 3, 4) totaling approximately 1.48 acres of the planted area were found to contain the invasive species, Chinese privet (*Ligustrum sinense*). The 1.48-acre area of privet was treated in October and November by mechanical removal and the use of the herbicide Glyphosate. These areas are scheduled to be treated again in 2017 during the appropriate treatment window.
