Mitigation Project Name UT to Mill Swamp Restoration Project
 DMS ID 95019
 River Basin White Oak
 Cataloging Unit 03030001

Subject: Task 11: Response Letter to DMS review comments regarding the Draft Year 5 Monitoring Report for the UT to Mill Swamp Restoration Project (#95019)
White Oak River Basin – CU#03030001, Onslow County, North Carolina
DEQ Contract No. 003992, Baker No. 124578

NCDMS Project ID Number – 95019, DEQ Contract No. 003992

Project Info: Credit Release Year: 5 of 7 (Sixth site measurement since construction)
Year of Data Collection: 2018
Year of Completed Construction: 2013
Submission Date: December 2019

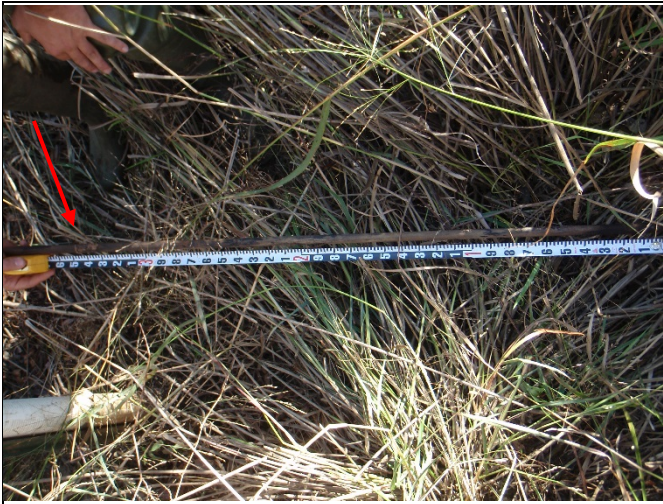
The Site was also found to have had at least two above-bankfull events based on the crest gauge readings during Year 5 monitoring. The highest recorded reading was measured to be 3.41 feet and was associated with Hurricane Florence on September 15, 2018. Crest gauge reading data are presented in Appendix E and gauge photographs are presented in Appendix B.

Crest gauge reading: 3.41 ft from 9/15/18
(Hurricane Florence)

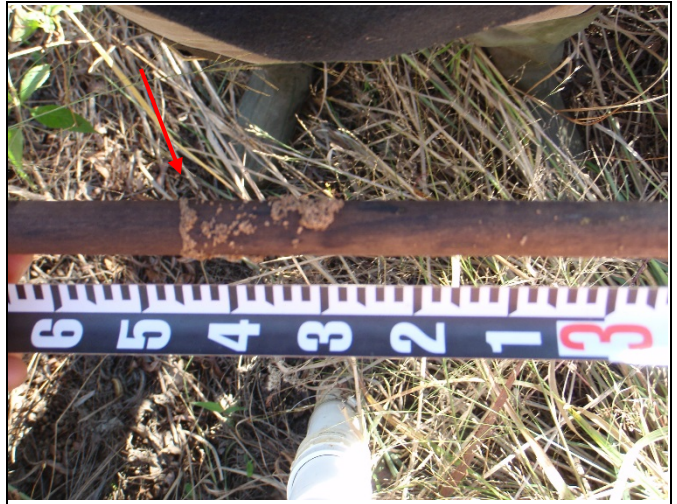
Crest gauge reading: 3.41 ft from 9/15/18
(Hurricane Florence)

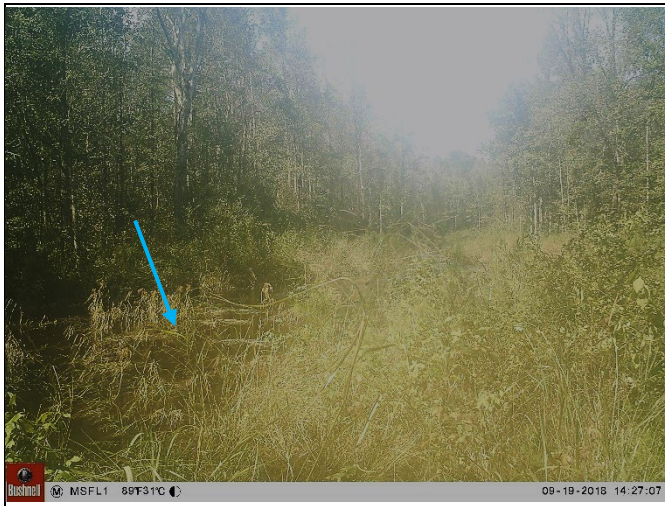
Flow Camera #1 on 9/19/18 (post-Hurricane Florence) with flow in channel

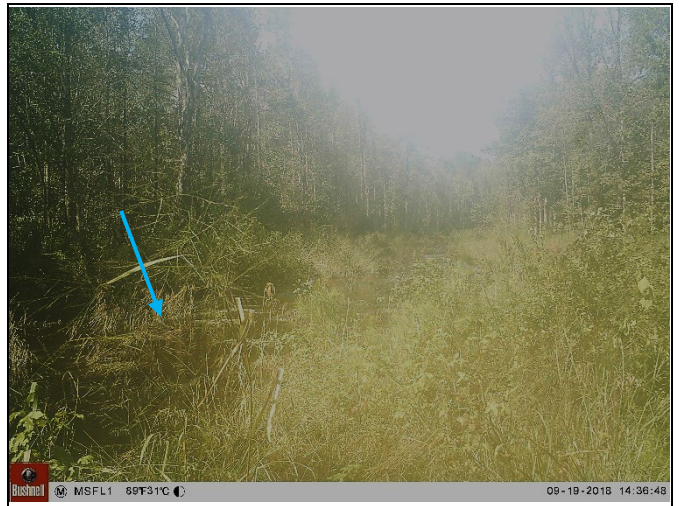
Flow Camera #1 on 9/19/18 (post-Hurricane Florence) with flow in channel

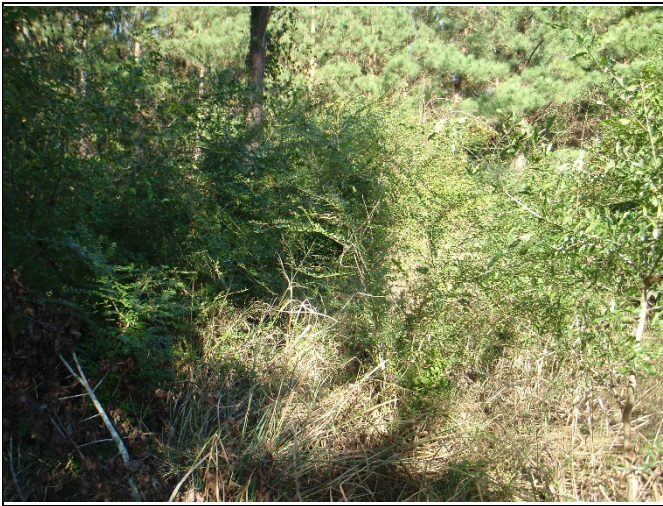
Table 6b. Vegetation Problem Areas (VPAs)			
UT to Mill Swamp Restoration Project: DMS Project ID No. 95019			
Feature Issue	Station Numbers / Location	Suspected Cause	Photos
Chinese privet (<i>Ligustrum sinense</i>)	Station 43+75 to 46+50 (along the outermost portion of the left bank). See CCPV for exact location	Re-sprouts	See Appendix B

VPA (*Ligustrum sinense* resprouts) 10/30/18

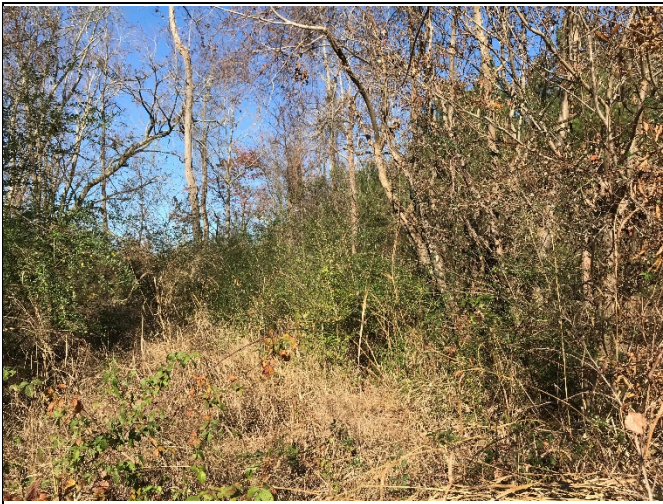
VPA (*Ligustrum sinense* resprouts) 12/04/18

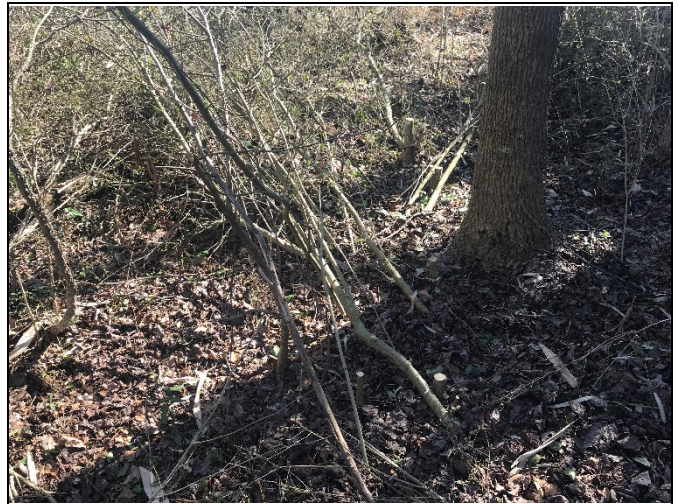
Ligustrum sinense (treated in Feb 2018)

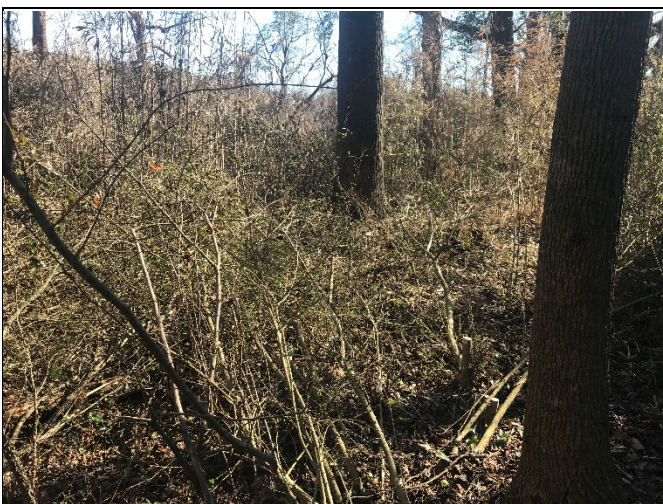
Ligustrum sinense (treated in Feb 2018)

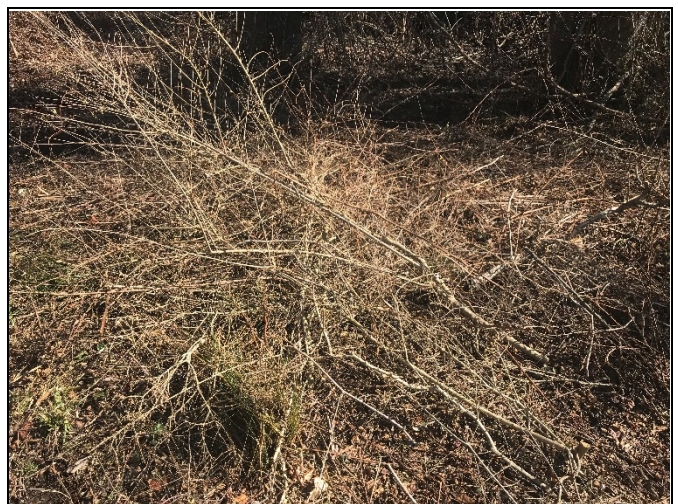
Ligustrum sinense (treated in Feb 2018)
