UT to Mill Swamp Restoration Project Eighth Monitoring Measurement Seventh Year of Credit Release - Final

Onslow County, North Carolina

NCDMS Project ID Number – 95019, DEQ Contract No. 003992

Report Prepared and Submitted by Michael Baker Engineering, Inc.

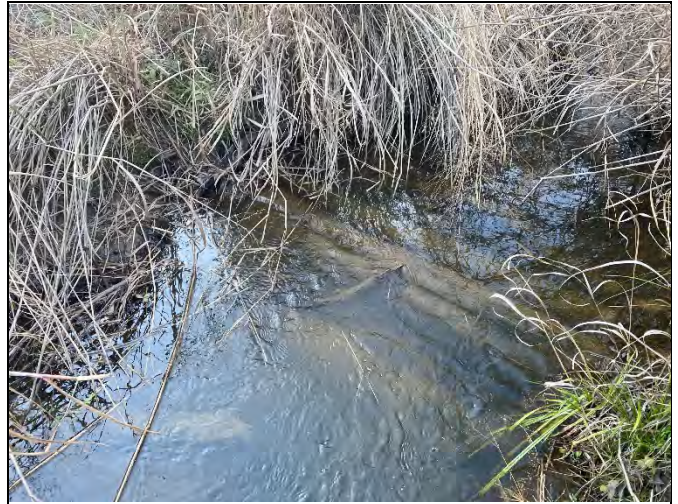
Photo Point 2 – UT1c Log Jam

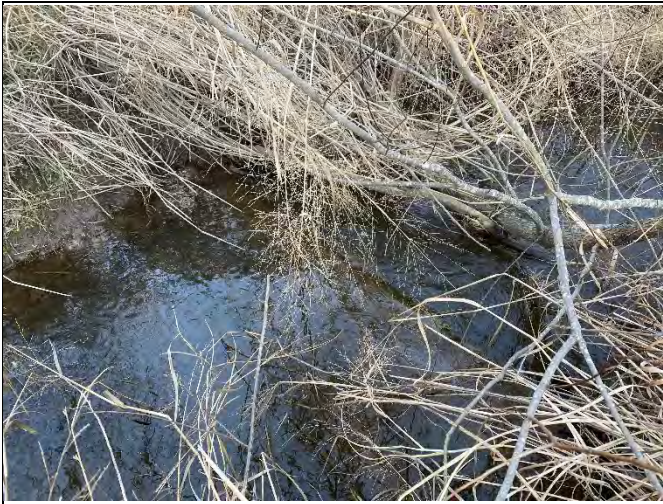
Photo Point 3 – UT1c Log Weir/Log Jam

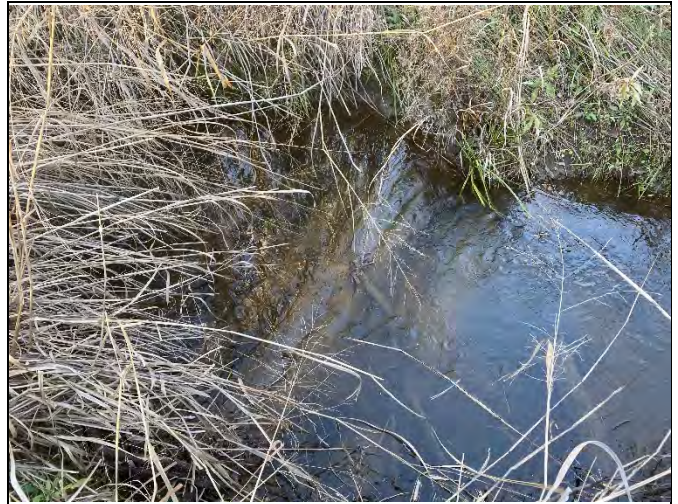
Photo Point 4 – UT1c Log Jam

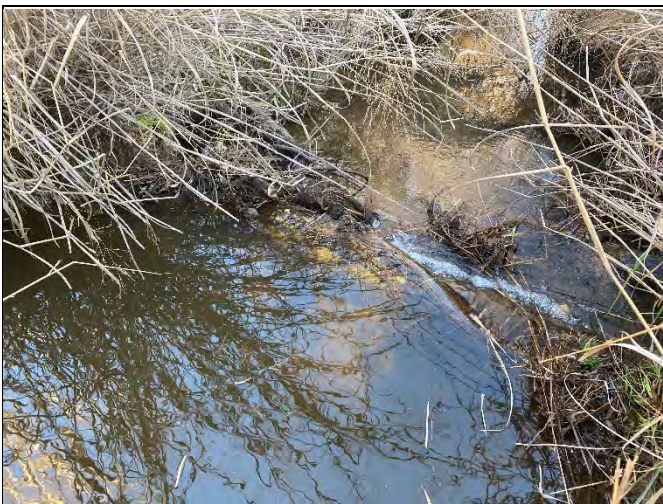
Photo Point 5 – UT1c Log Jam

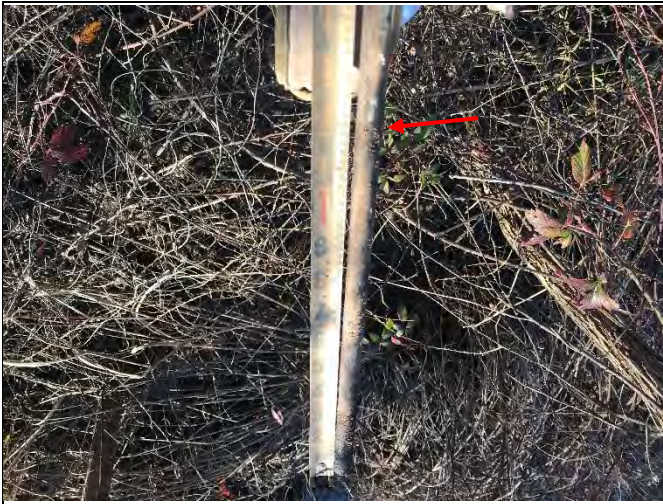
The Site was also found to have had at least one above-bankfull event based on the crest gauge monitoring conducted during Year 7. A reading of 1.20 feet was measured on 12/8/20 from a 4.9 inch storm on 11/12/20. This overbank event is also corroborated by the flow gauge readings. The complete project crest gauge data are presented in Appendix E and gauge photographs are presented in Appendix B. As bankfull events have now been documented in each year of monitoring, the project has met the bankfull standard required for credit release.

Crest gauge reading: 1.20 ft from 11/12/20 storm event (~4.9" rain)

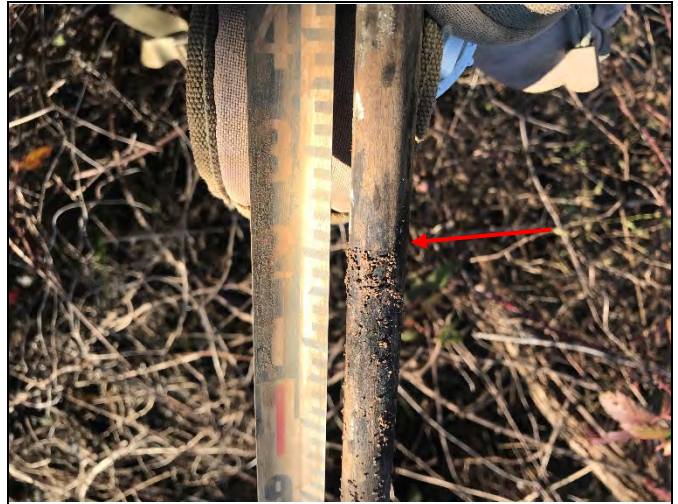
Close-up of crest gauge reading: 1.20 ft from 11/12/20 storm event

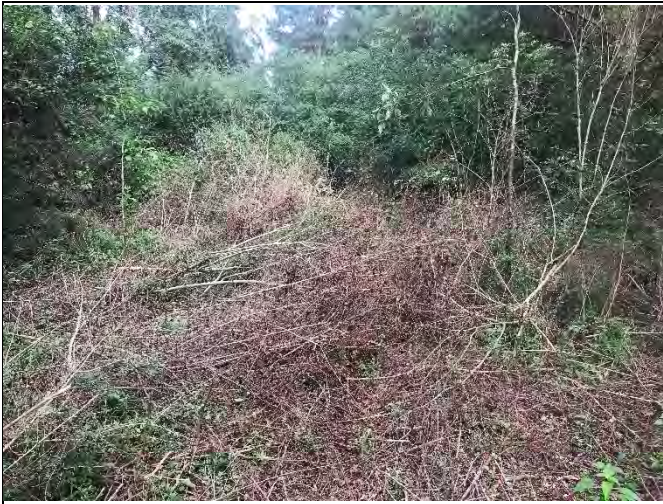
Table 6b. Vegetation Problem Areas (VPAs)			
UT to Mill Swamp Restoration Project: DMS Project ID No. 95019			
Feature Issue	Station Numbers / Location	Suspected Cause	Photos
Chinese privet (<i>Ligustrum sinense</i>)	Found scattered in the floodplain in sections of the middle right bank (~Station 44+00) and the lower left bank (~Stations 46+00 to 50+00) of UT1c. See CCPV for exact locations.	Re-sprouts	See Appendix B

Privet (*Ligustrum sinense*) treated Sept. 2020

Two areas of invasive Chinese privet (*Ligustrum sinense*) totaling 0.96 acres that had previously been identified as a Vegetation Problem Area (VPA) in the Year 6 report were treated in September of 2020. However, additional resprouts were again observed and documented during Year 7 monitoring. Scattered privet resprouts totaling 0.87 acres were observed in two areas along the left and right floodplain of the middle and lower sections of Reach UT1c. These invasives are identified as a Vegetation Problem Area (VPA) and will be treated in the spring of 2021, prior to Site closeout evaluations. These resprout areas overlap significantly with the previously treated areas. The CCPV found in Appendix B shows the locations of each of these areas.

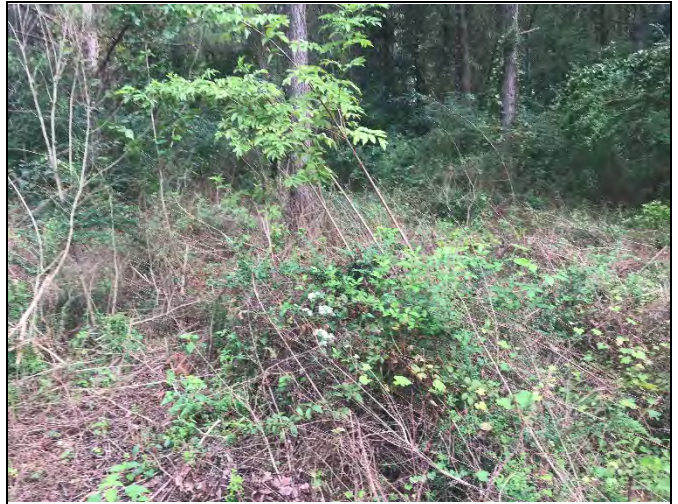
Privet treated Sept. 2020

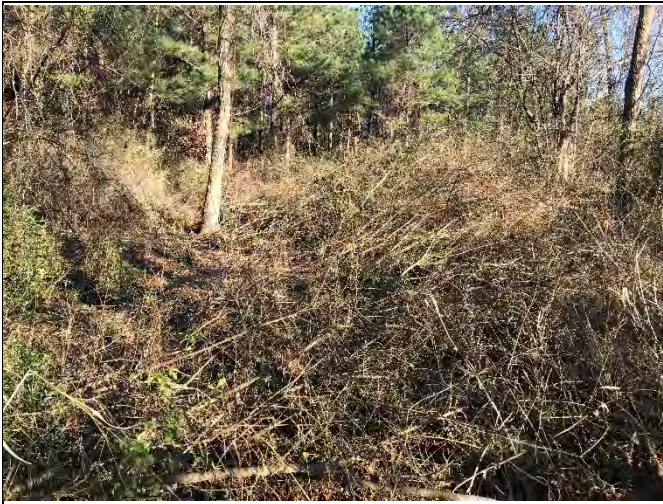
Privet treated (photo from Dec. 2020)

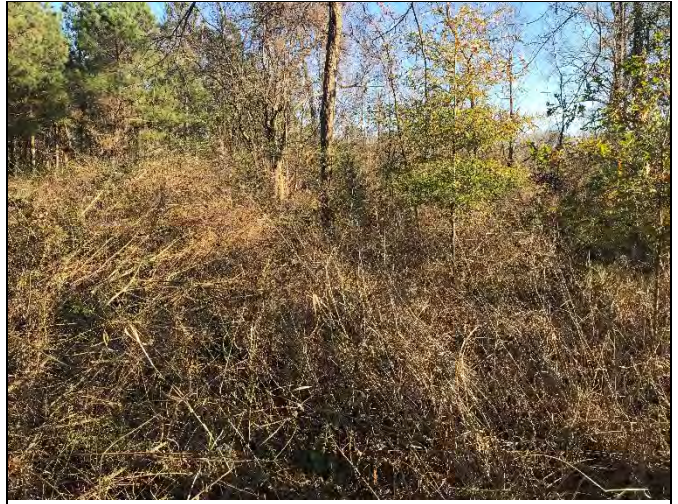
Privet treated (photo from Dec. 2020)

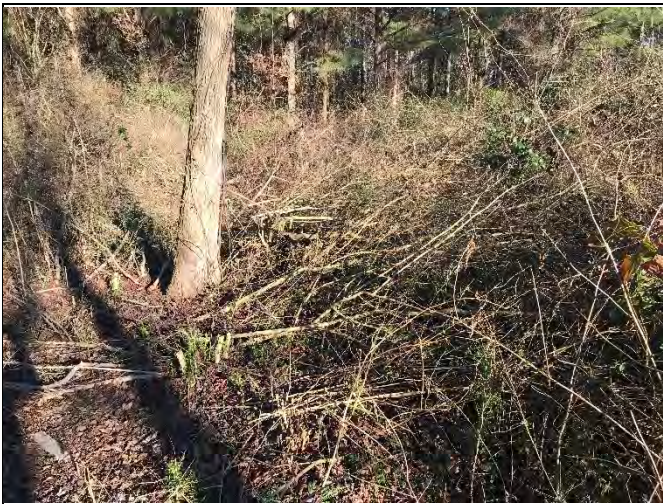
Privet treated (photo from Dec. 2020)

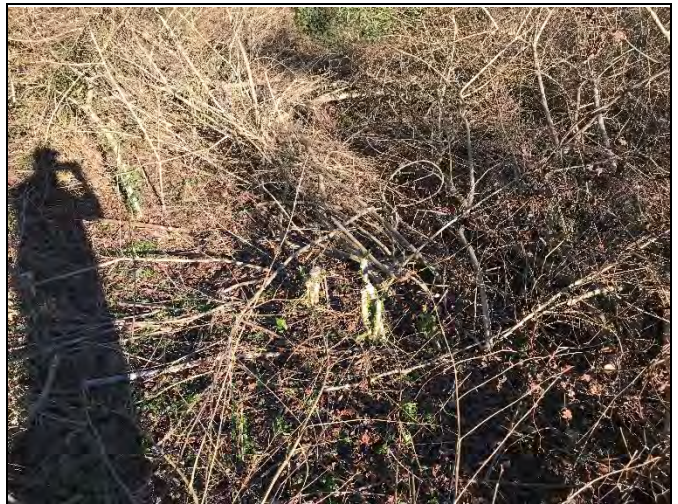
Privet treated (photo from Dec. 2020)

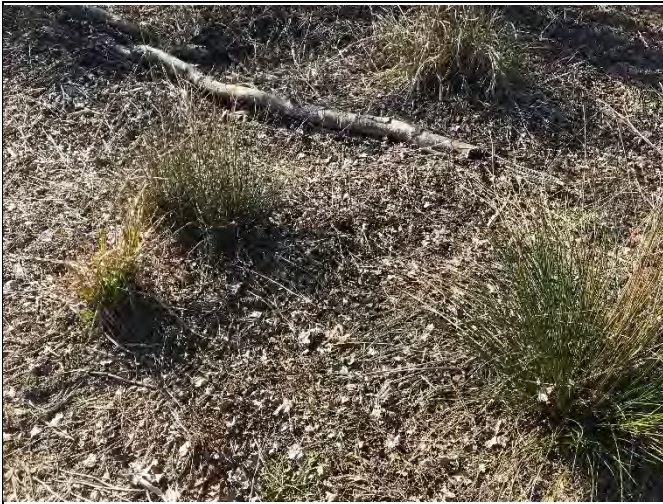
Soft rush in area with saturated soil

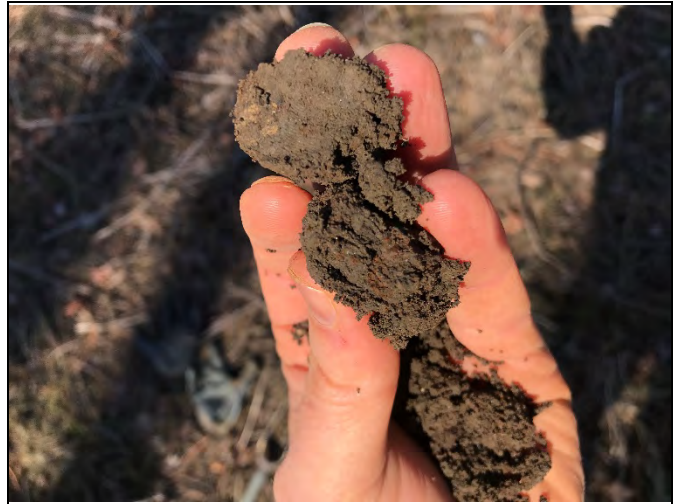
Hydric soil

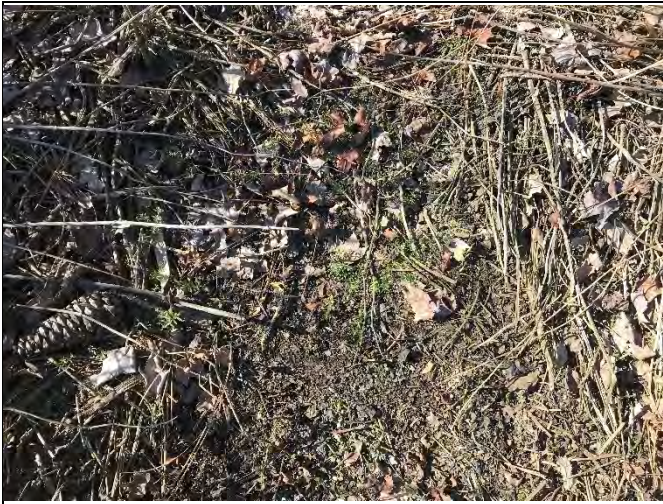
Saturated, hydric soil to surface

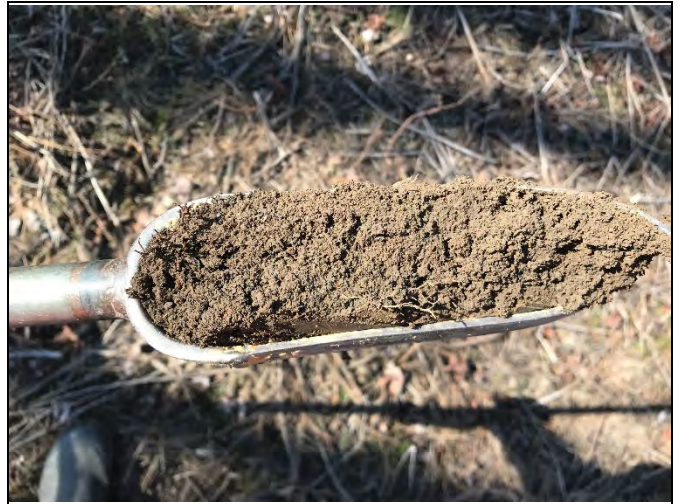
Hydric soil

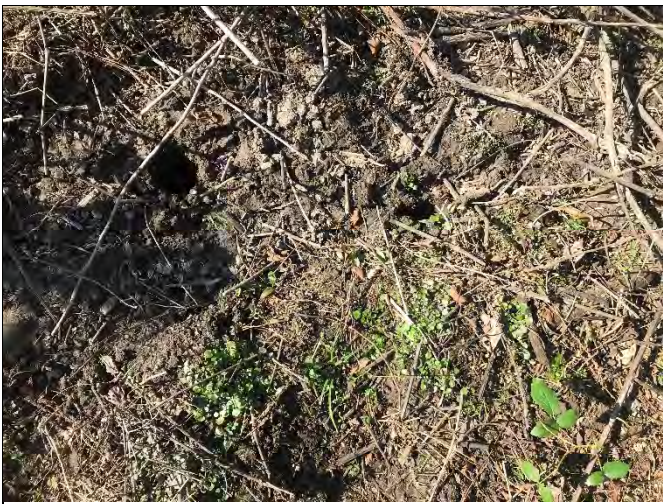
Saturated, hydric soil to surface

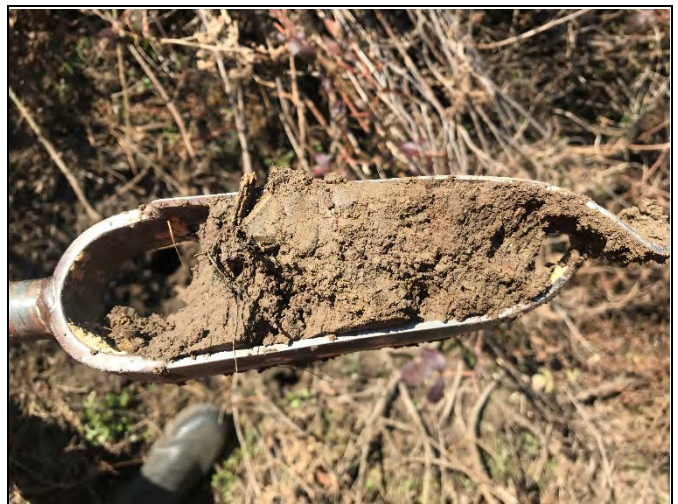
Hydric soil

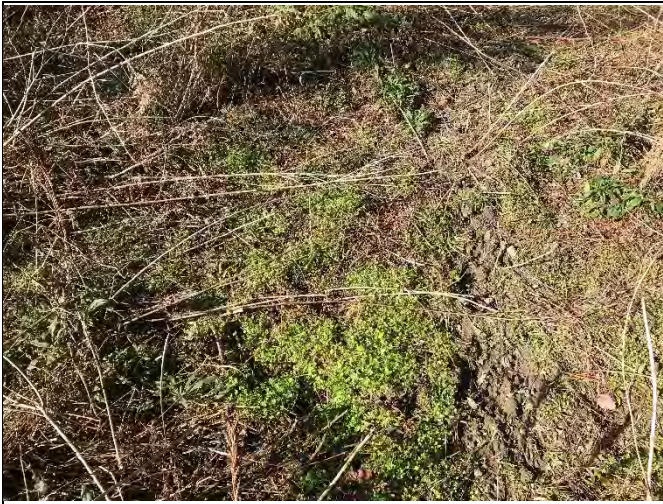
Saturated, hydric soil to surface

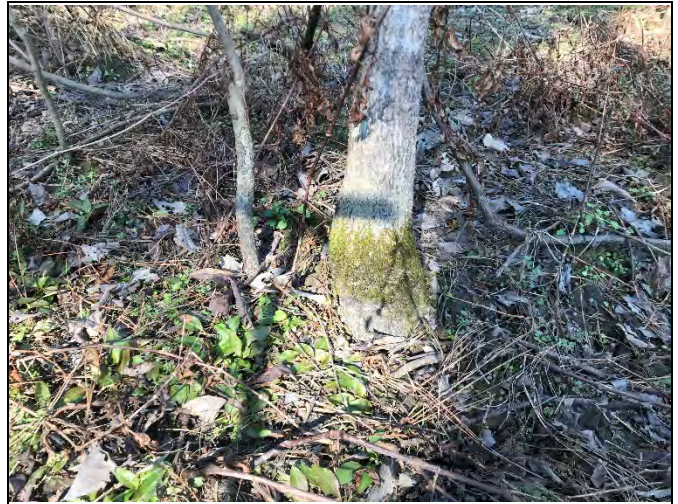
Moss trim-line on tree trunk

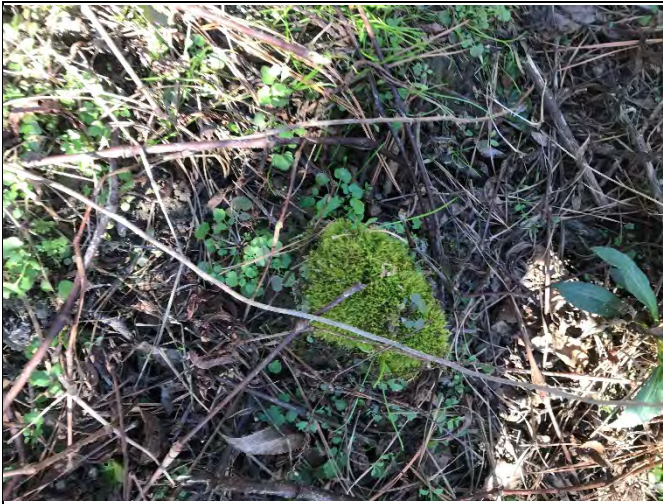
Saturated, hydric soil to surface with moss

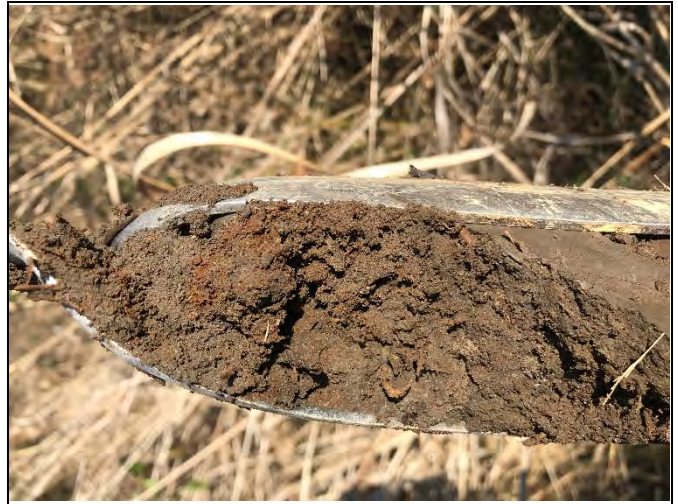
Hydric soil

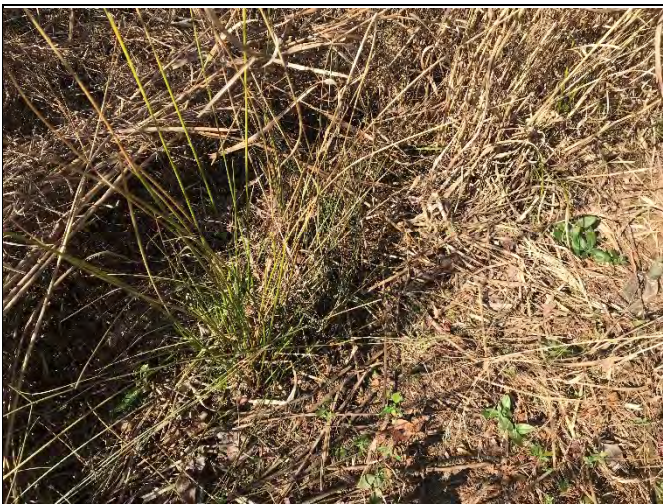
Saturated, hydric soil to surface (with soft rush)

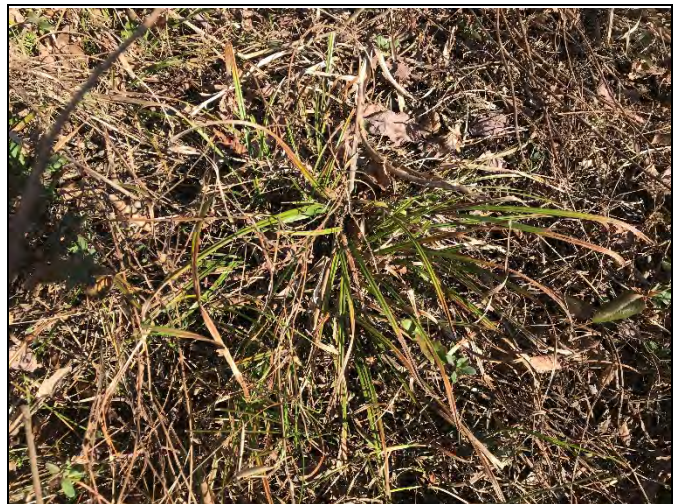
Saturated, hydric soil to surface (with *Carex spp.*)

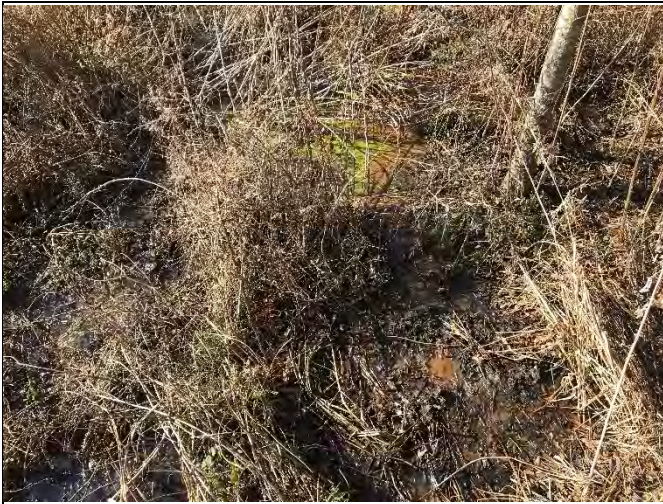
Pockets of shallow standing water

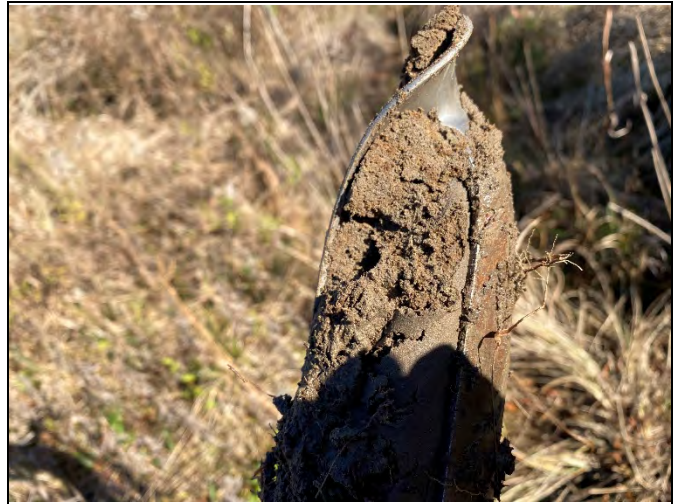
Hydric soil

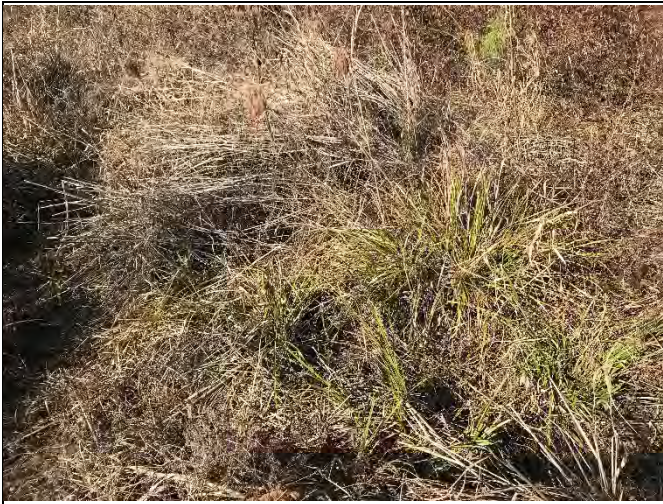
Carex spp. and *Scirpus* (Woolgrass) in area saturated to the surface

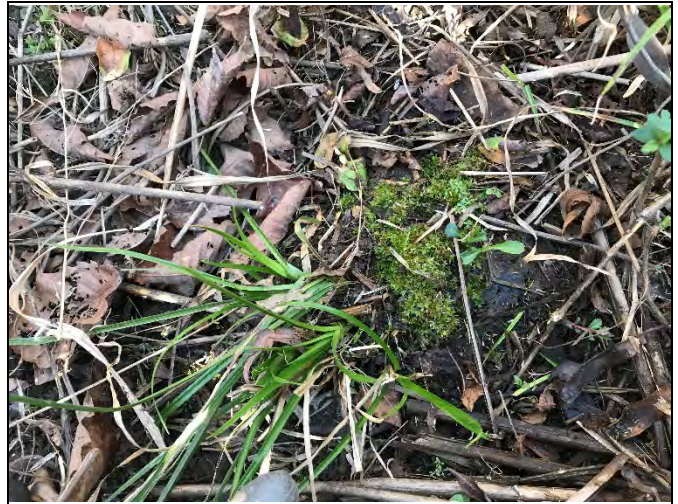
Area of shallow standing water

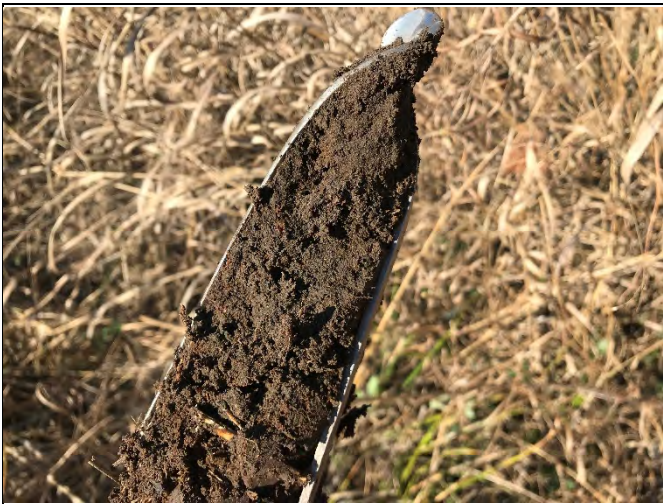
Hydric soil

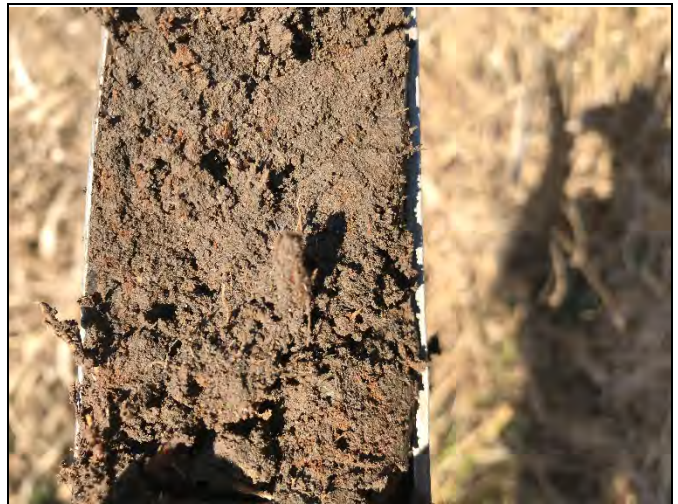
Close-up of hydric soil

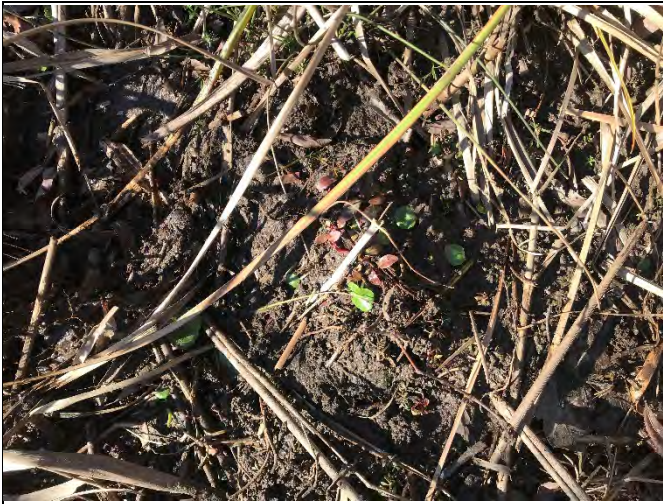
Saturated, hydric soil to surface

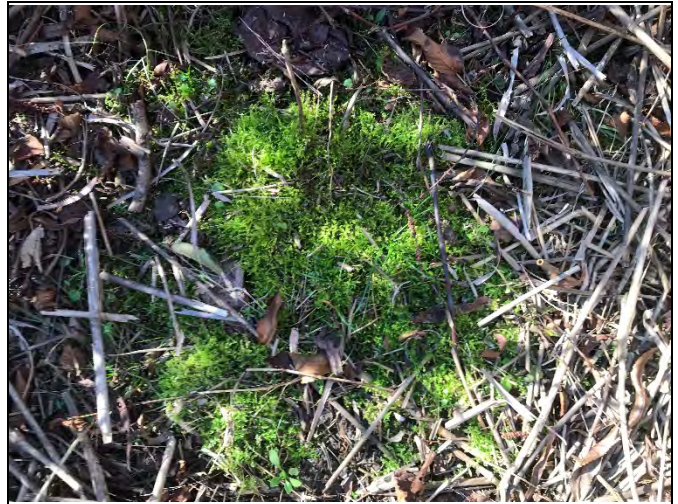
Saturated, hydric soil to surface with moss

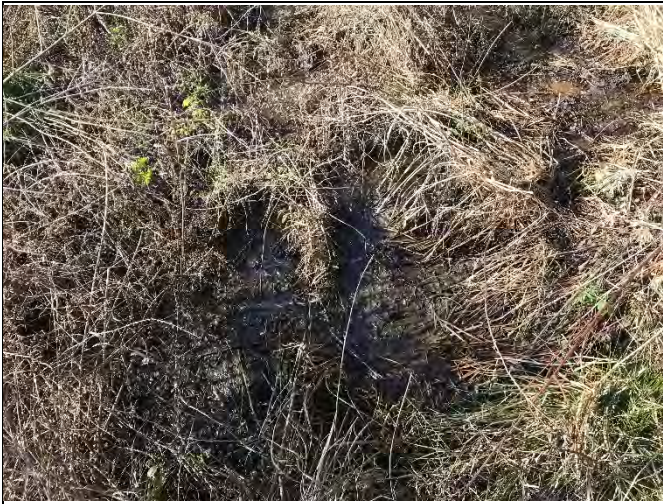
Pocket of standing water

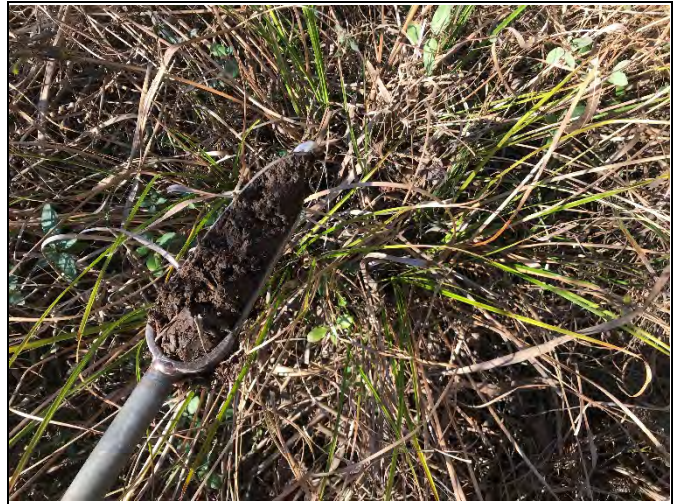
Hydric soil and *Carex spp.*

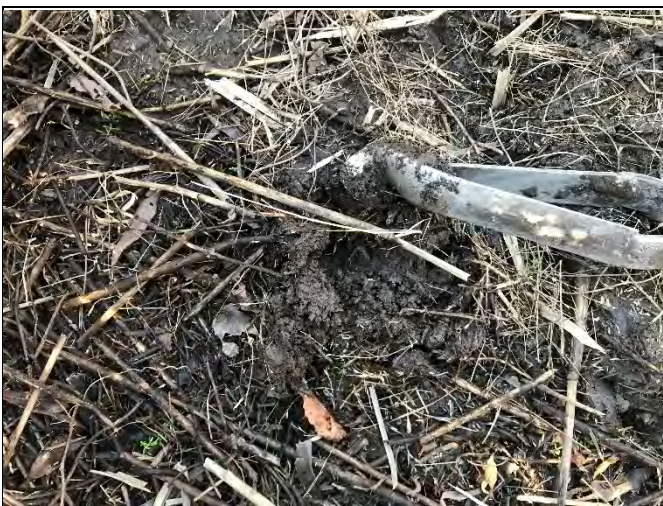
Saturated, hydric soil to surface

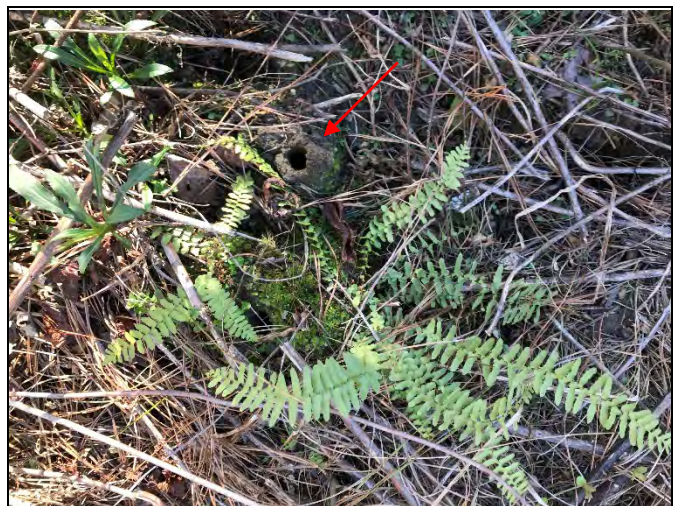
Crayfish burrow
