**UT to South Fork Creek (Stephens)
Stream and Wetland Restoration Project
Alamance County, North Carolina
EEP Project #405**

MY-04 Monitoring Report

**UT to South Fork Creek
Stream and Wetland Restoration
EEP Project #405
Liberty, North Carolina
Alamance County**

**MY-04 Monitoring Report
Prepared By:**

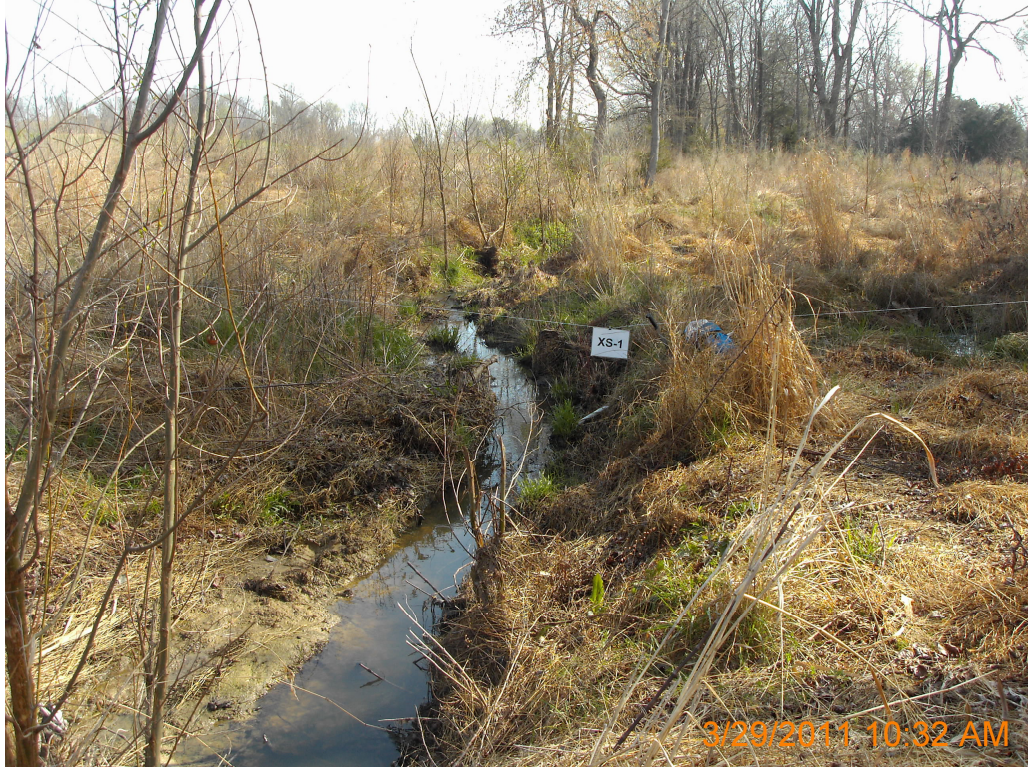
Photo 1. Looking downstream at XS-1

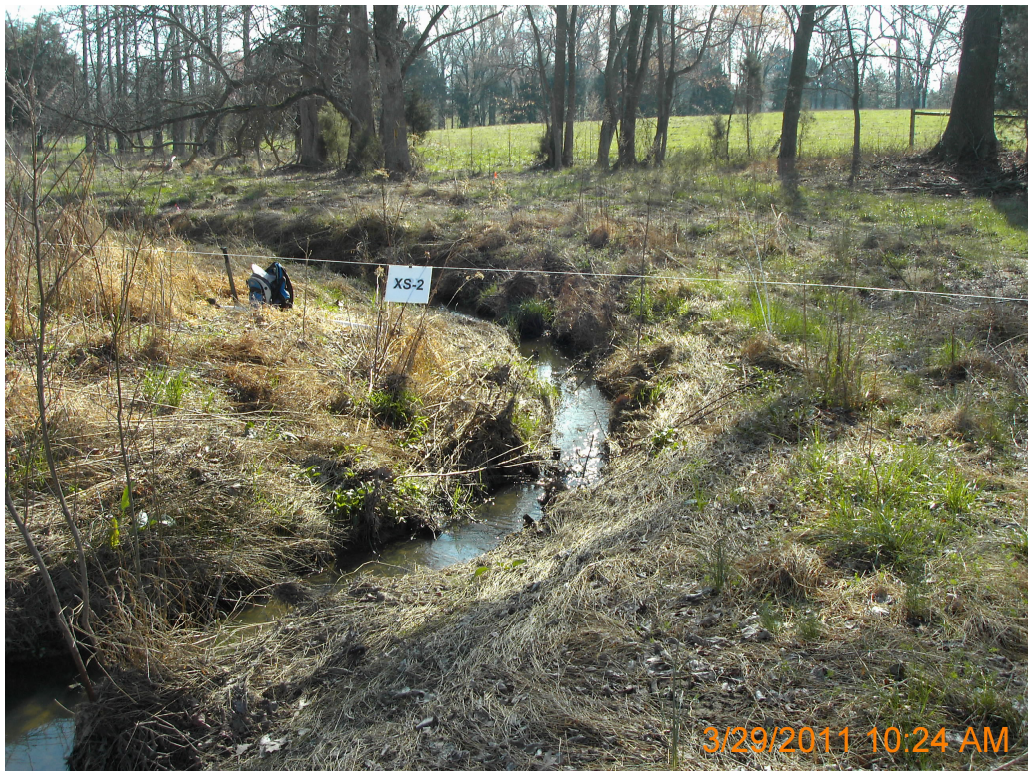
Photo 2. Looking downstream at XS-2

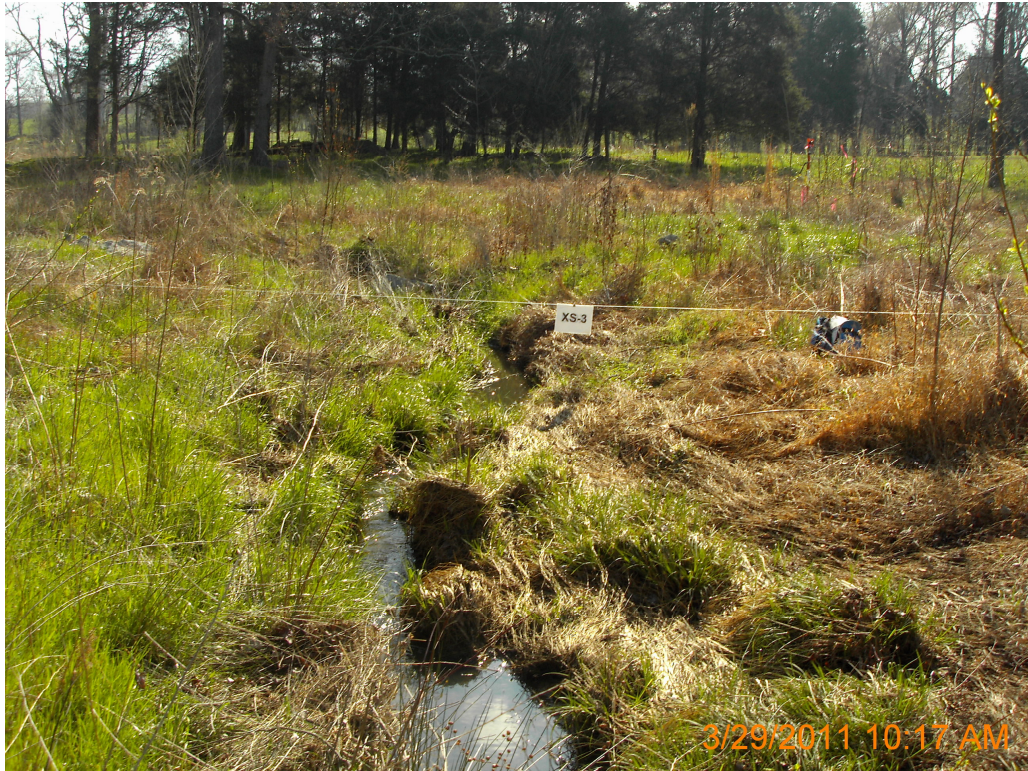
Photo 3. Looking downstream at XS-3

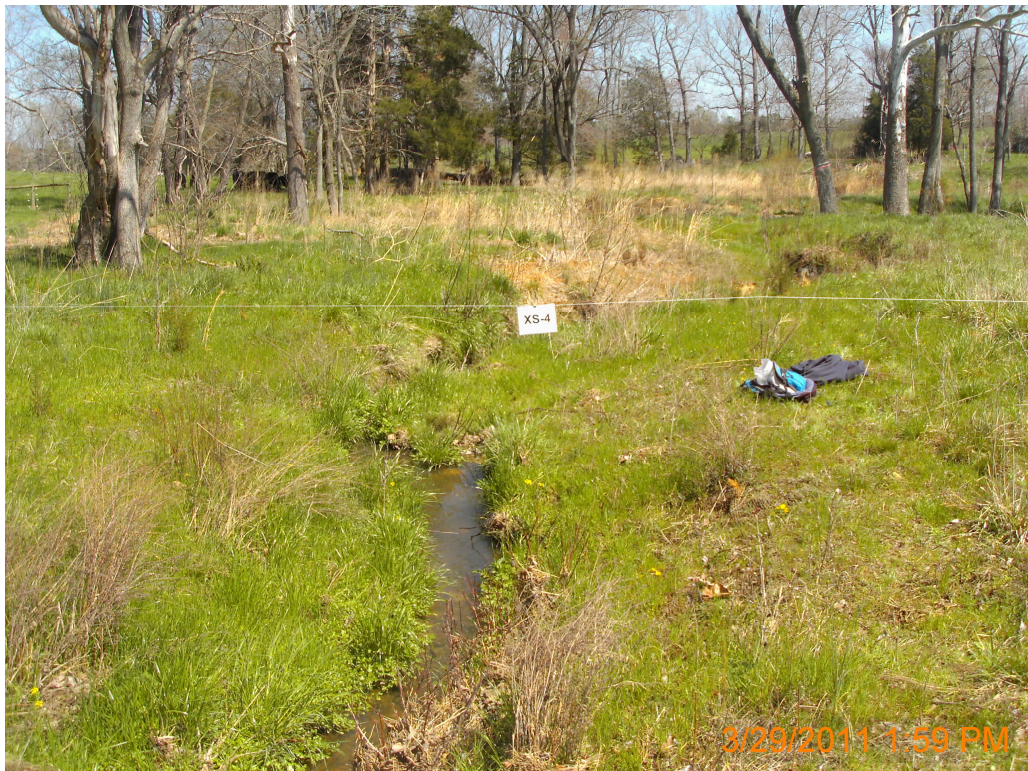
Photo 4. Looking downstream at XS-4

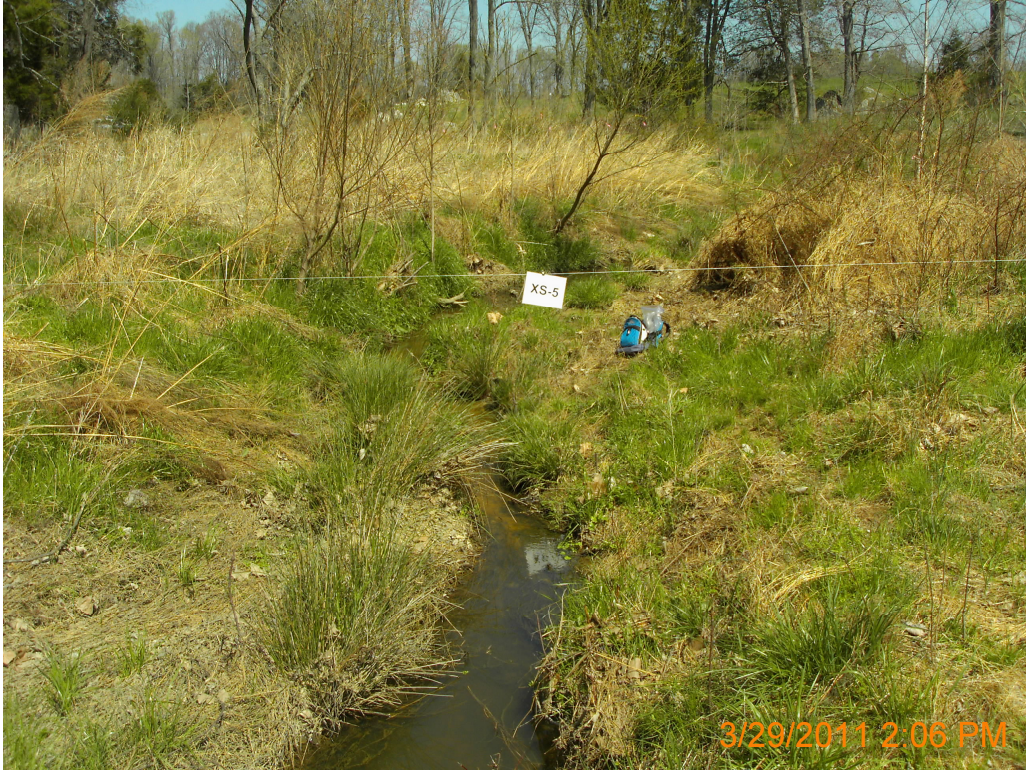
Photo 5. Looking downstream at XS-5

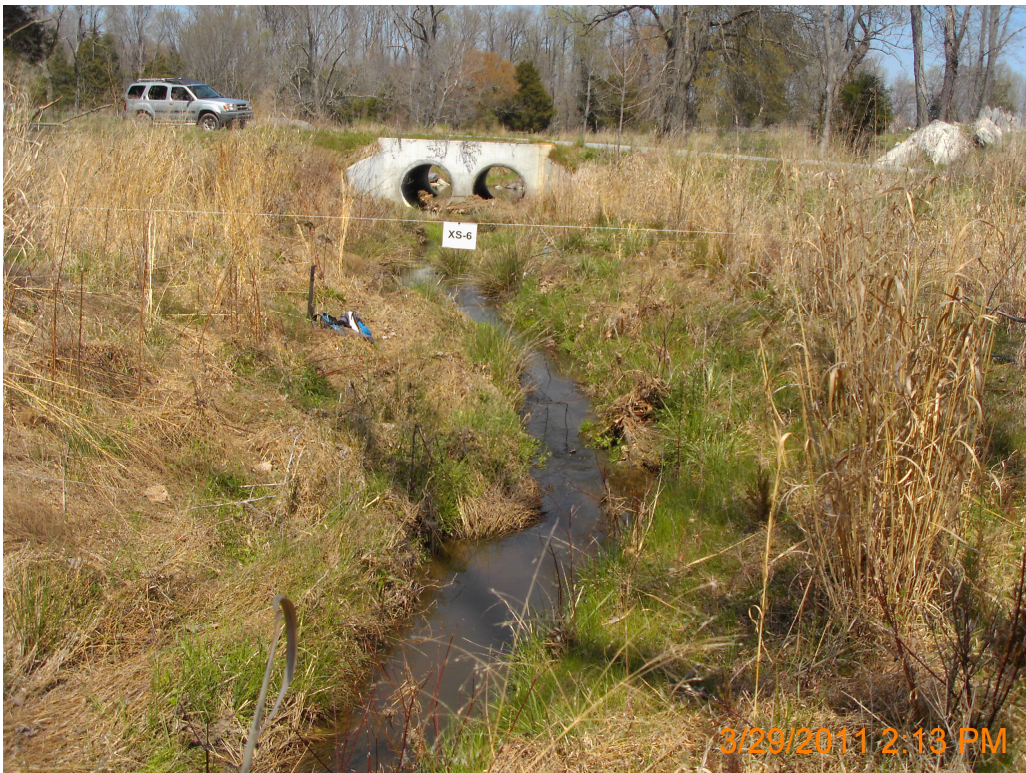
Photo 6. Looking downstream at XS-6

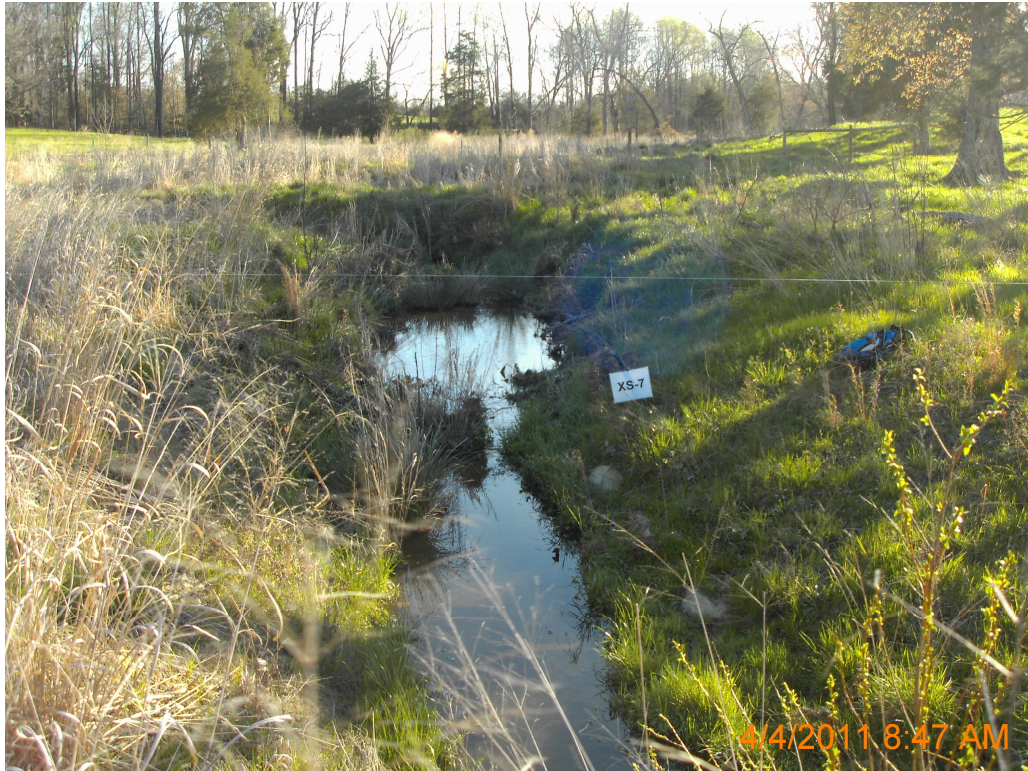
Photo 7. Looking downstream at XS-7

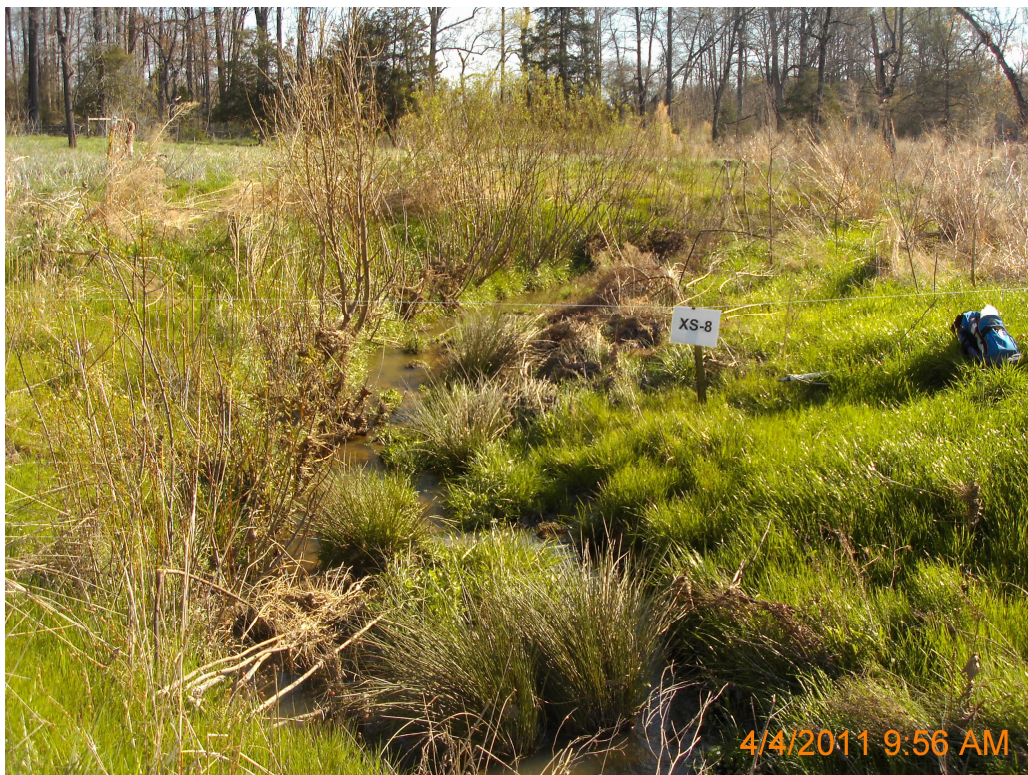
Photo 8. Looking downstream at XS-8

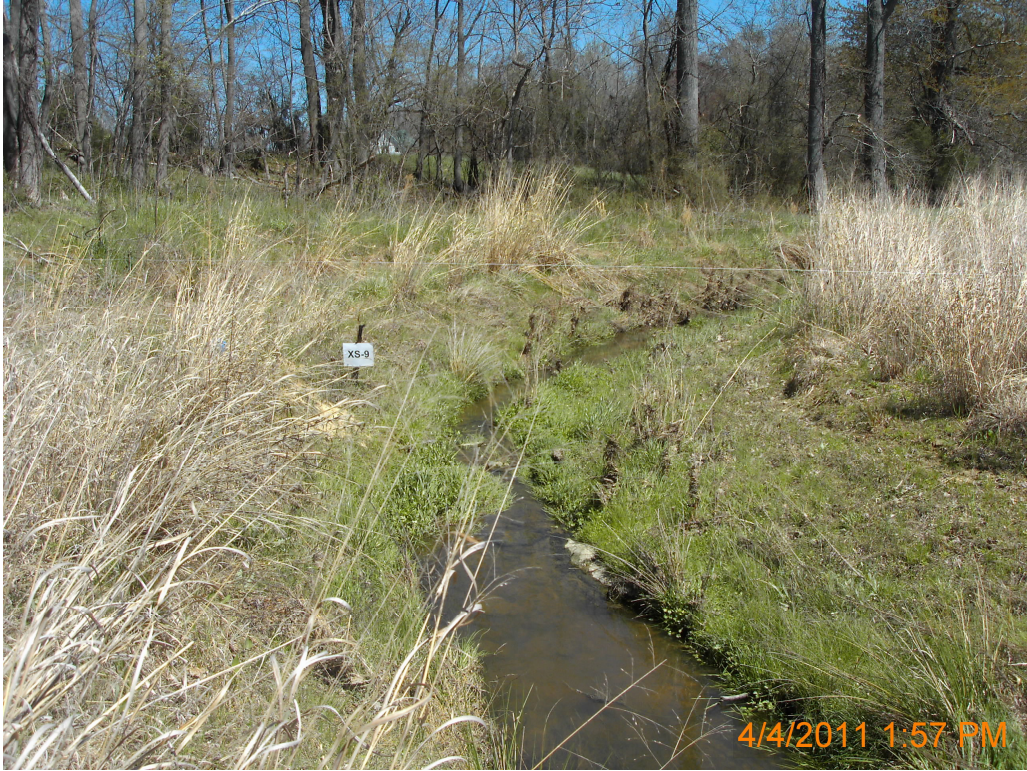
Photo 9. Looking downstream at XS-9

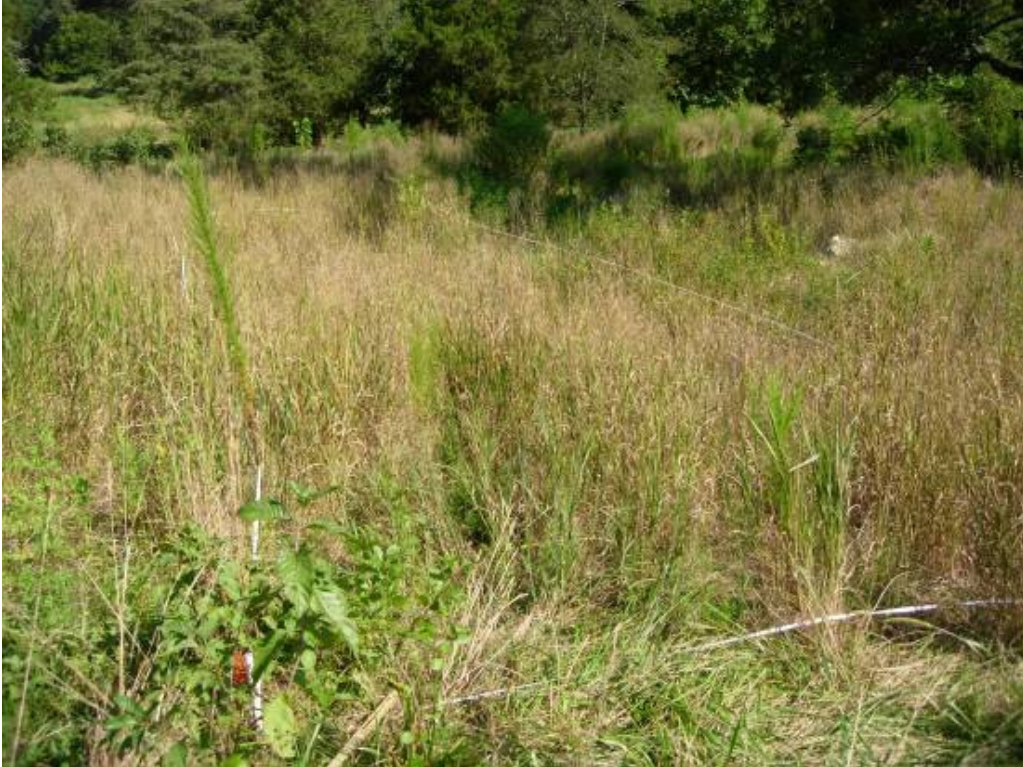
Photo 10. Vegetation Plot 1 (August 31,2011)

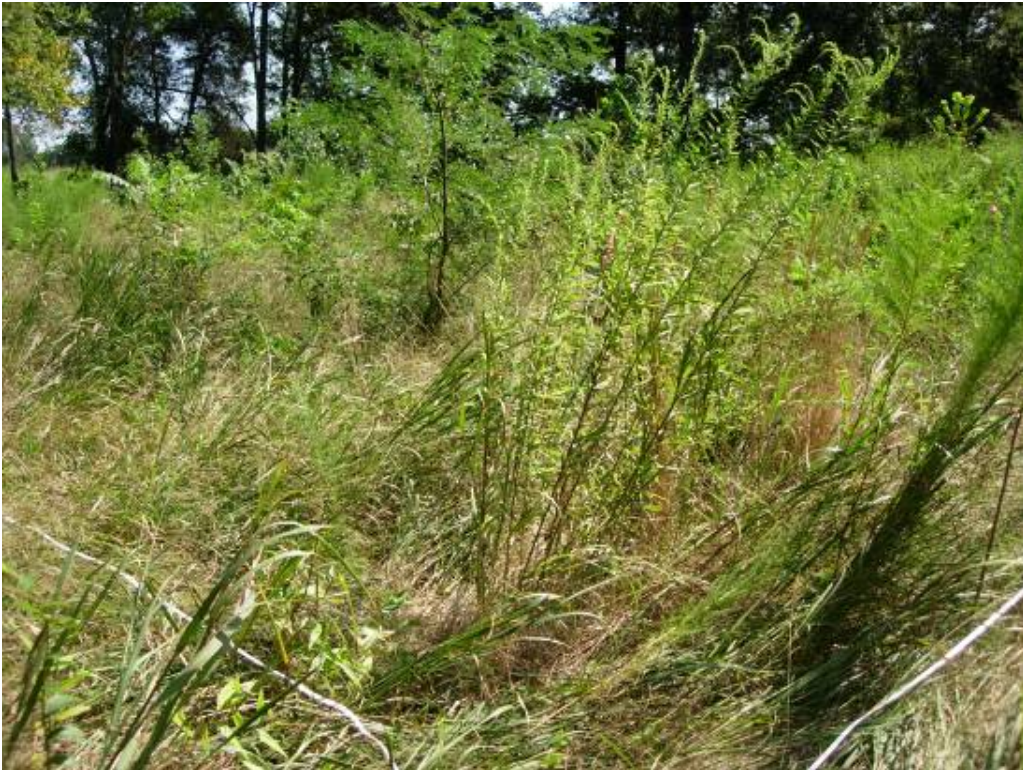
Photo 11. Vegetation Plot 2 (August 31,2011)

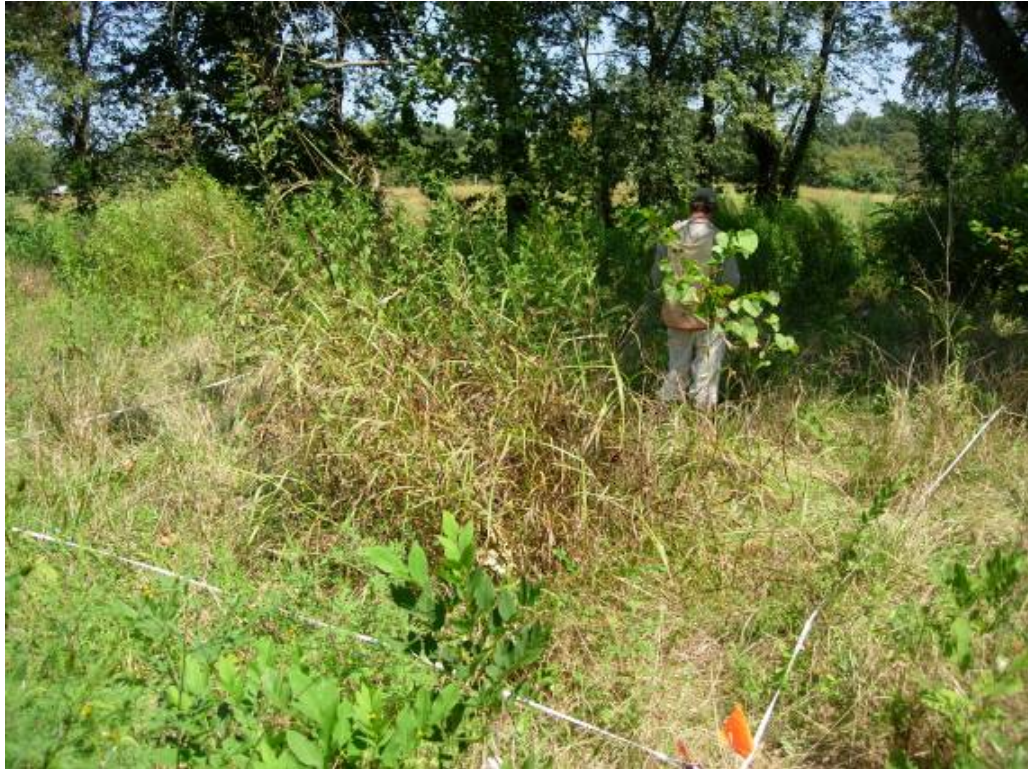
Photo 12. Vegetation Plot 3 (August 31,2011)

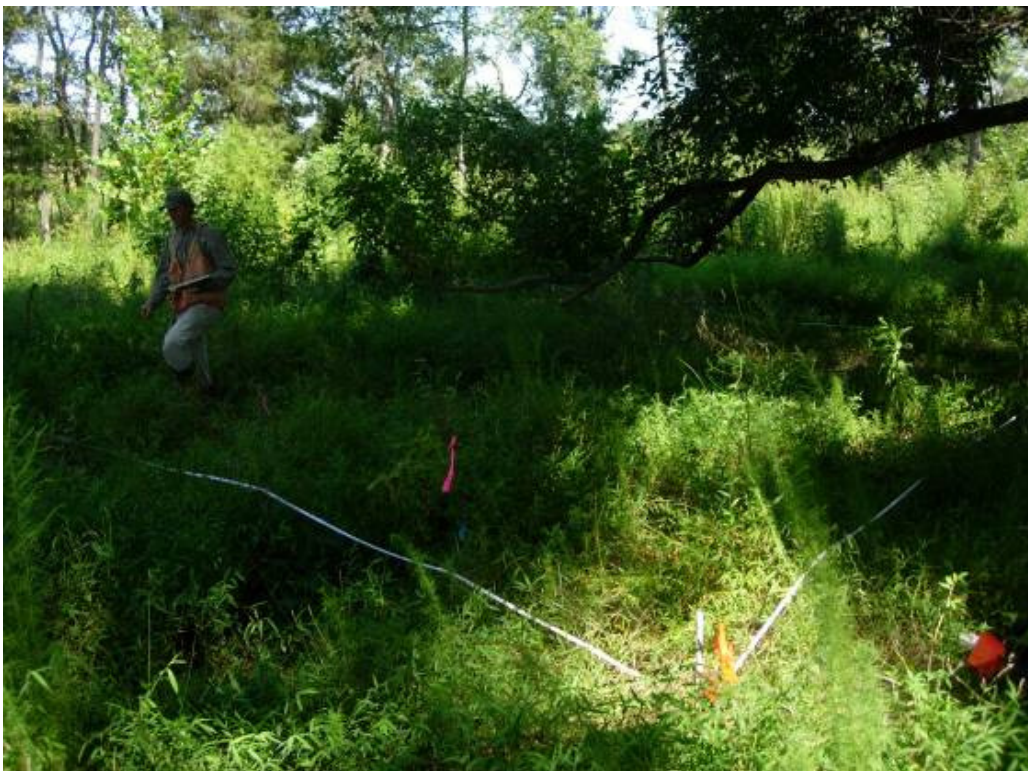
Photo 13. Vegetation Plot 4 (August 31,2011)

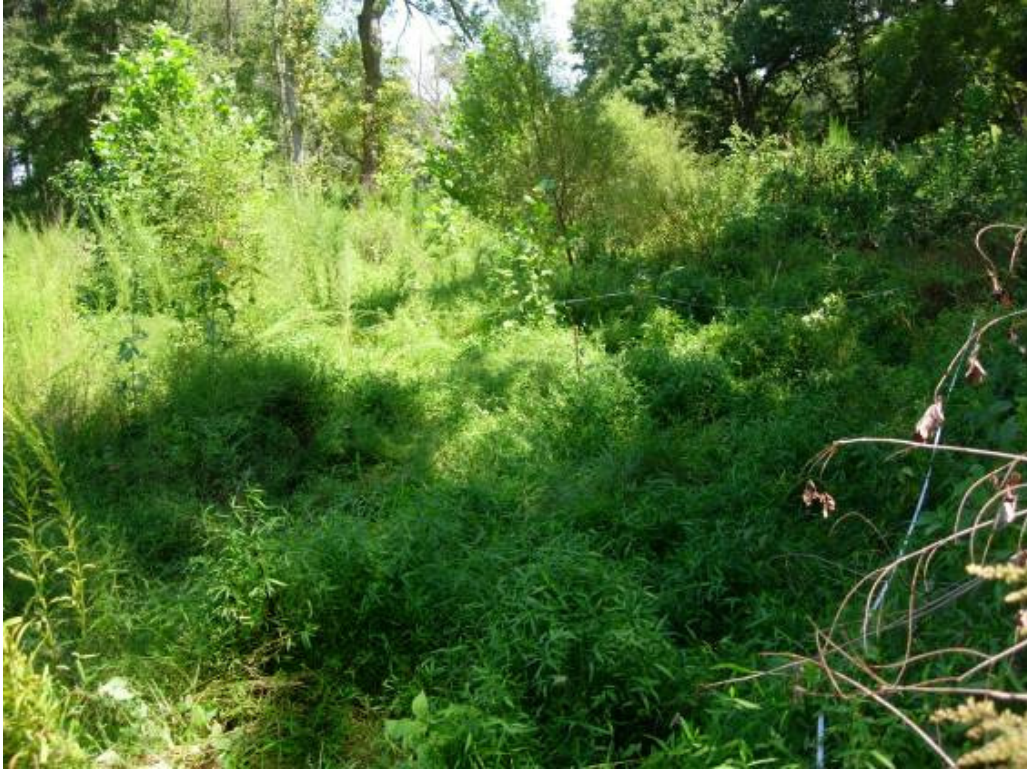
Photo 14. Vegetation Plot 5 (August 31,2011)

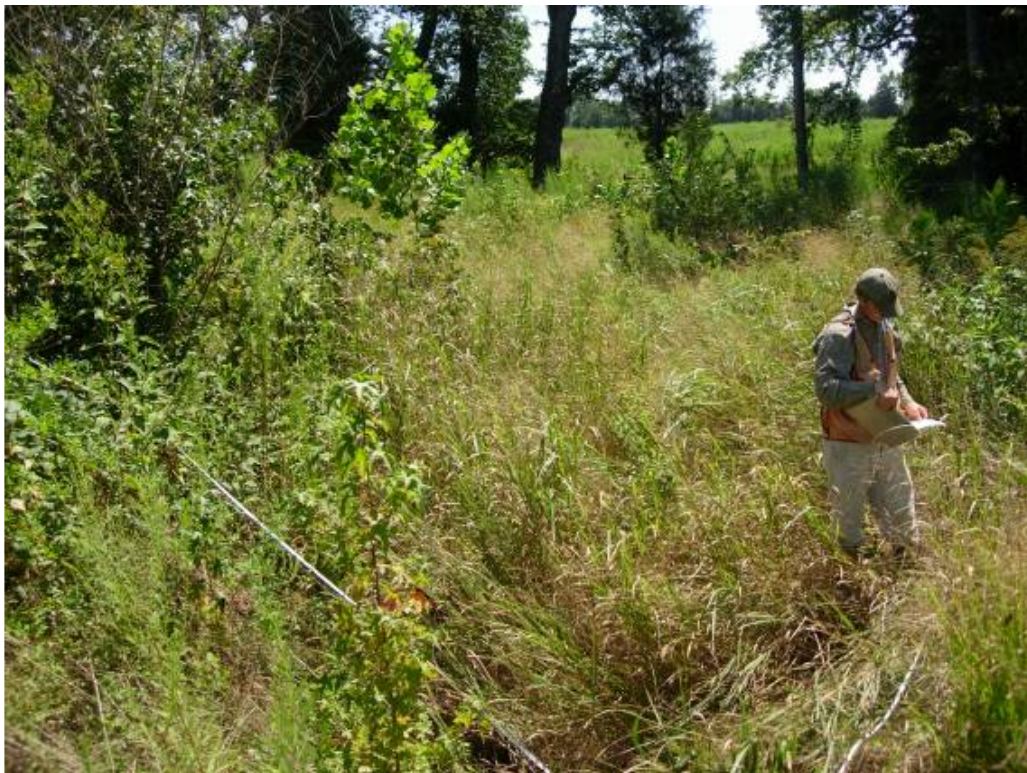
Photo 15. Vegetation Plot 6 (August 31,2011)

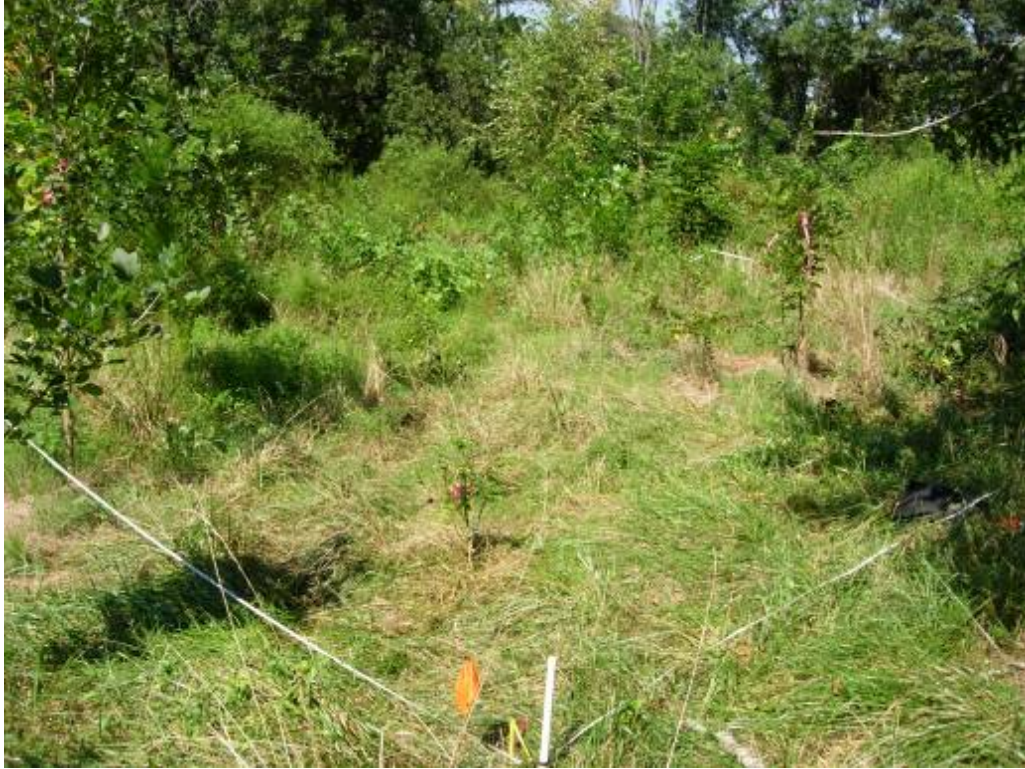
Photo 16. Vegetation Plot 7 (August 31,2011)

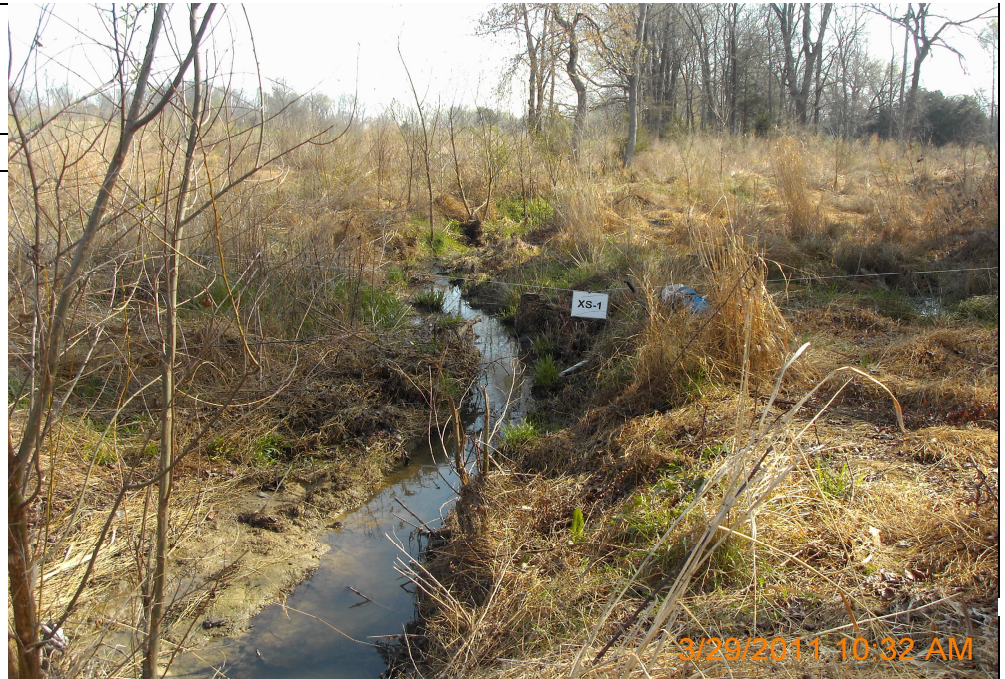
Photo of XS-1, looking in the downstream direction

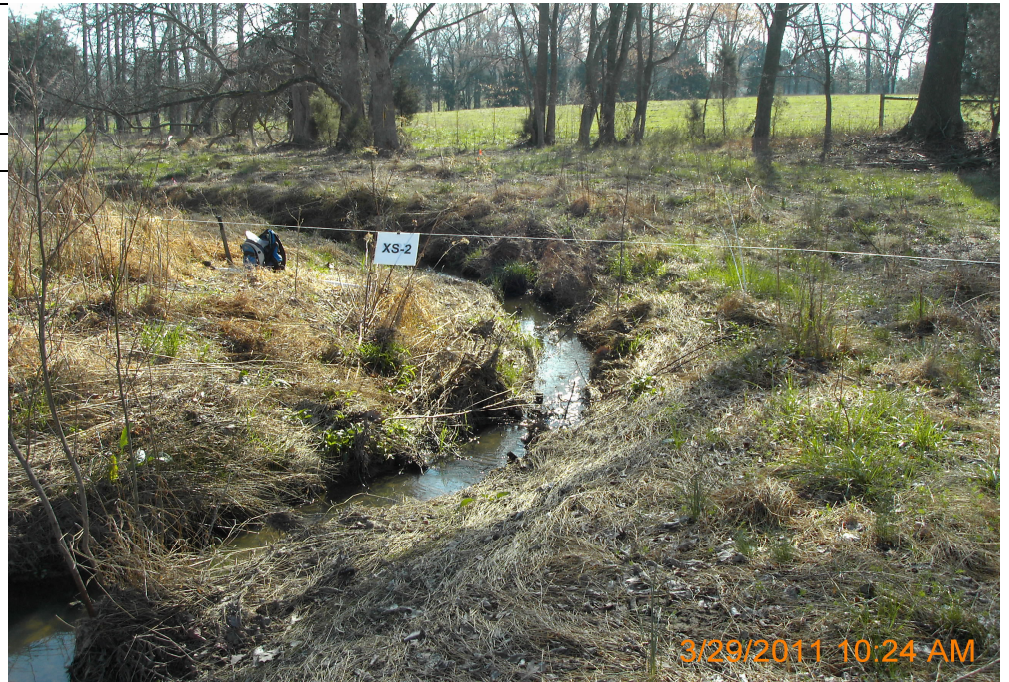
Photo of XS-2, looking in the downstream direction

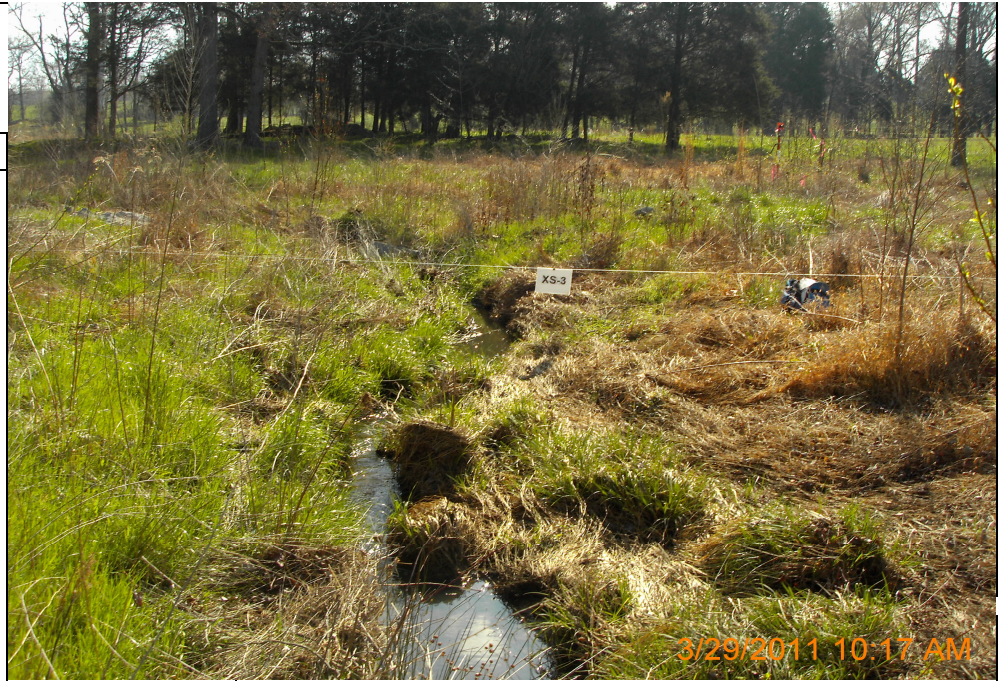
Photo of XS-3 looking in the downstream direction

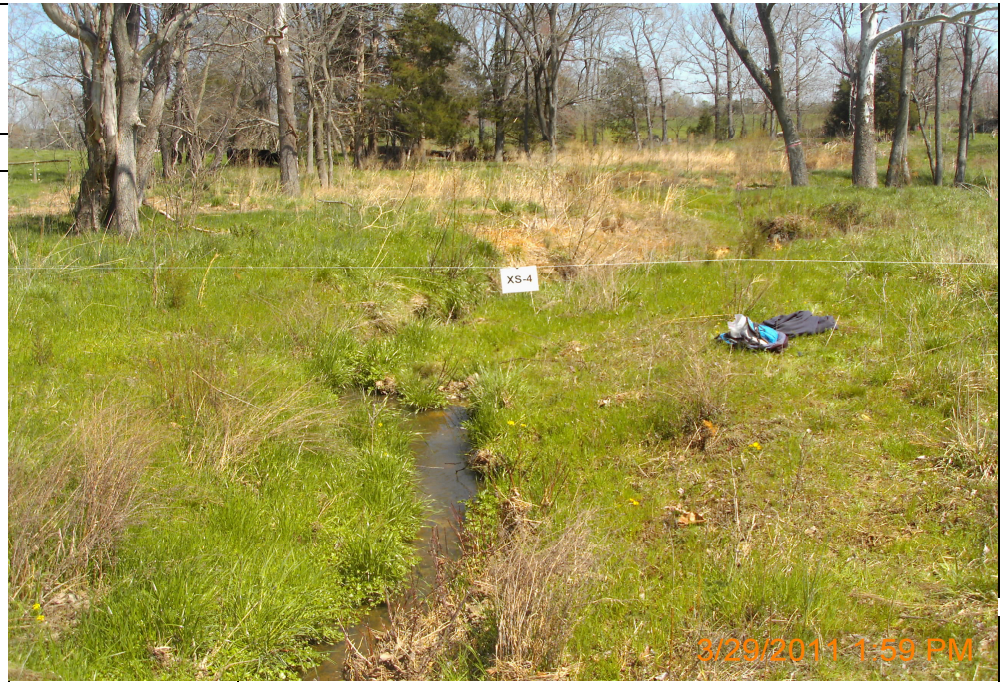
Photo of XS-4, looking in the downstream direction

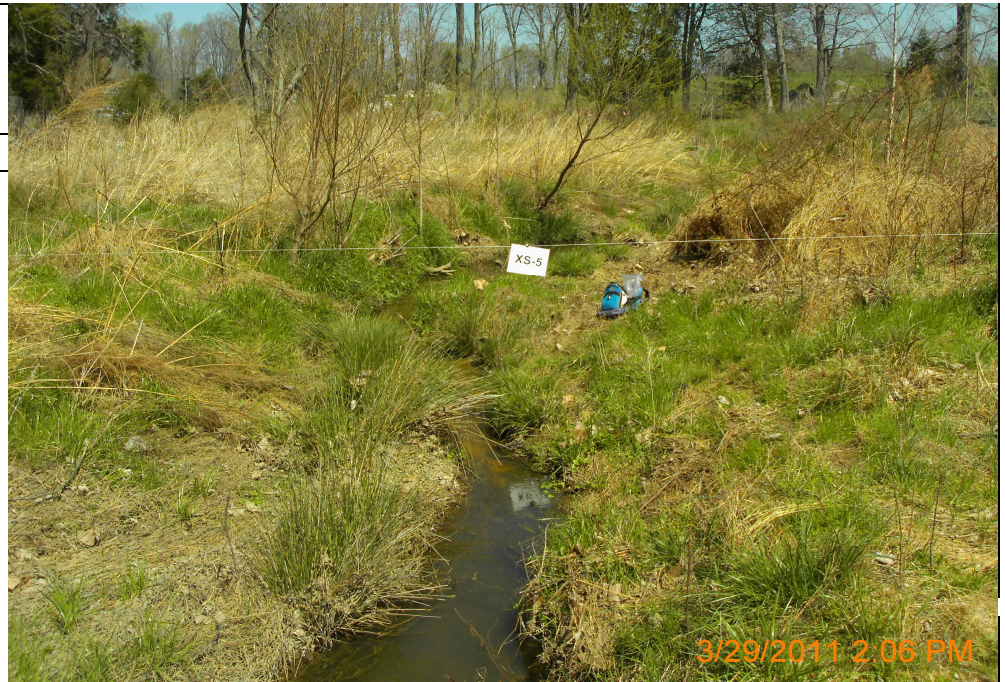
Photo of XS-5, looking in the downstream direction

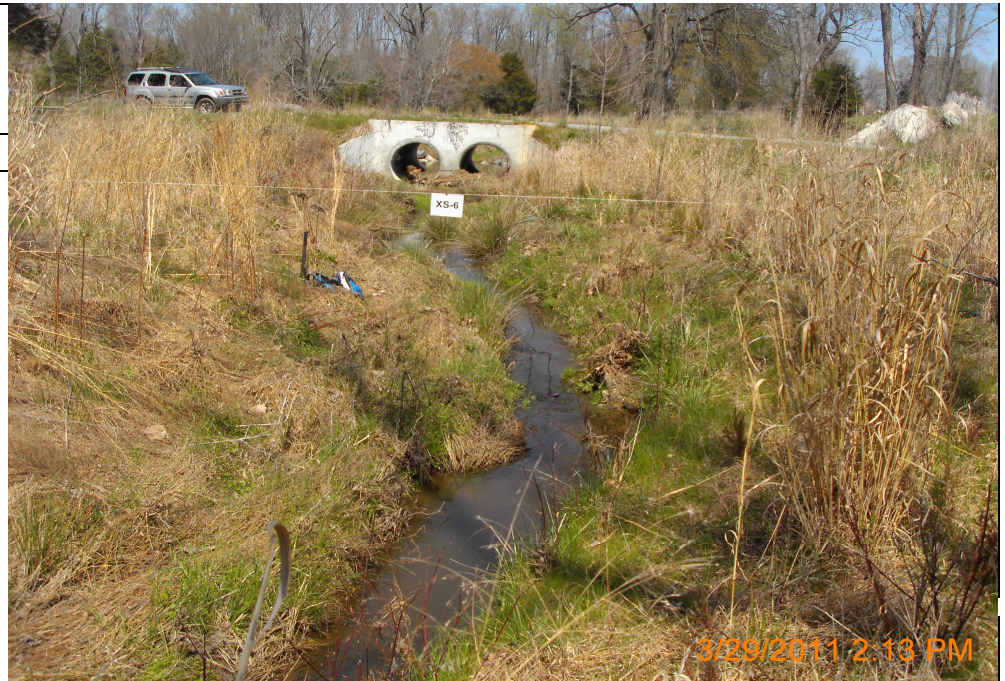
Photo of XS-6, looking in the downstream direction

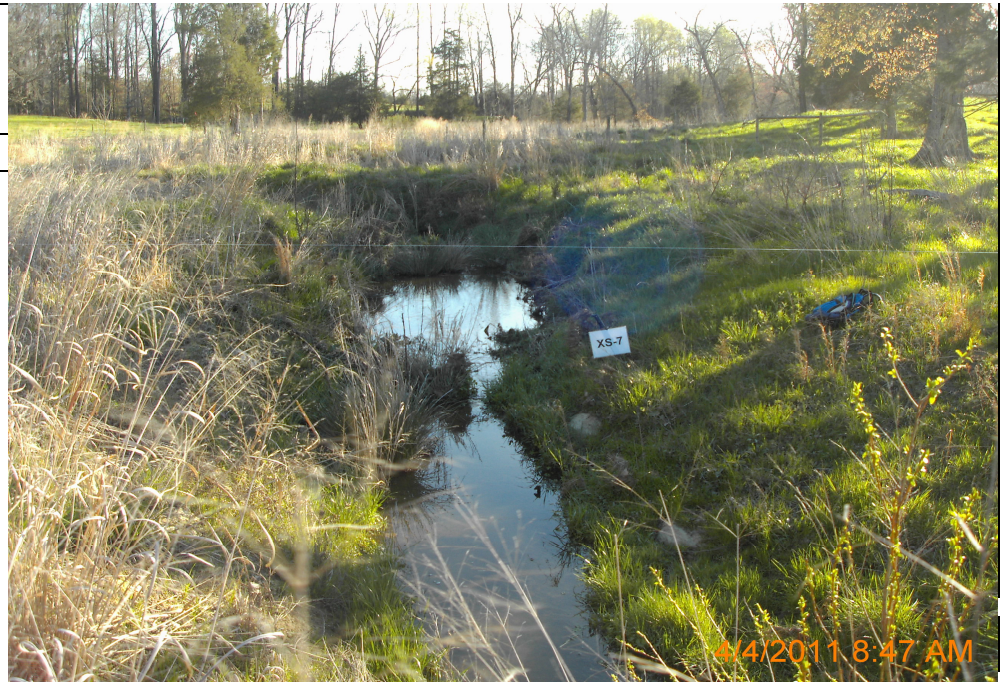
Photo of XS-7, looking in the downstream direction

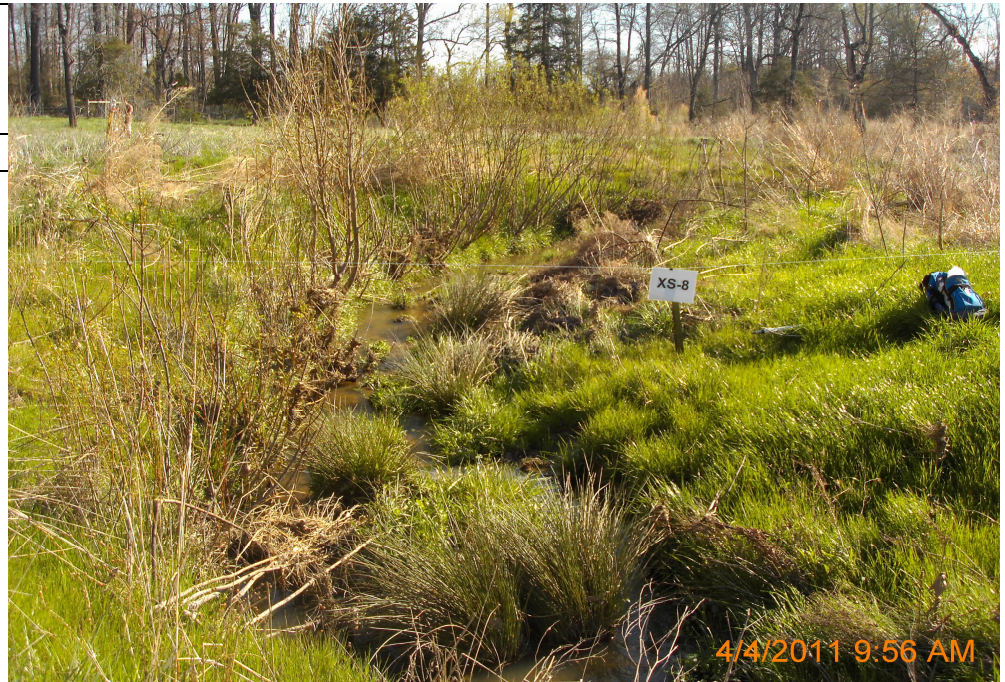
Photo of XS-8, looking in the downstream direction

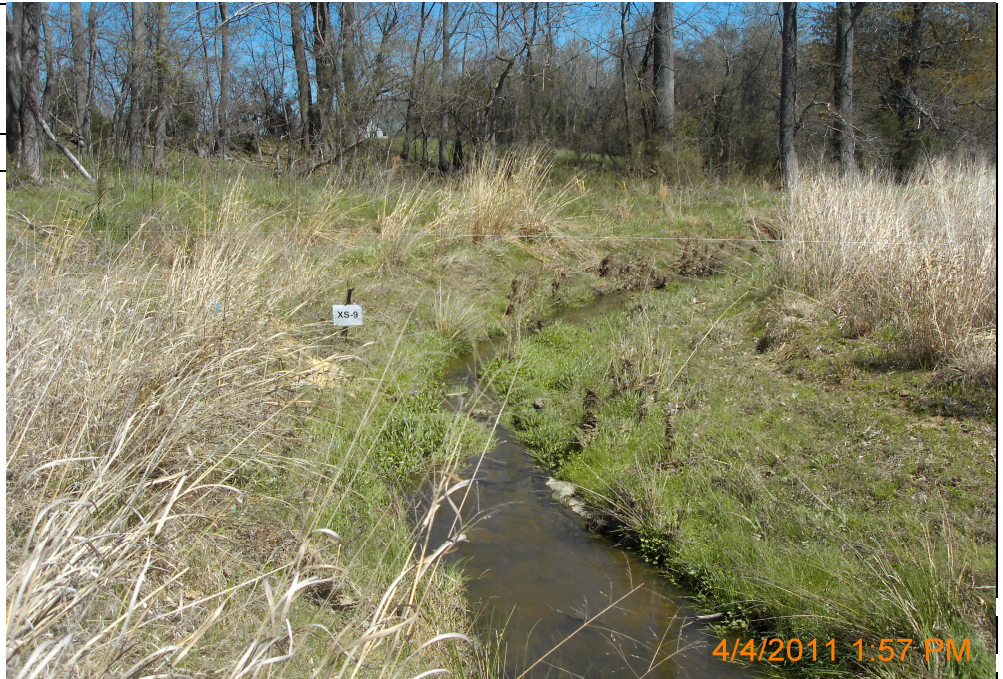
Photo of XS-9, looking in the downstream direction
