**UT TO SOUTH FORK  
FINAL MONITORING REPORT  
YEAR 2 OF 5  
2007**

**EEP Project # 435  
Alamance County, North Carolina**

## Executive Summary

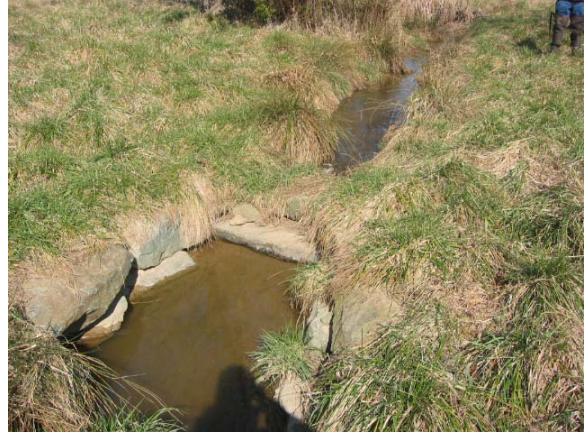
Photo 3: Representative problem cross vane (20+94 along plan view).

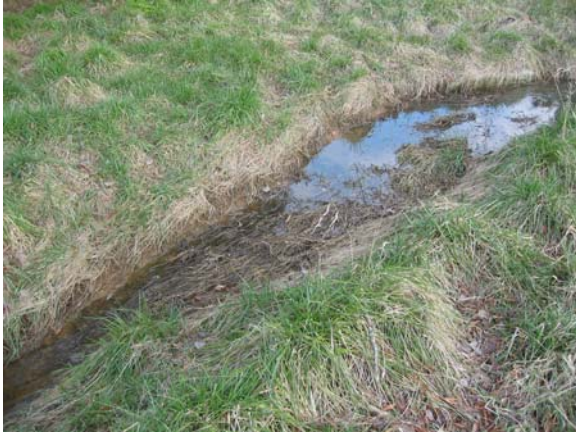
Photo 1: Representative grass aggradation problem area (13+88 along plan view).

12+37		
Aggradation (grass)	12+68	Channel possibly built too wide, naturally narrowing.	
	12+79		
Aggradation (grass)	13+06	Area is "washing" out and aggradation now located downstream of j-hook.	
	13+12		
Aggradation (grass)	13+88	Channel possibly built too wide, naturally narrowing.	Photo 1
	14+00		
Aggradation (grass)	14+05	Fine sediment deposition in tail of pool just upstream of j-hook.	
	14+10		
J-hook	14+12	Piping around structure, may have been placed too high.	Photo 5
Aggradation (grass)	14+74	Channel possibly built too wide, naturally narrowing.	
	14+79		
J-hook	14+80	Piping/undermining of center stone & center stone loose.	
Aggradation (grass)	14+90	Channel possibly built too wide, naturally narrowing.	
	14+93		
Aggradation (grass)	15+09	Channel possibly built too wide, naturally narrowing.	
	15+65		
Rootwad	15+39	Structure exposed, placed too high.	
J-hook	15+69	Piping around structure.	
Aggradation (grass)	15+79	Channel possibly built too wide, naturally narrowing.

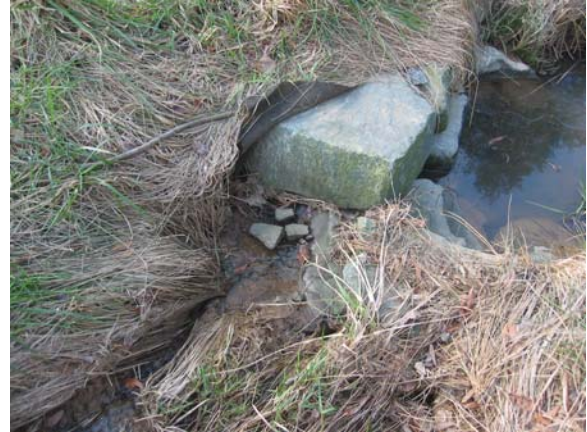
Photo 4: Representative problem J-hook (14+12 along plan view).

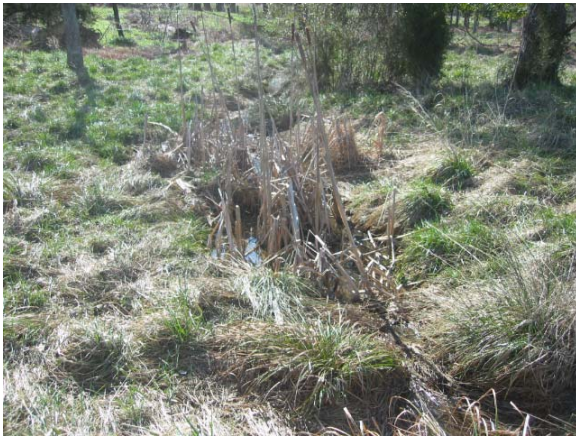
Photo 2: Representative cattail aggradation problem area (20+38 along plan view).

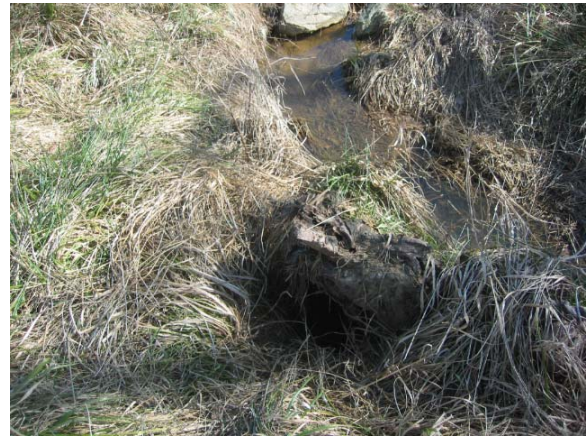
Photo 5: Representative problem Root Wad (19+56 along plan view).

Aggradation (grass)	19+22	Channel possibly built too wide, naturally narrowing.	
	19+40		
J-hook	19+48	Loose center stone, piping around structure.	
Rootwad	19+56	Bank failing behind structure, possibly installed too high.	Photo 6
Aggradation (grass)	19+99	Channel possibly built too wide, naturally narrowing.	
	20+11		
Aggradation (cattails)	20+38	Cattails growing in fine sediment deposition of slack pool section.	Photo 2
	20+53		
Aggradation (grass)	20+53	Channel possibly built too wide, naturally narrowing.	
	20+63		
Crossvane	20+94	Piping around/underming of center stone, possibly installed too high.	Photo 4
J-hook	21+30	Possibly installed too high.

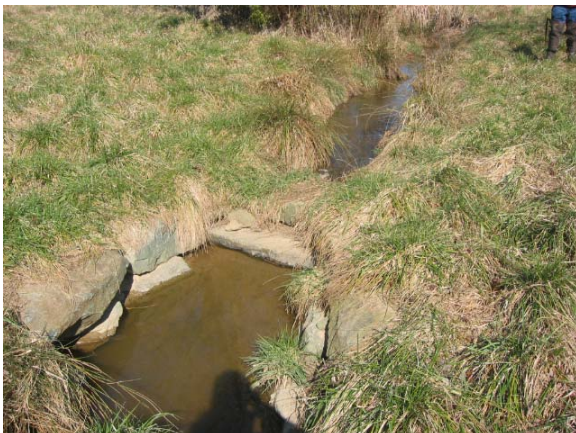
Photo 3: Representative problem cross vane (20+94 along plan view).

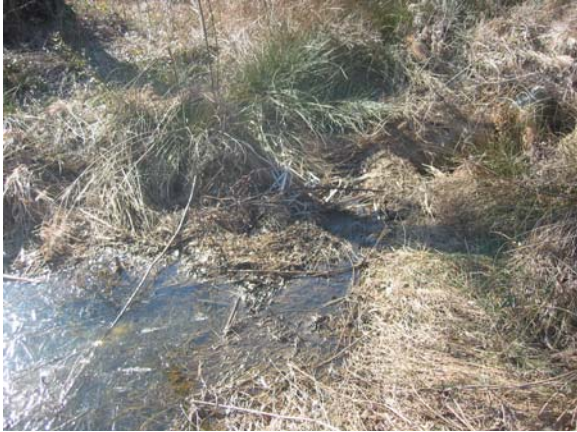
Photo 1: Representative grass aggradation problem area (11+12 along plan view).

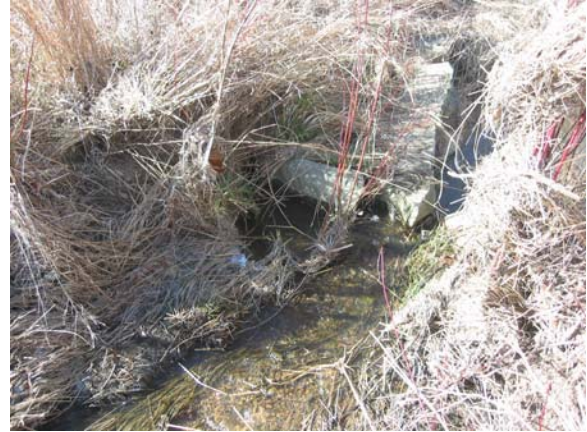
Photo 3: Representative problem cross vane (20+22 along plan view).

Aggradation (grass)	16+54 16+82	Channel possibly built too wide, naturally narrowing.	
Bank Erosion (left bank)	17+49 17+54	Possibly unstable soil characteristics and/or lack of vegetation at a point of moderate shear stress (outside of slight meander). Channel may be naturally narrowing.	
Aggradation (cattails)	18+20 18+31	Channel possibly built too wide, naturally narrowing.	
Aggradation (cattails)	18+51 18+76	Channel possibly built too wide, naturally narrowing.	
Crossvane	18+56	Missing center rock.	
Aggradation (cattails)	19+27 19+32	Channel possibly built too wide, naturally narrowing.	
Aggradation (cattails)	19+43 19+55	Channel possibly built too wide, naturally narrowing.	
Crossvane	20+22	Piping around structure.	Photo 4

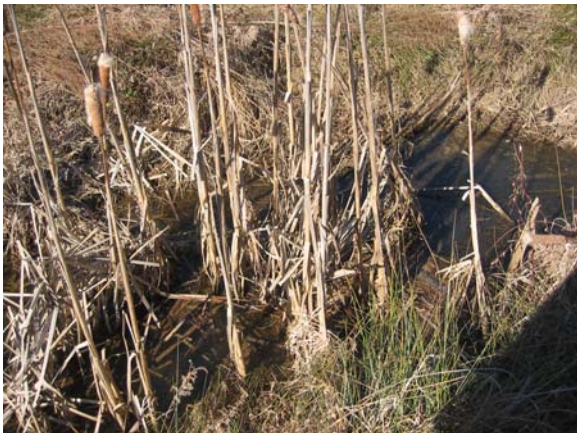
Photo 2: Representative cattail aggradation problem area (10+78 along plan view).

Feature Issue	Station numbers	Suspected Cause	Photo number
Aggradation (grass)	10+11 10+31	Channel possibly built too wide, naturally narrowing.	
Aggradation (cattails)	10+78 11+05	Channel possibly built too wide, naturally narrowing.	Photo 2
Aggradation (grass)	11+12 11+17	Channel possibly built too wide, naturally narrowing.	Photo 1
Crossvane	11+18	Piping around structure, pool behind structure filling in with sediment deposit on right side.	
Aggradation (grass)	11+24 11+26	Channel possibly built too wide, naturally narrowing.	
Aggradation (grass)	11+50 12+08	Channel possibly built too wide, naturally narrowing.	
Aggradation (grass & willows)	12+27 12+33	Channel possibly built too wide, naturally narrowing.	
Aggradation (cattails)	12+38 12+66	Channel possibly built too wide, naturally narrowing.	
Aggradation (grass)	12+82 13+06	Channel possibly built too wide, naturally narrowing.	
Bank Erosion (right bank)	12+97 13+00	Flow directed into bank from structure directly upstream and rootwad inadequate to protect bank.

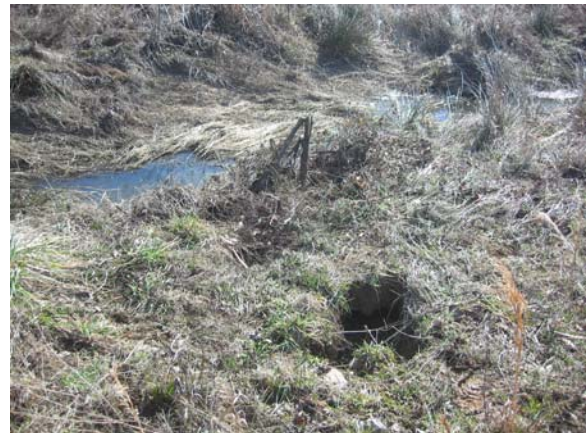
Photo 4: Representative problem Root Wad (12+99 along plan view).

Rootwad (severe)	12+99	Exposed, installed too high, bank failures caving in and around structure.	Photo 5
Aggradation (cattails)	13+29 13+49	Channel possibly built too wide, naturally narrowing.	
Aggradation (grass)	13+87 14+02	Riffle narrowing, channel possibly built too wide, naturally narrowing.	
Rootwad	14+18	Some evidence of undercutting, possibly installed too high.	
Aggradation (grass)	14+24 14+44	Channel possibly built too wide, naturally narrowing.	
Rootwad	14+98	Bank failure around structure.	
Bank Erosion (right bank)	14+99 15+03	Possible improper installation of rootwads causing bank to cave in around structures, however area is healing over with new vegetation.	
Rootwad	15+03	Bank failure around structure.	
Aggradation (cattails)	15+38 15+47	Channel possibly built too wide, naturally narrowing.	
Aggradation (grass)	16+02 16+36	Channel possibly built too wide, naturally narrowing.	
Bank Erosion (left bank)	16+03 16+10	Lack of protective vegetation and/or soil stability characteristics.	Photo 3

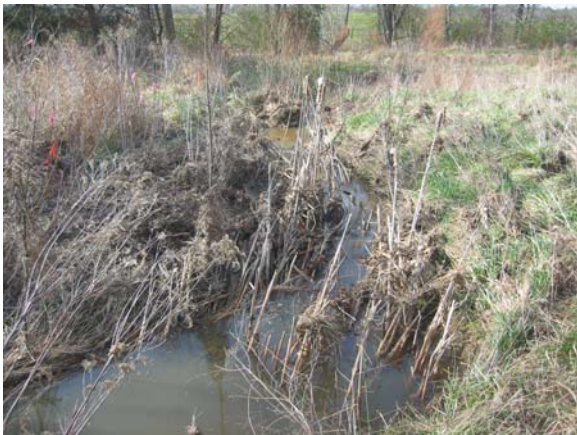
Photo 2: Representative cattail aggradation problem area (Station 10+85 along plan view).

<b>UT to South Fork, Reach 3</b>			
<b>Feature Issue</b>	<b>Station numbers</b>	<b>Suspected Cause</b>	<b>Photo number</b>
<b>Aggradation (cattails)</b>	10+85	Channel possibly built too wide, naturally narrowing.	
	11+14		
<b>Bank Erosion (Right Bank)</b>	11+33	Soil type or lack of vegetation. Perhaps built too wide and is narrowing.	
	11+37		
<b>Aggradation (cattails)</b>	11+85	Channel possibly built too wide, naturally narrowing.	Photo 2
	11+97		
<b>Aggradation (grass)</b>	12+14	Channel possibly built too wide, naturally narrowing.	
	12+34		
<b>Aggradation (grass)</b>	12+66	Channel possibly built too wide, naturally narrowing.	Photo 1
	12+87		
<b>Aggradation (cattails)</b>	13+30	Channel possibly built too wide, naturally narrowing.	
	13+33		
<b>Aggradation (grass)</b>	13+56	Channel possibly built too wide, naturally narrowing.	
	13+60		
<b>Aggradation (cattails)</b>	13+79	Channel possibly built too wide, naturally narrowing.
