**UT TO SOUTH FORK
FINAL MONITORING REPORT
YEAR 3
2008**

EEP Project # 435
Alamance County, North Carolina

Original Design Firm:
ARCADIS G&M of North Carolina, Inc.
801 Corporate Center Drive, Suite 300
Raleigh, NC 27607

Monitoring Firm:

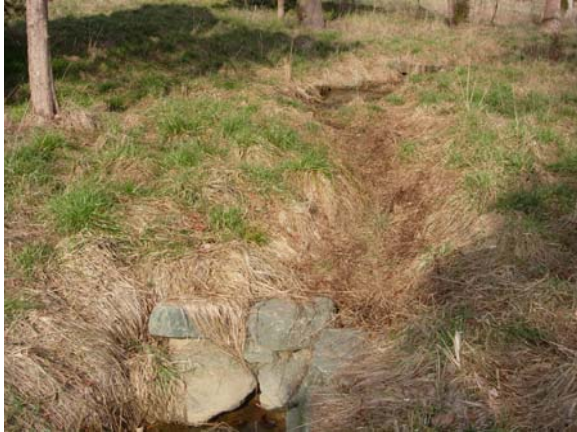
Photo 1: Representative aggradation problem area (Station No. 14+07 – 14+22; view upstream on 3-03-2008).

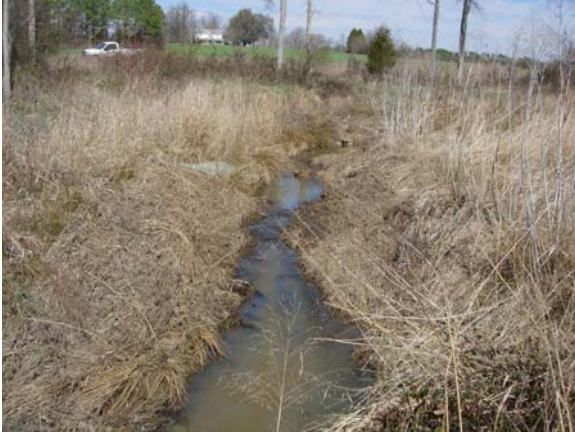
Photo 1: Representative aggradation problem area (Station No. 13+96 – 14+15; view upstream on 3-11-2008).
