# **UT to Cane Creek Restoration Project Year 1 Monitoring Report**

**Alamance County, North Carolina  
NCDENR DMS Project ID Number – 95729**

Report Prepared and Submitted by Michael Baker Engineering, Inc.  
NC Professional Engineering License # F-1084

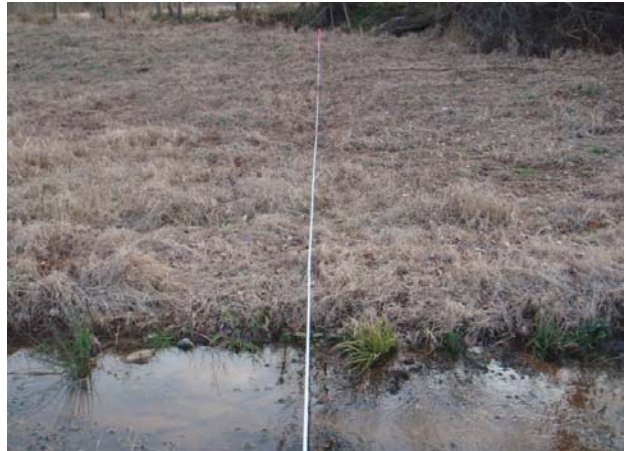
Looking at the Right Bank
