# UT to Cane Creek Restoration Project Year 7 Final Monitoring Report

Alamance County, North Carolina

DMS Project ID Number – 95729, DEQ Contract No. 4951

Monitoring Year: 7 of 7

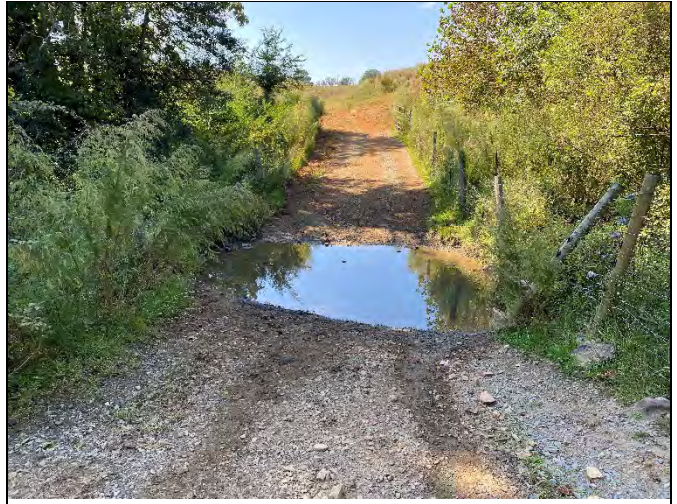
Ford crossing in upper Reach R4

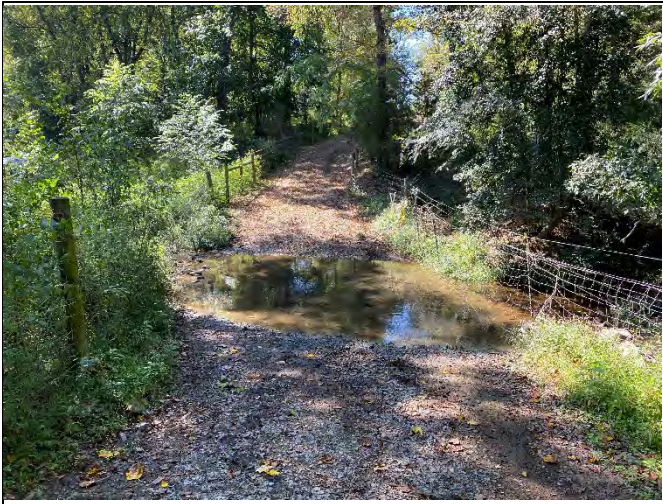
Ford crossing in lower Reach R4
