UT to Town Creek Restoration Project – Option A Year 7 Monitoring Report/Closeout Report

Stanly County, North Carolina

DMS Project ID Number – 94648; NC DEQ Contract No. 003277

Monitoring Year: 7

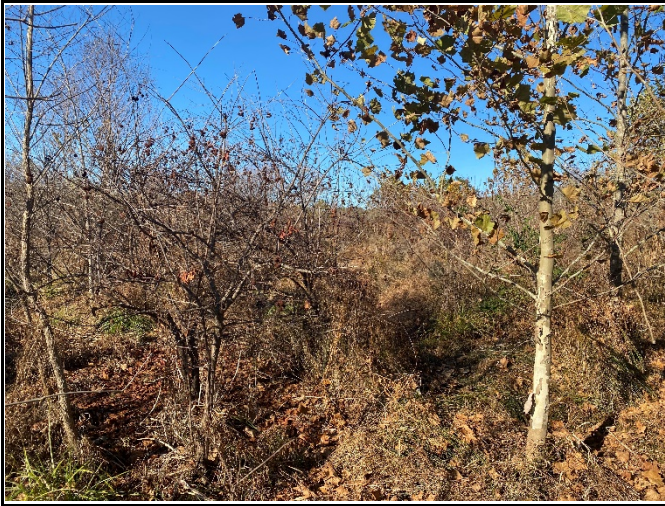
Abundant, tall, diverse vegetation present

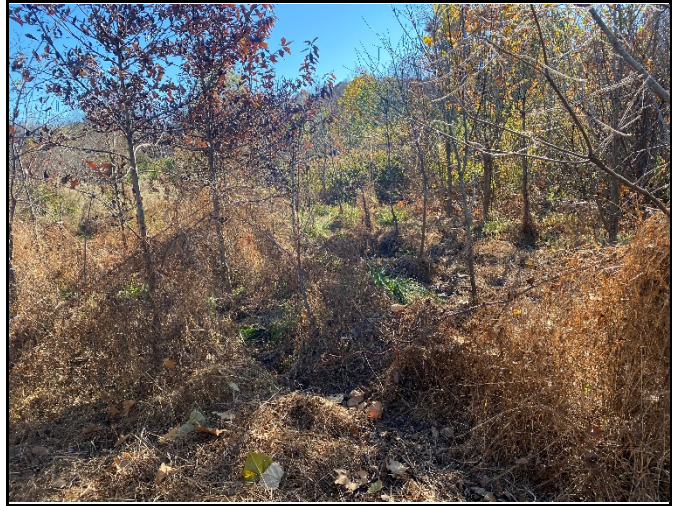
Abundant, tall, diverse vegetation present

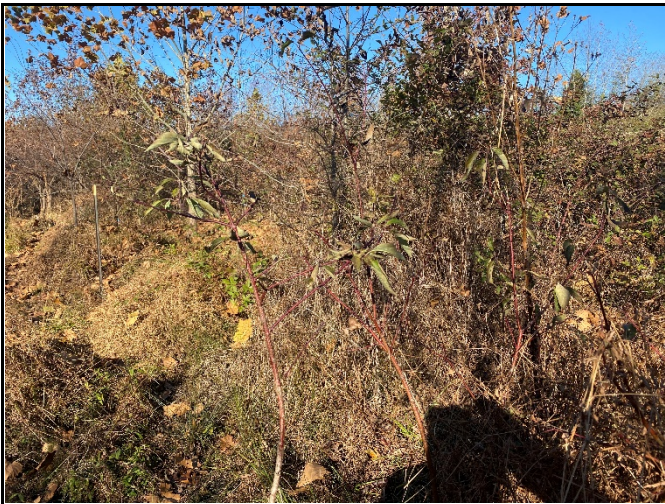
Abundant, tall, diverse vegetation present (silky dogwood in foreground)

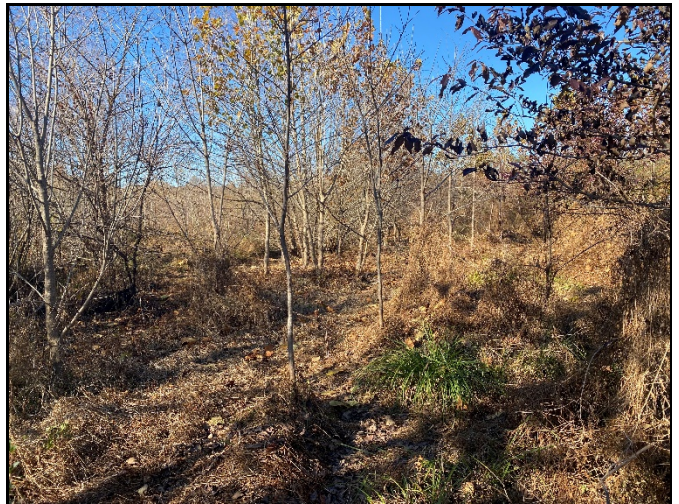
Abundant, tall, diverse vegetation present
