UT to Town Creek Restoration Project – Option A Final Monitoring Report/Closeout Report

Stanly County, North Carolina

DMS Project ID Number – 94648; NC DEQ Contract No. 003277

Monitoring Year: 5

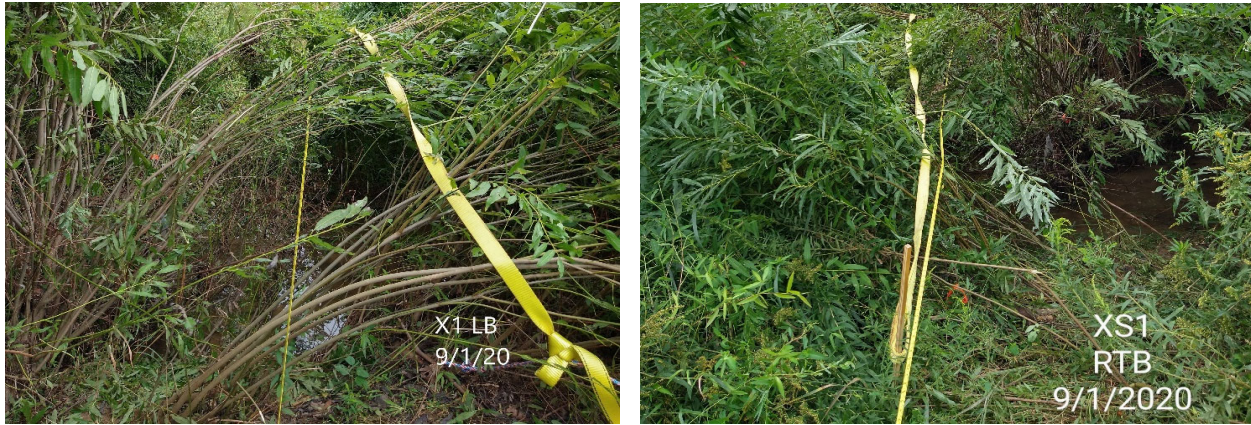
Permanent Cross-section
X1 Riffle - Reach 1 (Station 11+61)
Monitoring Year 5 - Collected September 2020

Feature	Stream Type	BKF Area	BKF Width	BKF Depth	Max BKF Depth	W/D	BH Ratio*	ER	BKF Elev**	TOB Elev	WFPA
Riffle	C	7.1	8.7	0.8	1.1	10.7	1.1	3.7	574.3	574.6	32.4

*BHR = 1.1 is based on as-built bkf area of 9.1 at an elevation of 574.52. Remainder of data based on actual bankfull elevation from as-built which is 574.3. Thalweg elevation is 573.147.

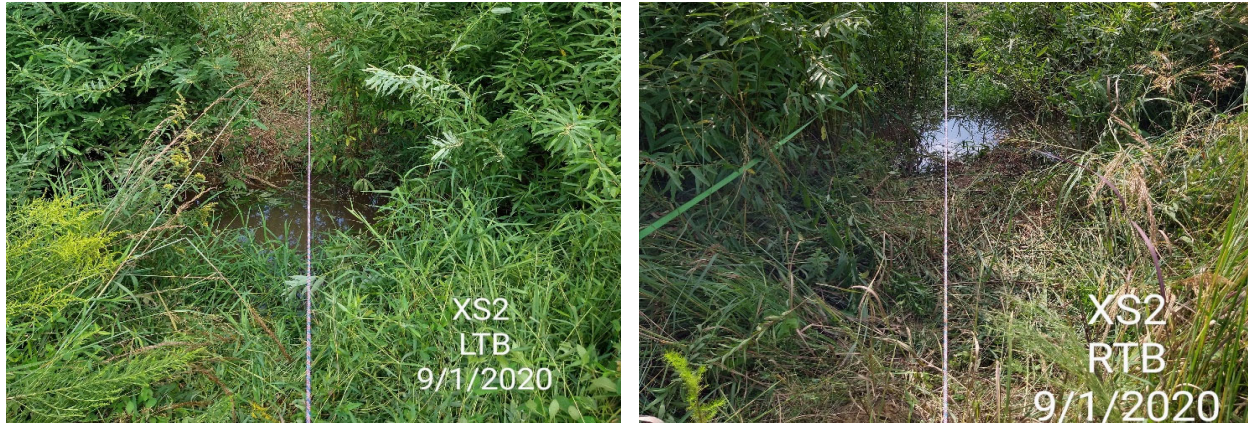
Permanent Cross-section
X2 Pool - Reach 1 (Station 12+00)
Monitoring Year 5 - Collected September 2020

Feature	Stream Type	BKF Area	BKF Width	BKF Depth	Max BKF Depth	W/D	BH Ratio*	ER	BKF Elev	TOB Elev	WFPA
Pool		18.5	11.3	1.6	2.7	6.8			574.7	575.0	70.6

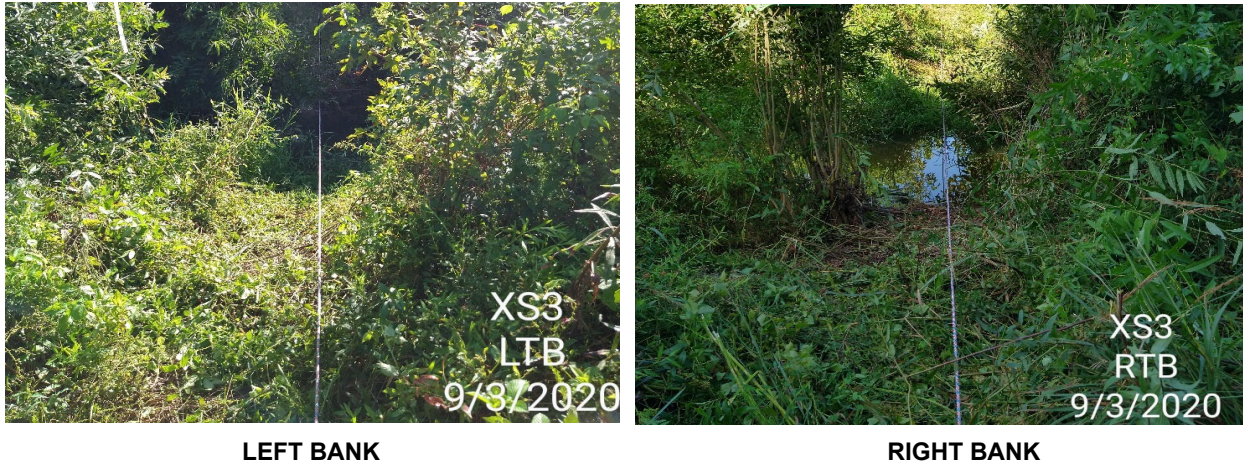
Permanent Cross-section
 X3 Pool - Reach 1 (Station 15+99)
 Monitoring Year 5 - Collected September 2020

Feature	Stream Type	BKF Area	BKF Width	BKF Depth	Max BKF Depth	W/D	BH Ratio	ER	BKF Elev*	TOB Elev	WFGPA
Pool		21.5	12.6	1.7	2.8	7.4			571.7	571.6	77.7

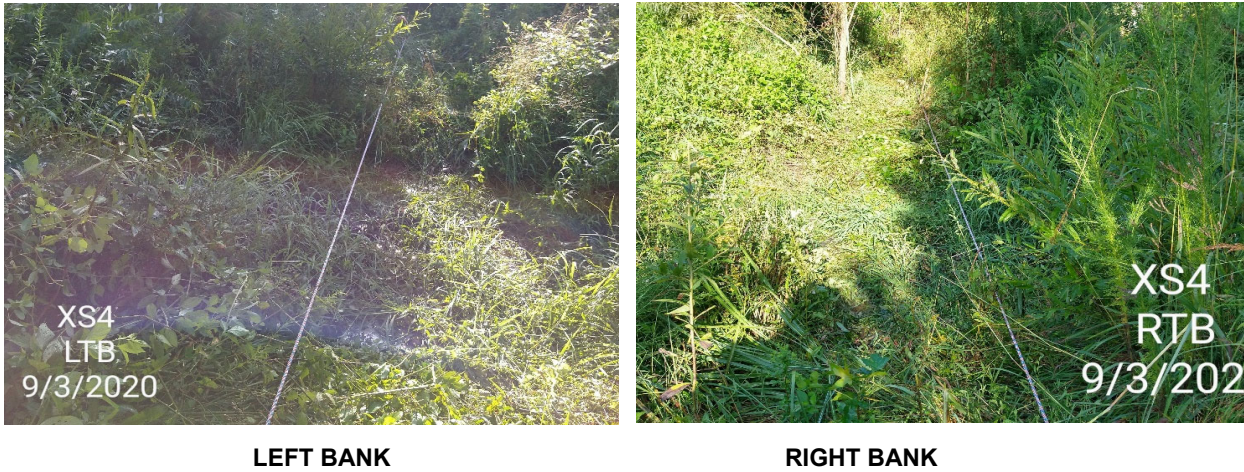
Permanent Cross-section
X4 Riffle - Reach 1 (Station 16+18)
Monitoring Year 5 - Collected September 2020

Feature	Stream Type	BKF Area	BKF Width	BKF Depth	Max BKF Depth	W/D	BH Ratio*	ER	BKF Elev	TOB Elev	WFGA
Riffle	C	8.5	12.8	0.7	1.0	19.3	1.0	6.9	571.5	571.7	88.5

*BHR = 1.0 is based on as-built bkf area of 13.9 at an elevation of 571.7. Remainder of data based on actual bankfull elevation from as-built which is 571.5. Thalweg elevation is 570.44.

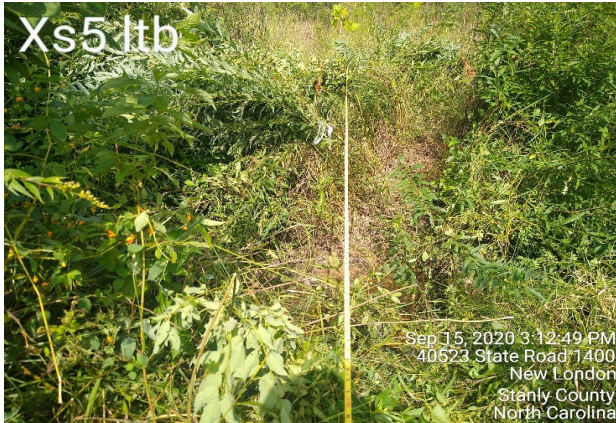
Permanent Cross-section
X5 Riffle - Reach 1 (Station 19+41)
Monitoring Year 5 - Collected September 2020

Feature	Stream Type	BKF Area	BKF Width	BKF Depth	Max BKF Depth	W/D	BH Ratio*	ER	BKF Elev	TOB Elev	WFPA
Riffle	C	6.9	10.4	0.7	1.0	15.6	1.1	7.4	568.0	568.4	77.3

*BHR = 1.1 is based on as-built bkf area of 10.1 at an elevation of 568.24. Remainder of data based on actual bankfull elevation from as-built which is 568.0. Thalweg elevation is 567.92

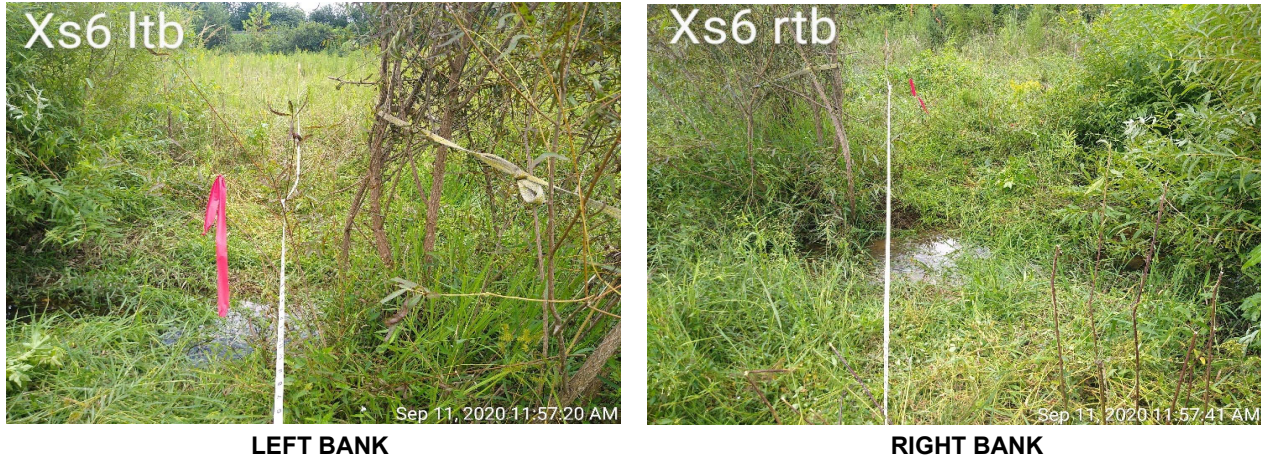
Permanent Cross-section
X6 Riffle - Reach 2 (Station 25+16)
Monitoring Year 5 - Collected September 2020

Feature	Stream Type	BKF Area	BKF Width	BKF Depth	Max BKF Depth	W/D	BH Ratio*	ER	BKF Elev	TOB Elev	WFGPA
Riffle	C	12.5	25.3	0.5	1.2	51.2	0.8	2.9	561.9	561.7	72.4

*BHR = 0.8 is based on as-built bkf area of 14.8 at an elevation of 561.99. Remainder of data based on actual bankfull elevation from as-built which is 561.9. Thalweg elevation is 560.674.

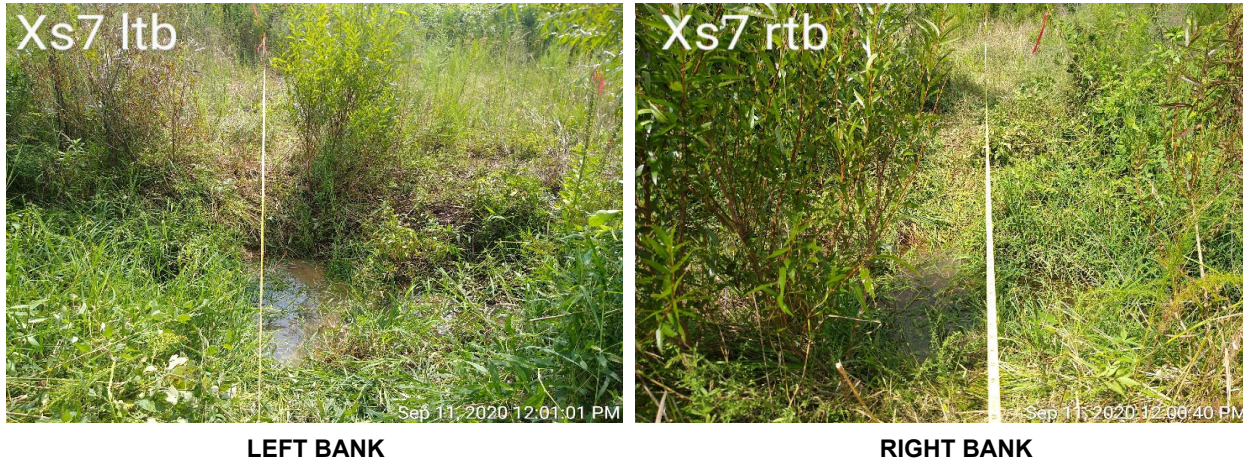
Permanent Cross-section
X7 Pool - Reach 2 (Station 25+60)
Monitoring Year 5 - Collected September 2020

Feature	Stream Type	BKF Area	BKF Width	BKF Depth	Max BKF Depth	W/D	BH Ratio*	ER	BKF Elev	TOB Elev	WFPA
Pool		18.1	15.6	1.2	2.5	13.5			561.6	561.9	76.3

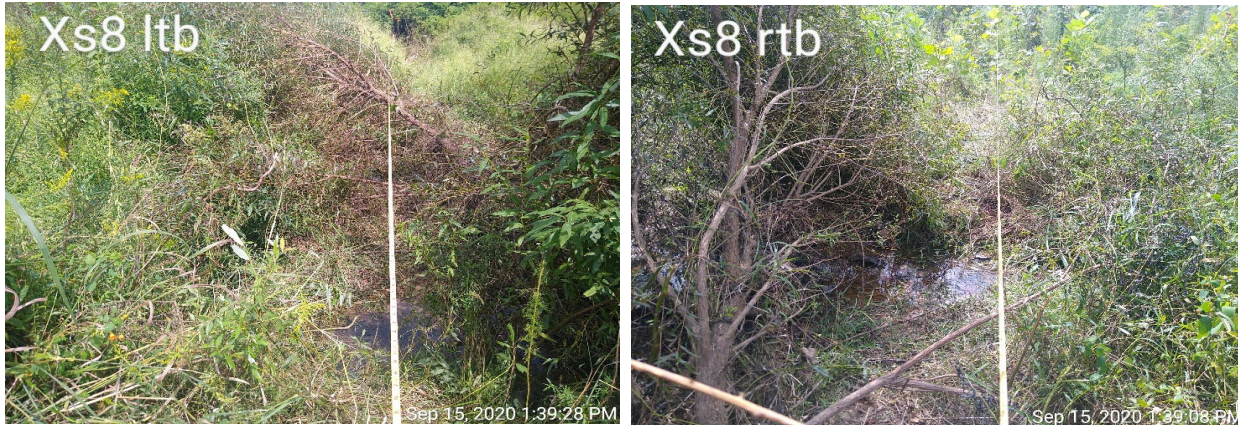
Permanent Cross-section
X8 Riffle - Reach 2 (Station 29+17)
Monitoring Year 5 - Collected September 2020

Feature	Stream Type	BKF Area	BKF Width	BKF Depth	Max BKF Depth	W/D	BH Ratio*	ER	BKF Elev	TOB Elev	WFPA
Riffle	C	12.5	14.2	0.9	1.5	16.3	1.0	7.2	558.8	559.1	102.7

*BHR = 1.0 is based on as-built bkf area of 16.5 at an elevation of 559.06. Remainder of data based on actual bankfull elevation from as-built which is 558.8. Thalweg elevation is 557.27.

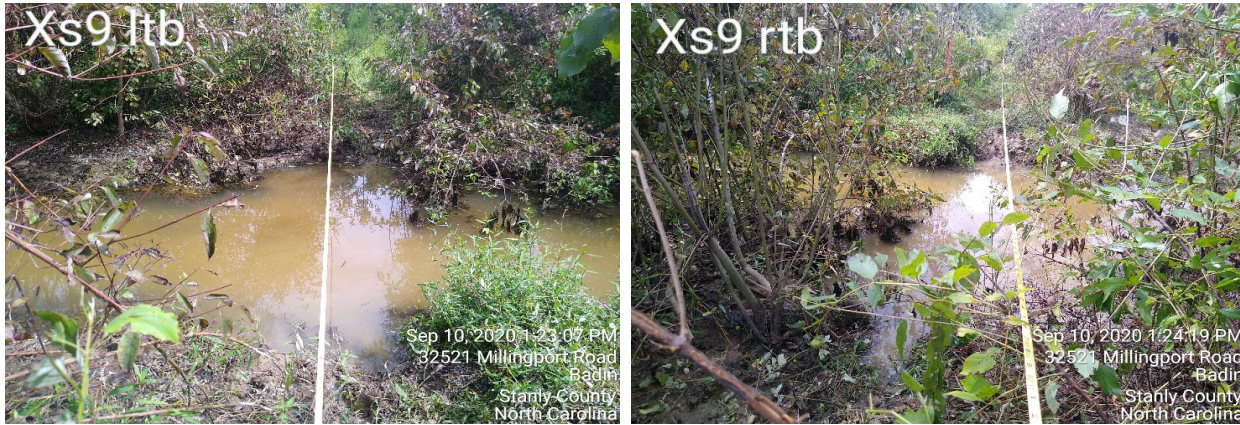
Permanent Cross-section
X9 Pool - Reach 2 (Station 37+60)
Monitoring Year 5 - Collected September 2020

Feature	Stream Type	BKF Area	BKF Width	BKF Depth	Max BKF Depth	W/D	BH Ratio*	ER	BKF Elev	TOB Elev	WFPA
Pool		33.8	18.2	1.9	2.7	9.8			552.7	553.0	95.4

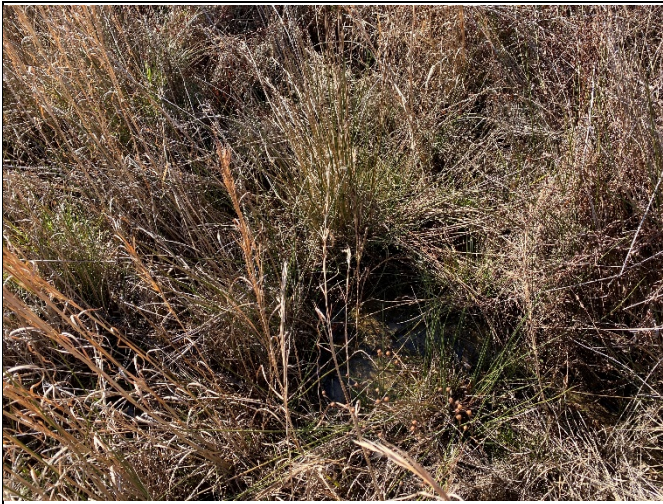
Soft rush in area with shallow standing water

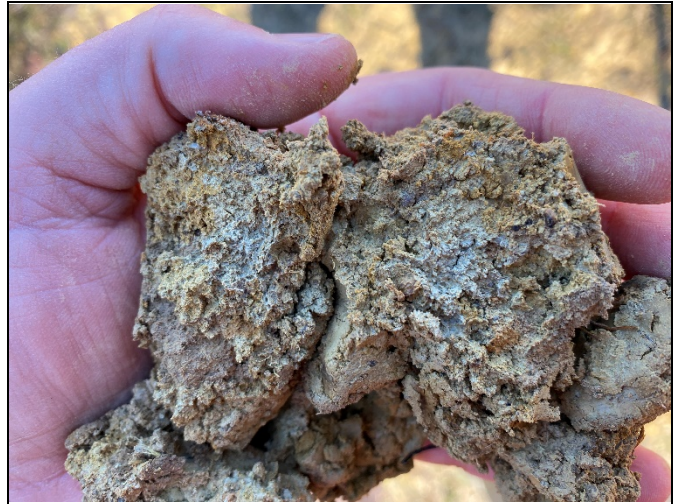
Hydric soil

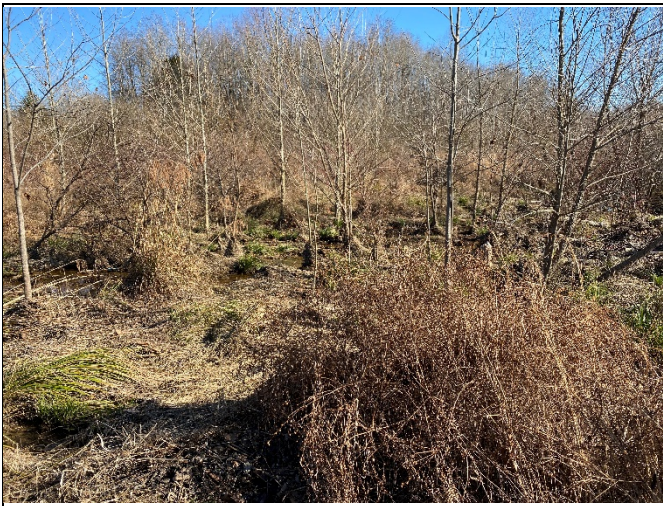
Wetland vegetation and standing water in floodplain

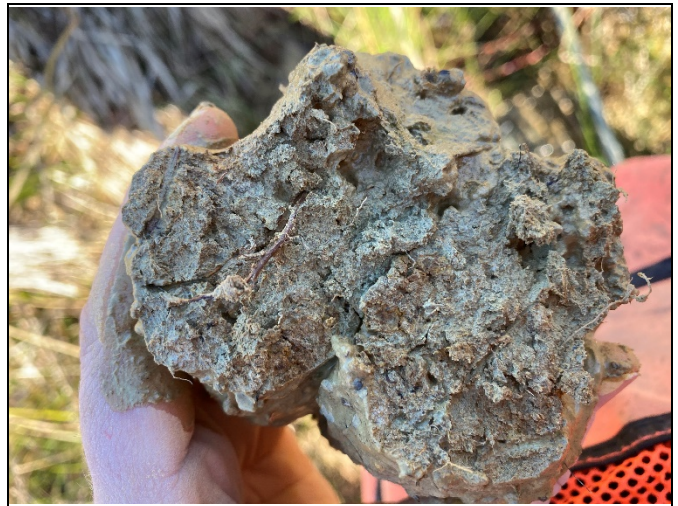
Hydric soil

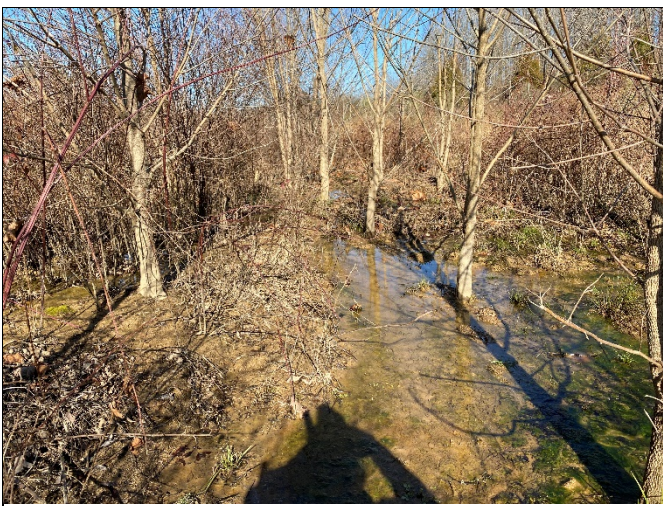
Wetland vegetation and standing water in floodplain

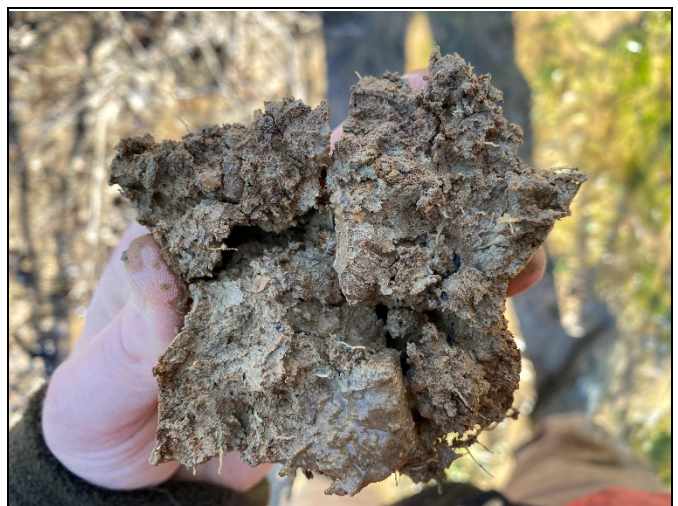
Hydric soil

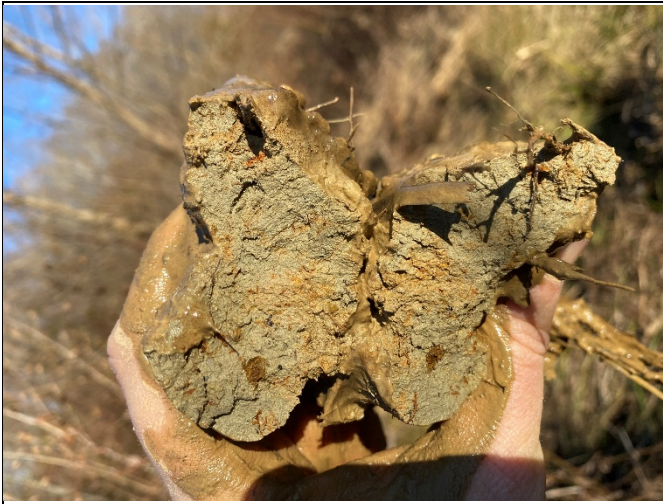
Hydric soil

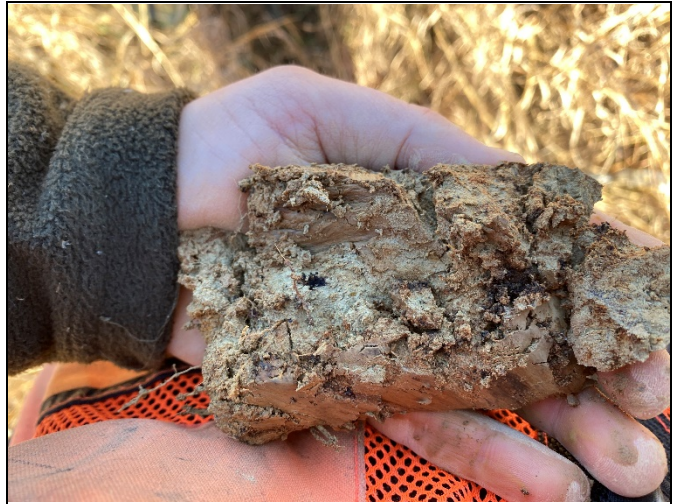
Hydric Soil

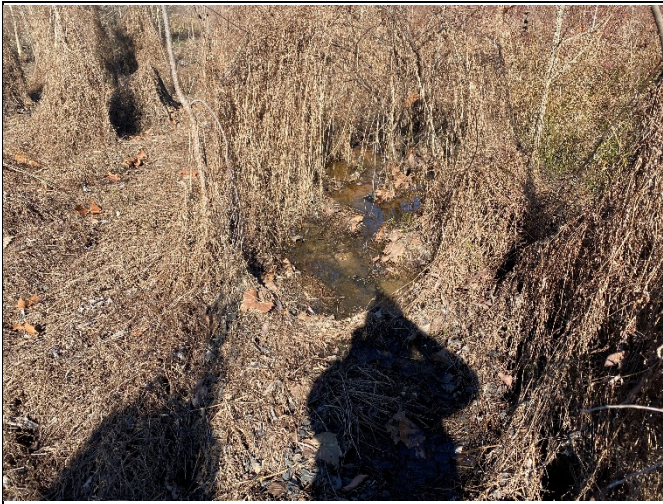
Wetland vegetation and standing water in floodplain

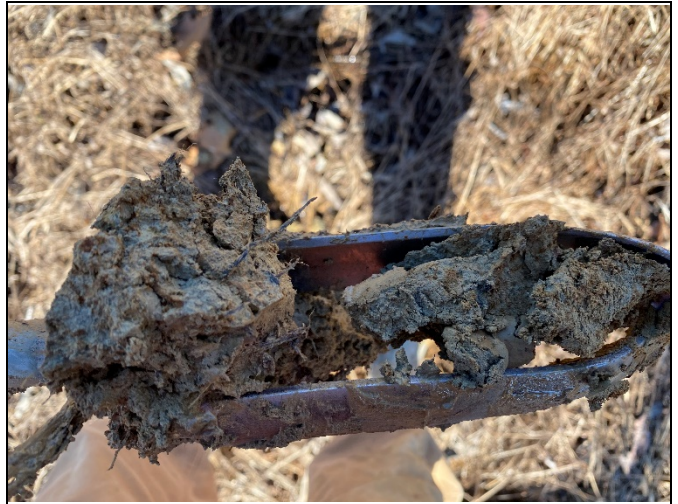
Hydric soil

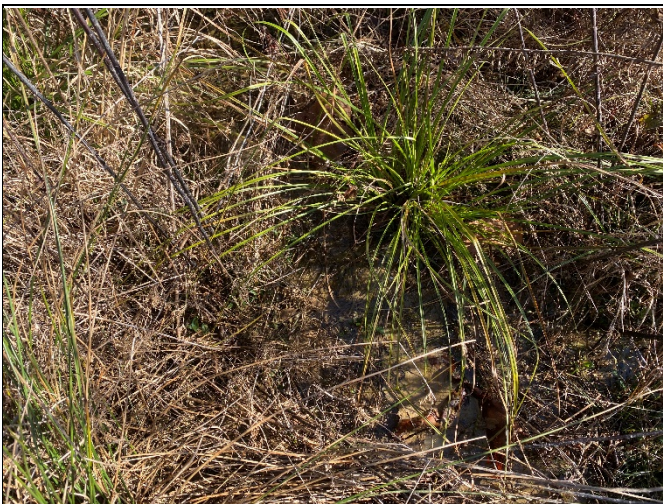
Sedges and shallow standing water in floodplain

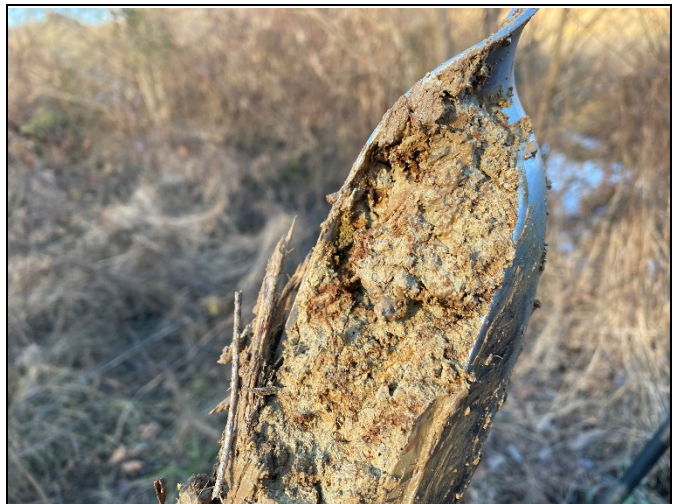
Hydric soil

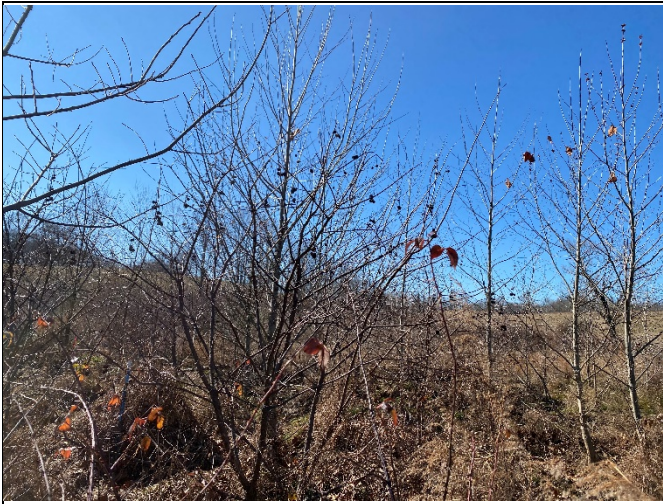
Wetland vegetation and standing water in floodplain

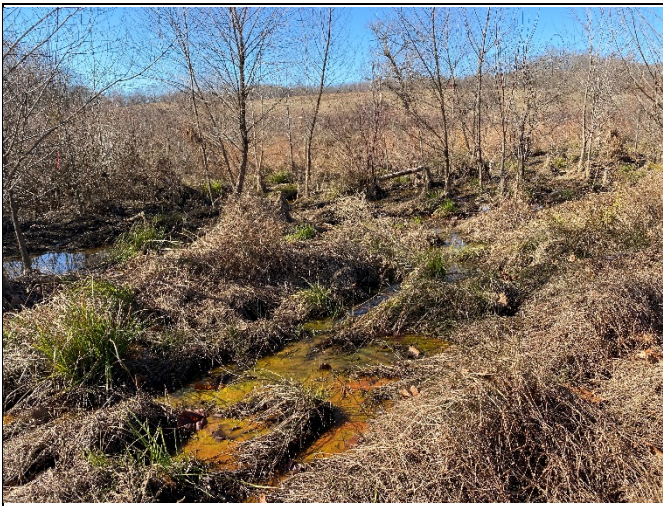
Wetland vegetation and standing water in floodplain

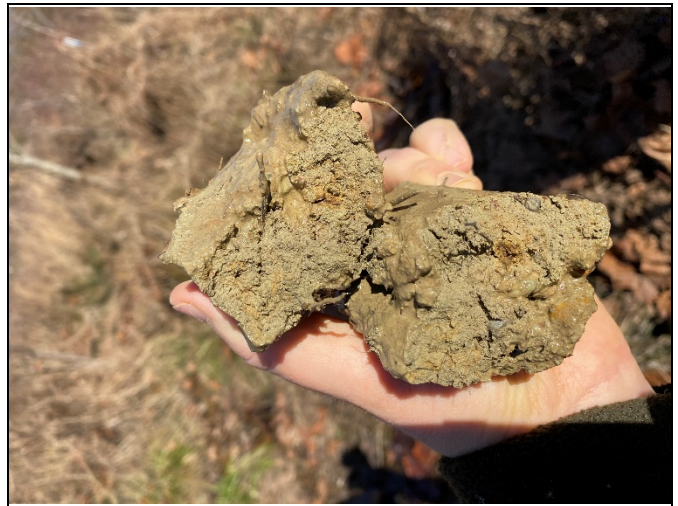
Hydric soil

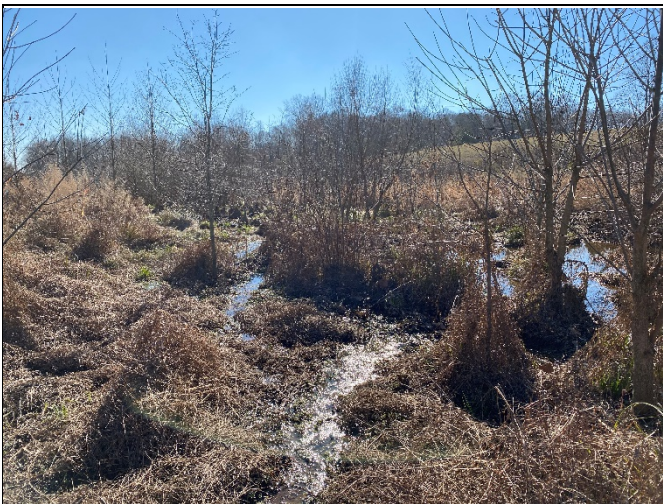
Wetland vegetation and standing water in floodplain

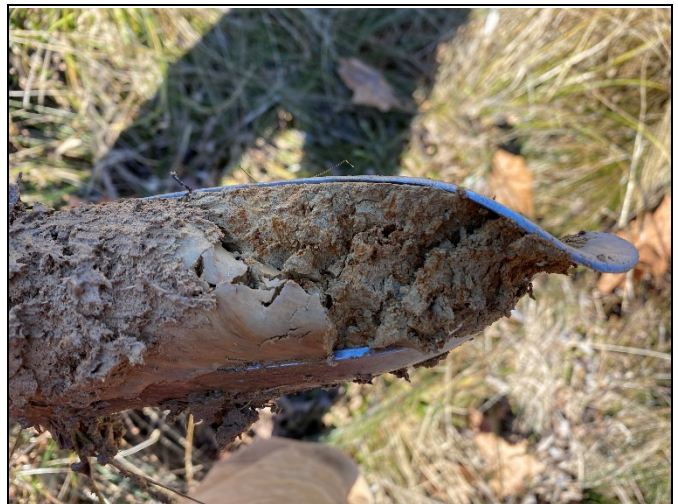
Hydric soil

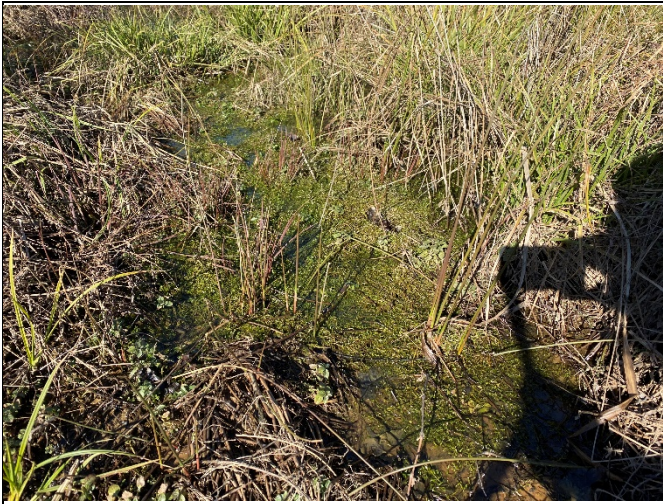
Wetland vegetation and standing water in floodplain

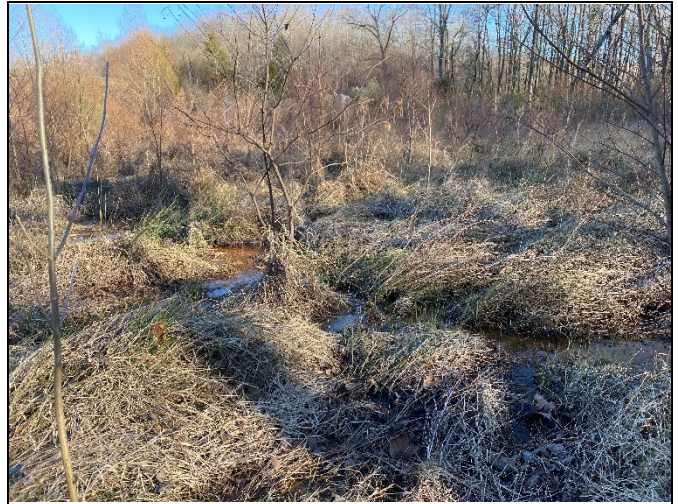
Wetland vegetation and standing water in floodplain

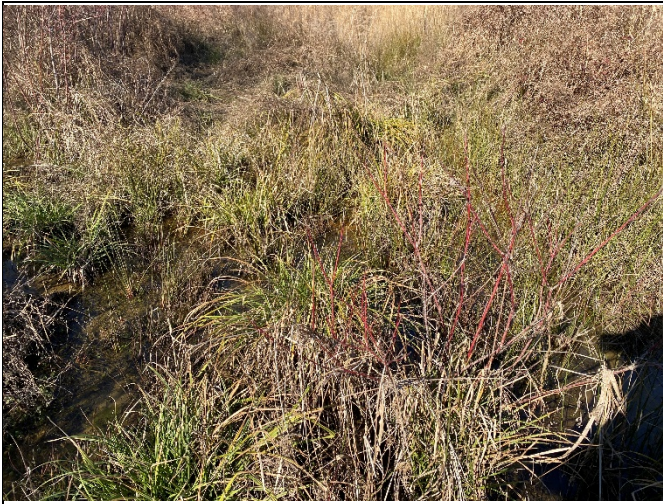
Wetland vegetation and standing water in floodplain

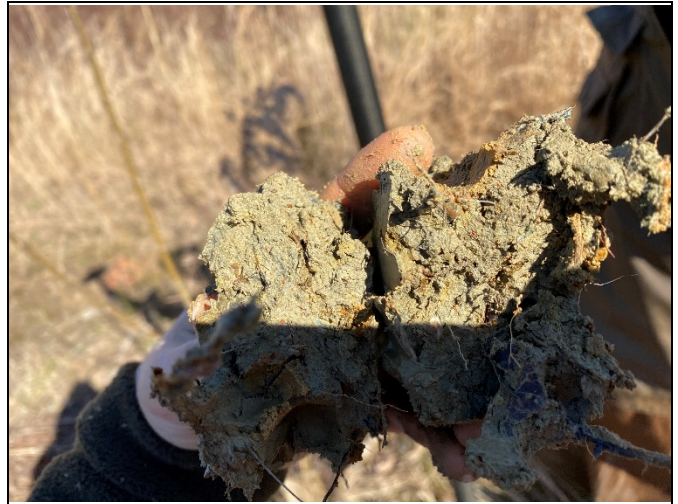
Hydric soil

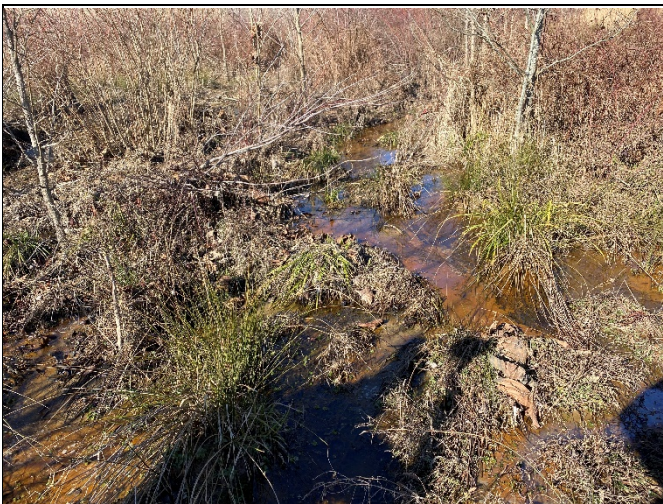
Wetland vegetation and standing water in floodplain

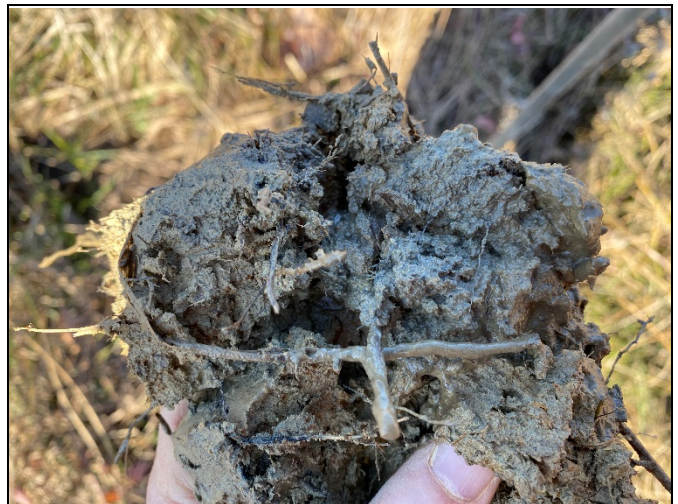
Hydric soil

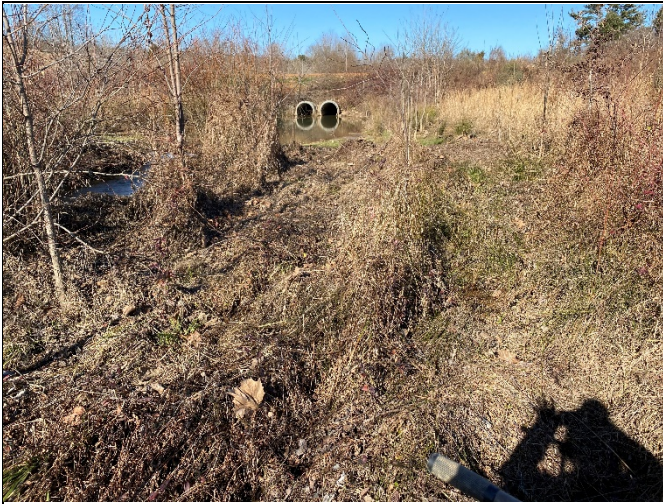
Wetland vegetation and standing water in floodplain

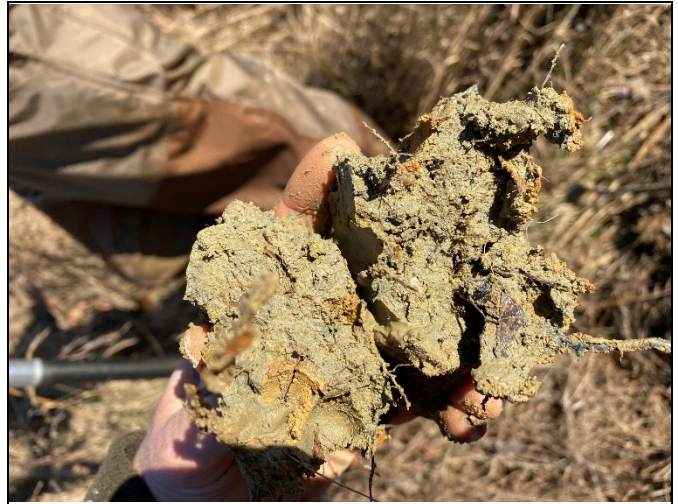
Hydric soil

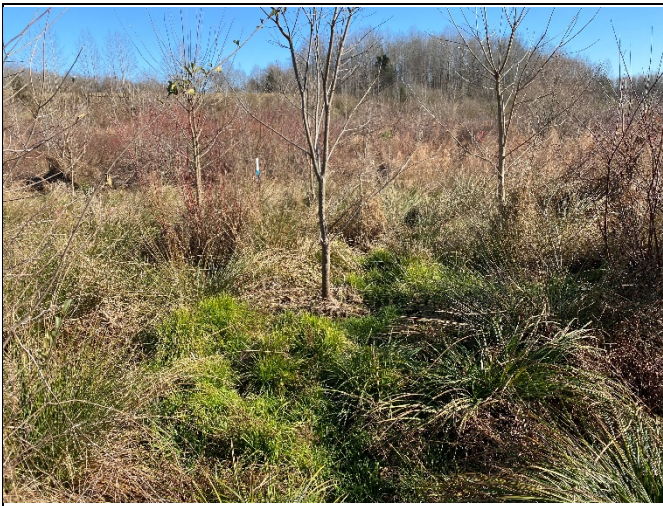
Wetland vegetation and standing water in floodplain
