*Final*  
**Year 4 Monitoring Report**

**UT to Uwharrie River Stream Restoration Project  
Randolph County, North Carolina  
DMS Project No. 847**

Construction Completed: March 2011  
Vegetation Data Collected: August 2015  
Morphology Data Collected: November 2015  
Submission Date: March 2016

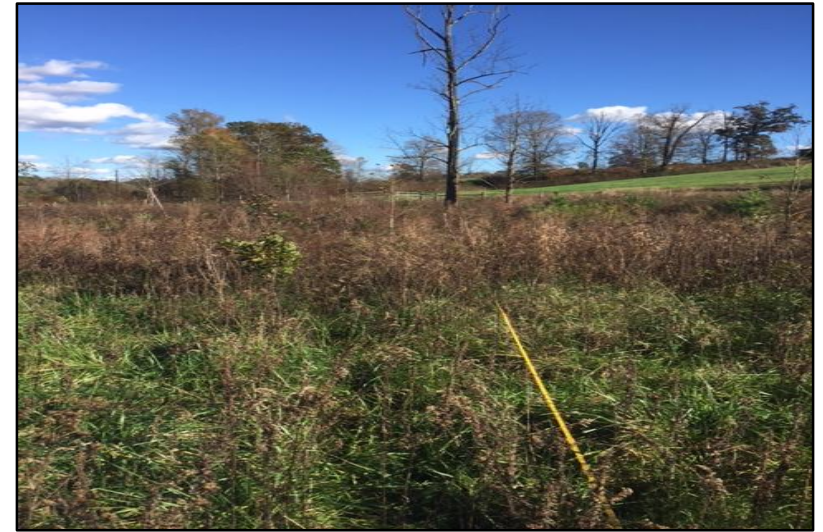
<b>River Basin:</b>	Yadkin - Pee Dee
<b>Watershed:</b>	Uwharrie River
<b>XS ID:</b>	XS-3, Riffle, SW-Trib, 13+83
<b>Drainage Area (sq mi):</b>	0.08 (51.2 ac)
<b>Date:</b>	11/10/2015
<b>Field Crew:</b>	M. Mickley, B. Dustin, S. Beavans

SUMMARY DATA	
<b>Bankfull Elevation:</b>	678.75
<b>Bankfull Cross-Sectional Area:</b>	2.15
<b>Bankfull Width:</b>	3.99
<b>Floodprone Area Elevation:</b>	680.09
<b>Floodprone Width:</b>	12.94
<b>Max Depth at Bankfull:</b>	1.64
<b>Mean Depth at Bankfull:</b>	0.54
<b>W/D Ratio:</b>	7.39
<b>Entrenchment Ratio:</b>	3.24
<b>Bank Height Ratio:</b>	1.0

Stream Type
E5b

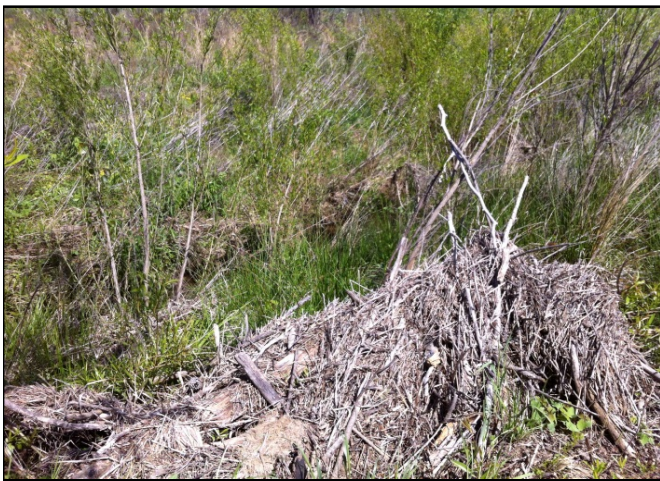
Photo 1: Wrack Lines on Main Center Following Bankfull Event - Spring 2013

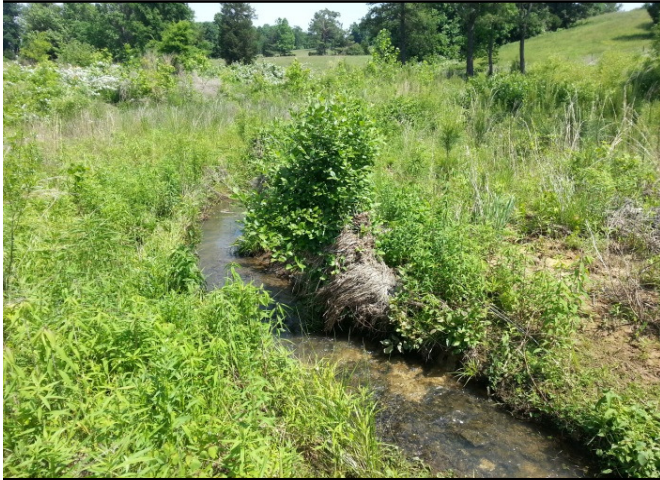
Photo 5: Wrack Lines on Main East  
Following Bankfull Event - Spring 2014
