**Final
Year 5 Monitoring Report**

**UT to Uwharrie River Stream Restoration Project
Randolph County, North Carolina
DMS Project No. 847**

Construction Completed: March 2011
Vegetation Data Collected: September 2016
Morphology Data Collected: November 2016
Submission Date: January 2017

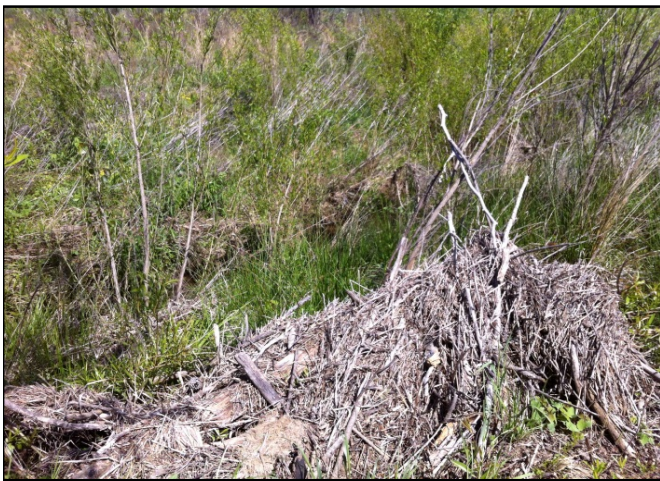
Photo 1: Wrack Lines on Main Center Following Bankfull Event - Spring 2013

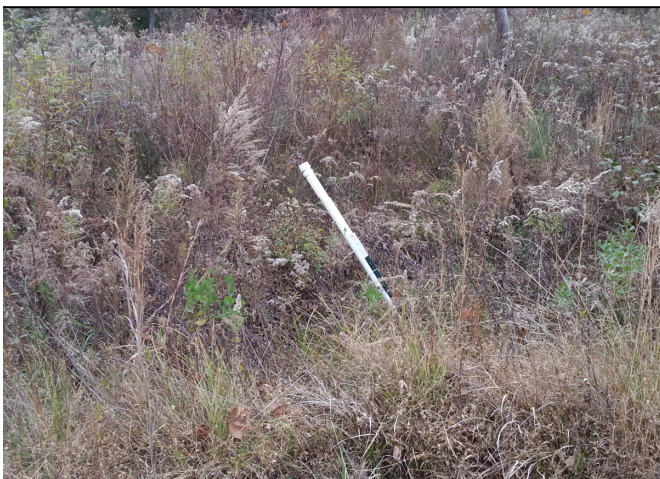
Photo 3: Crest Gauge (Main East) Leaning Over Following Bankfull Event - Fall 2013

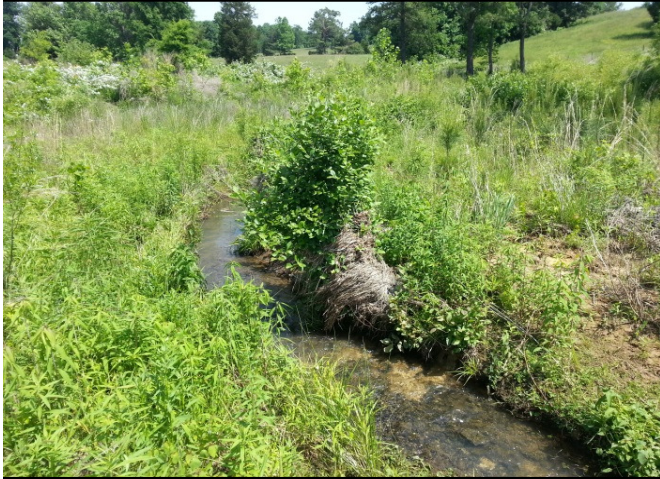
Photo 5: Wrack Lines on Main East
Following Bankfull Event - Spring 2014
