Valley Fields Farm Monitoring Report FINAL Year 2 (2011)

Davidson County, North Carolina

EEP Project ID #407

Submitted December 2011

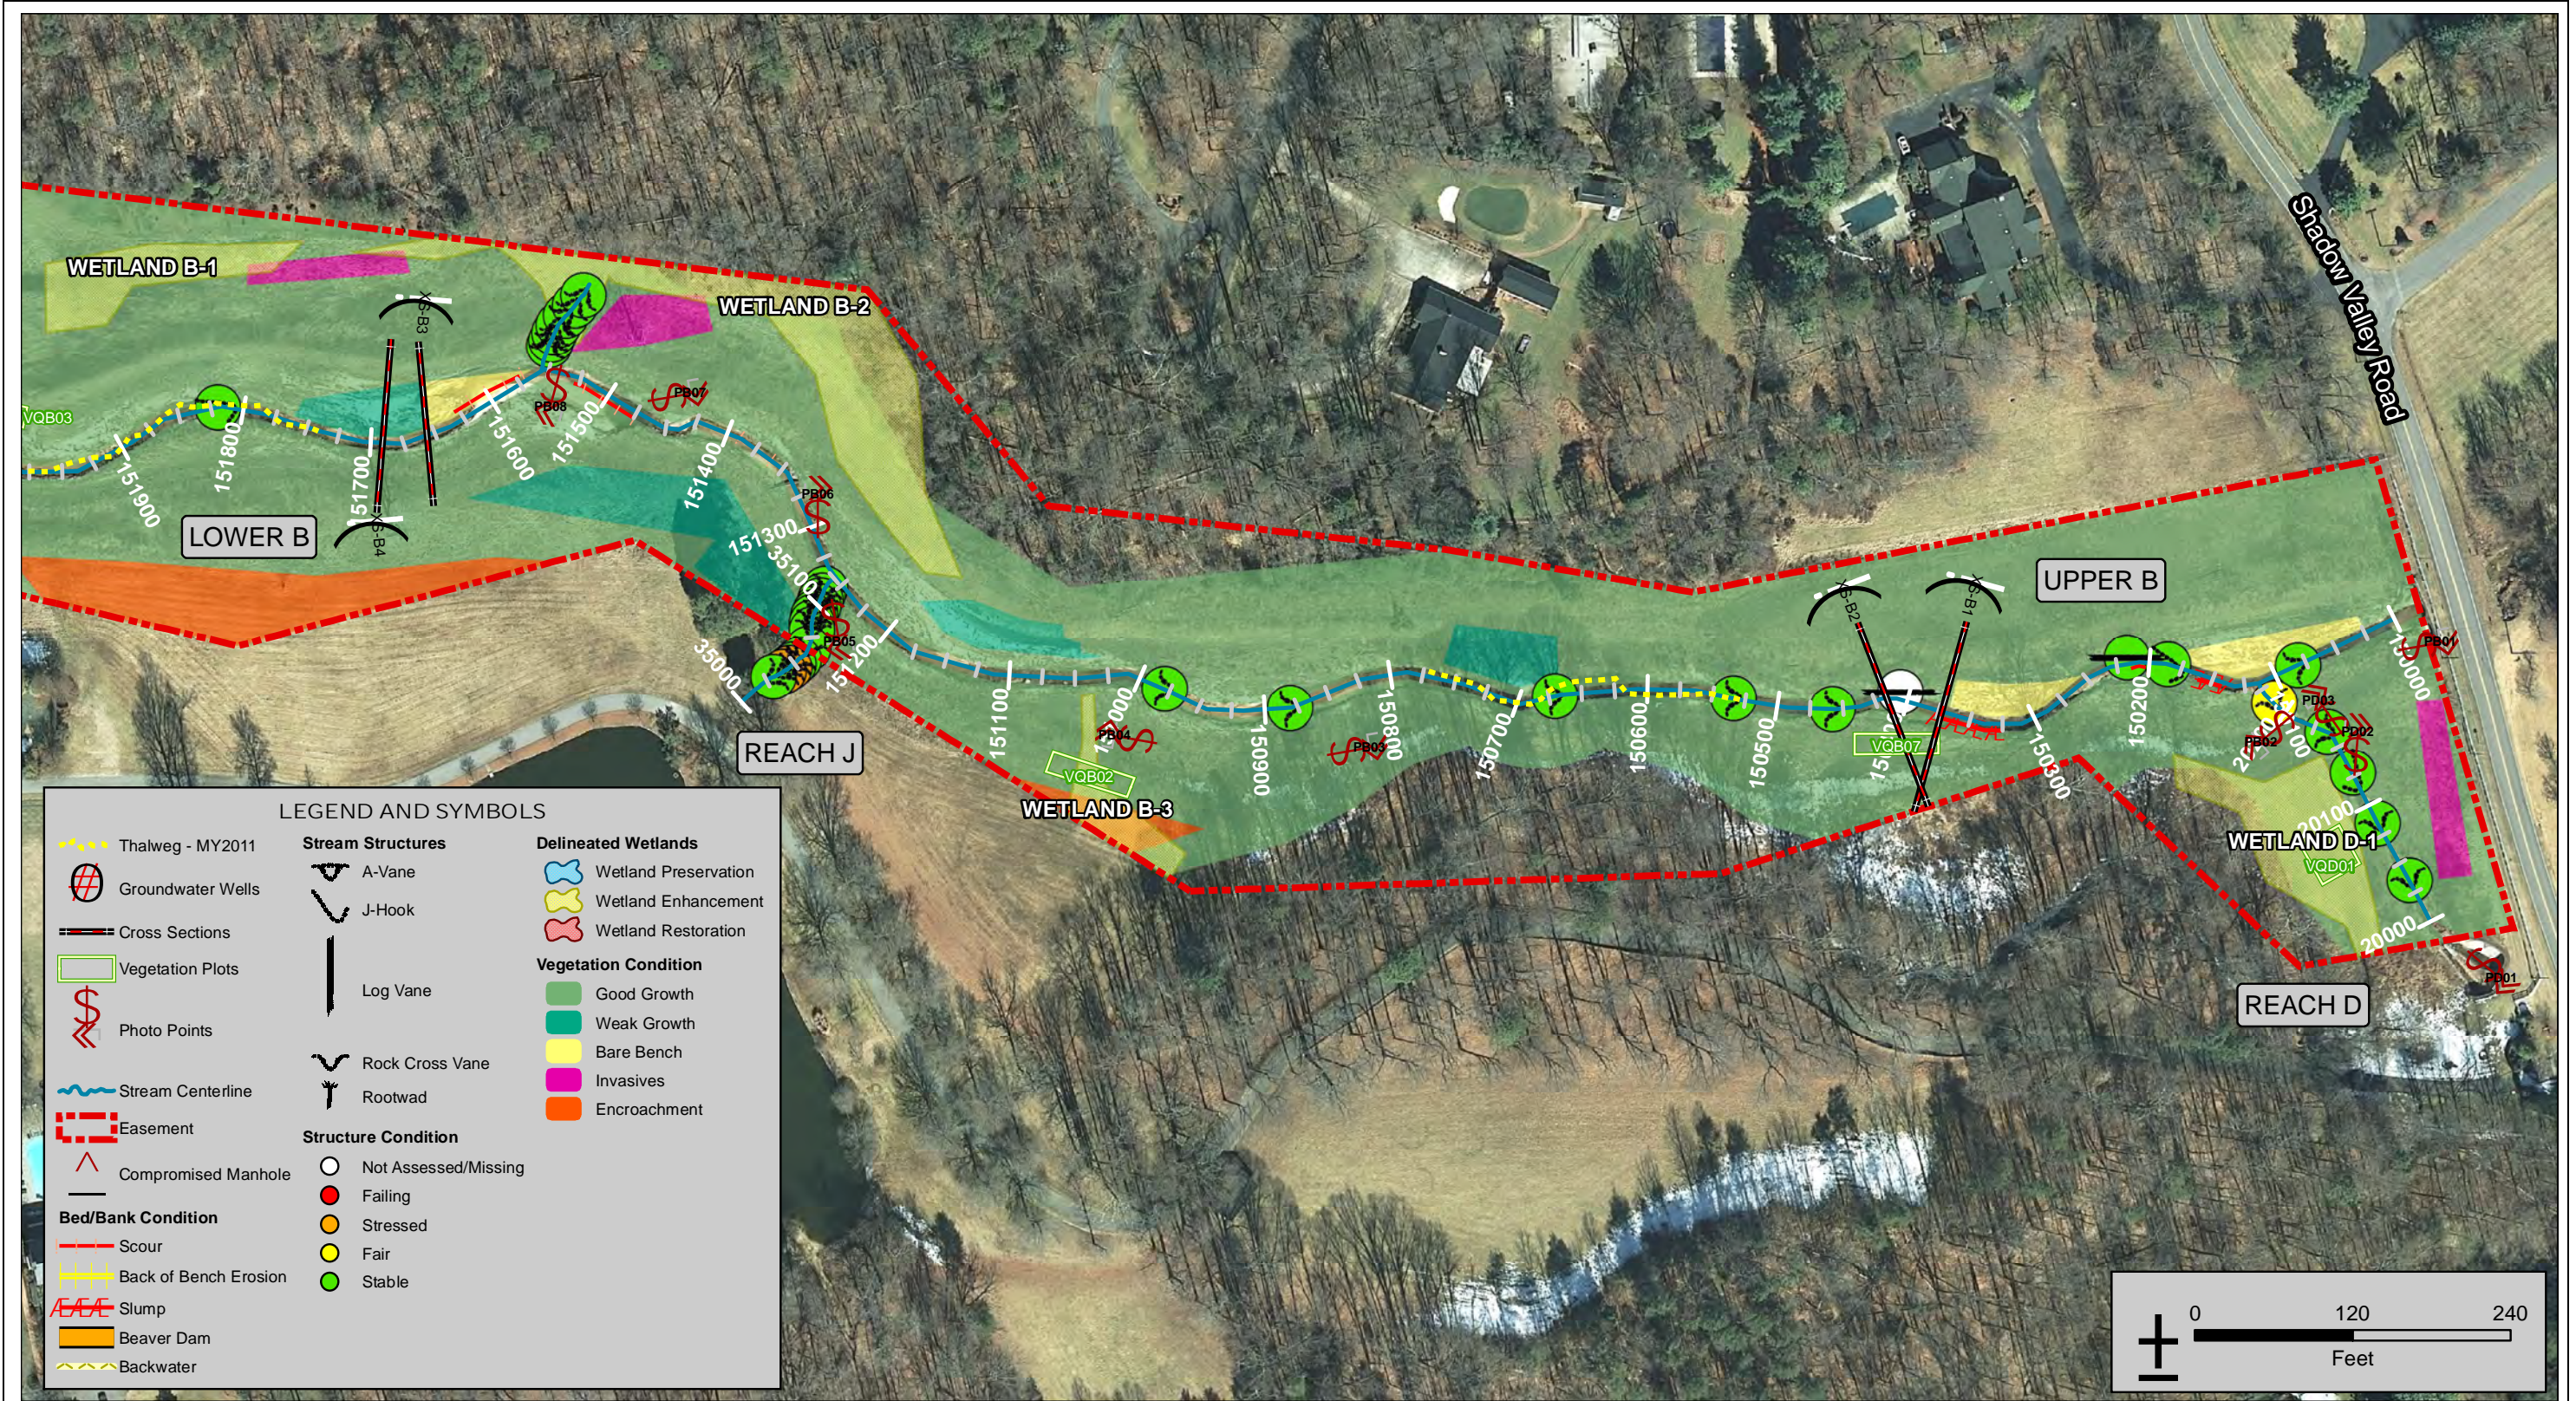
- Most of the structures were observed in good stable condition and holding grade. Several structures on Lower A were noted as missing, most likely due to aggradation of the channel resulting from the beaver dam. Refer to the CCPV (Figures 2-6) in Appendix B for a map displaying structure conditions.

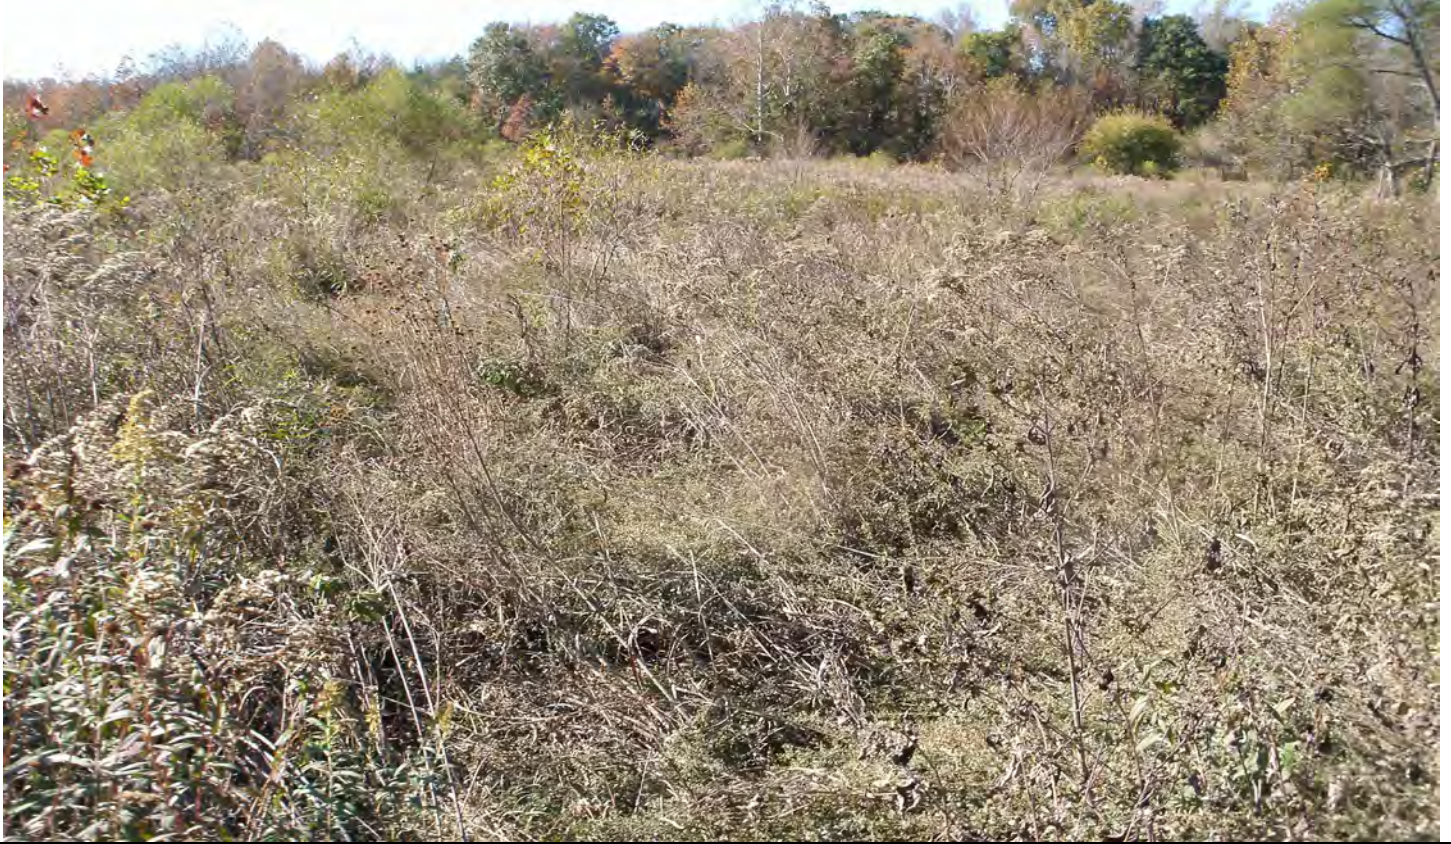
SP09 (2011) - Bankfull indicator (wracklines) on Reach A

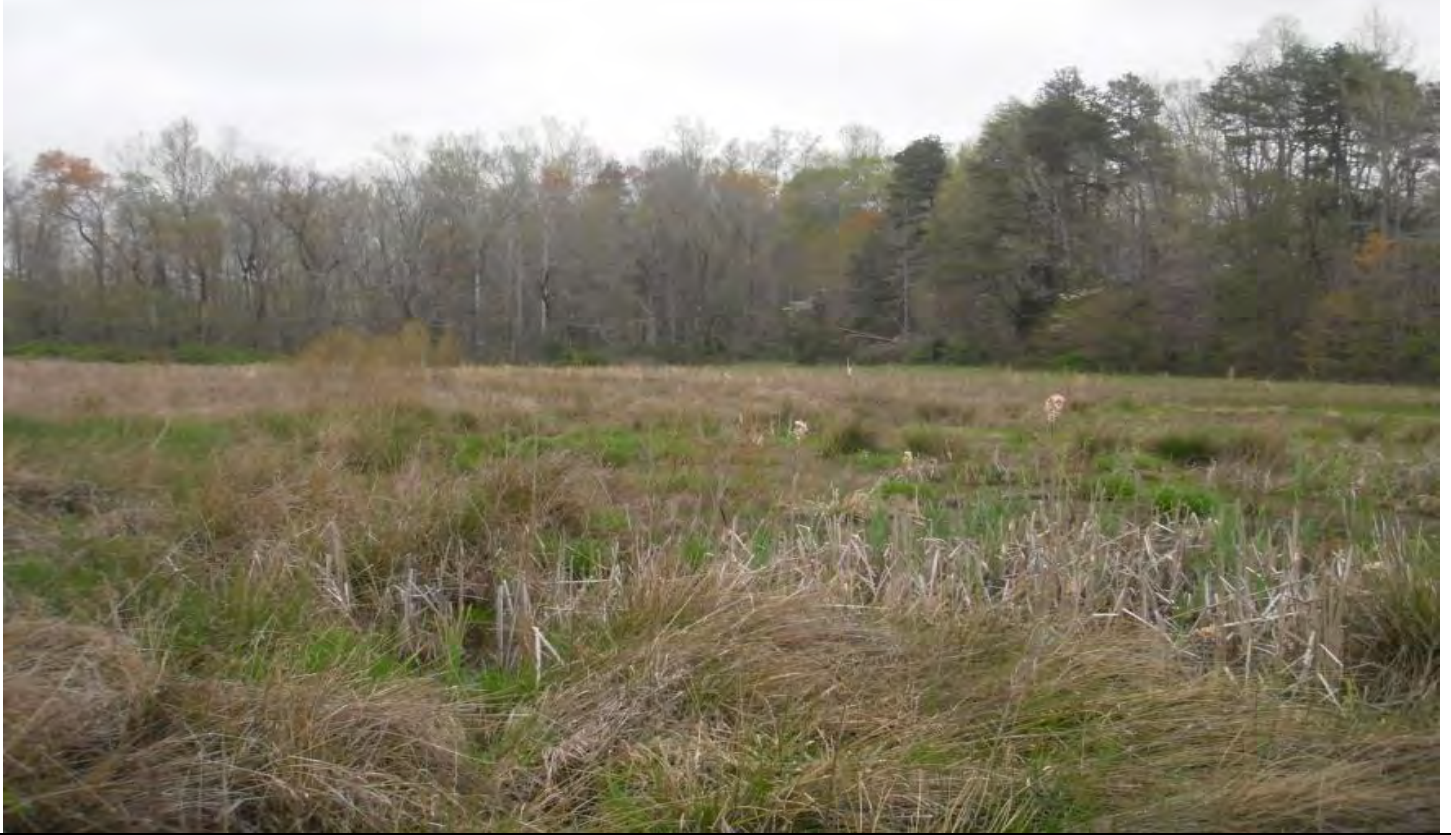
VP08 (2011) - Multiflora Rose located on right buffer of Reach B (STA 151+700)

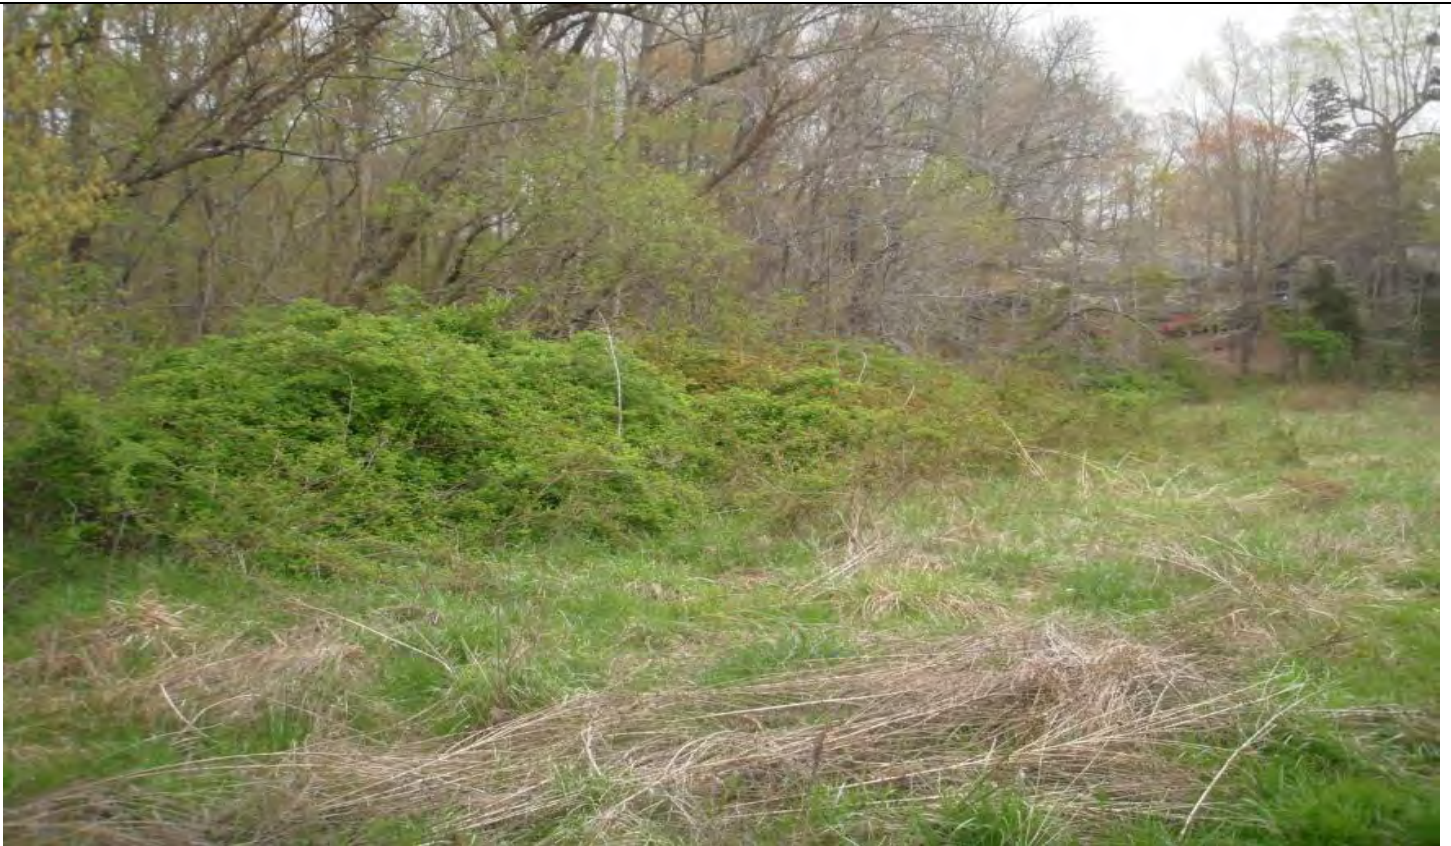
VP09 (2011) - Cattails located in Wetland A-5

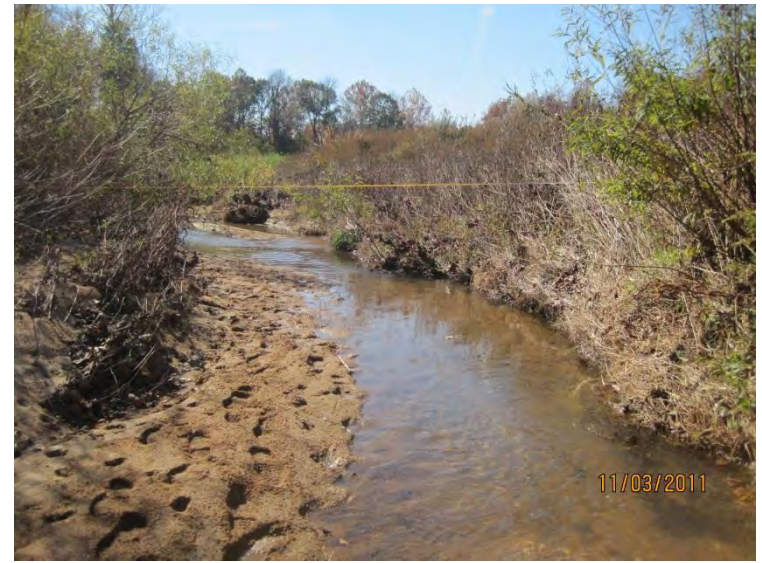
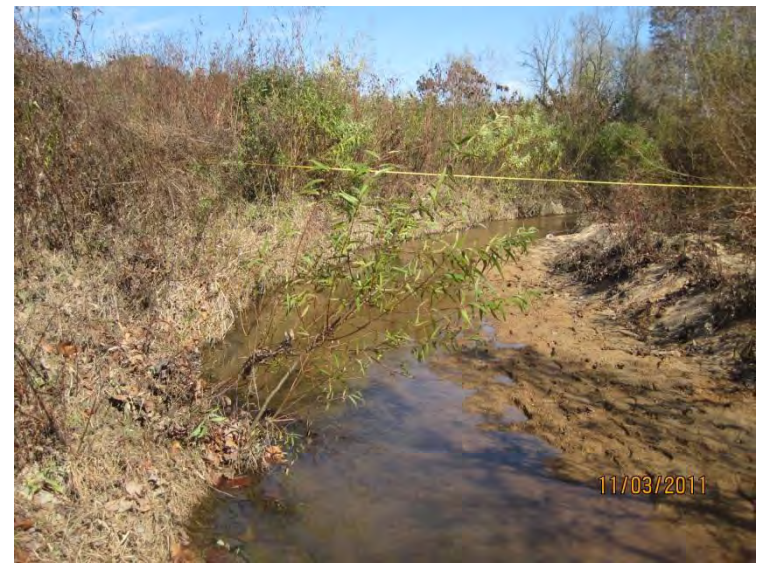
ID	YEAR	PHASE	FACET TYPE	Wbkf	Abkf	Dbkf
XS A10	2008	AB	RIFFLE	41.3	95.5	4.0
XS A10	2010	MY1	RIFFLE	47.1	85.4	3.8
XS A10	2011	MY2	RIFFLE	42.9	74.0	3.8

NOTES: Impacted by beaver dam on downstream end of profile.

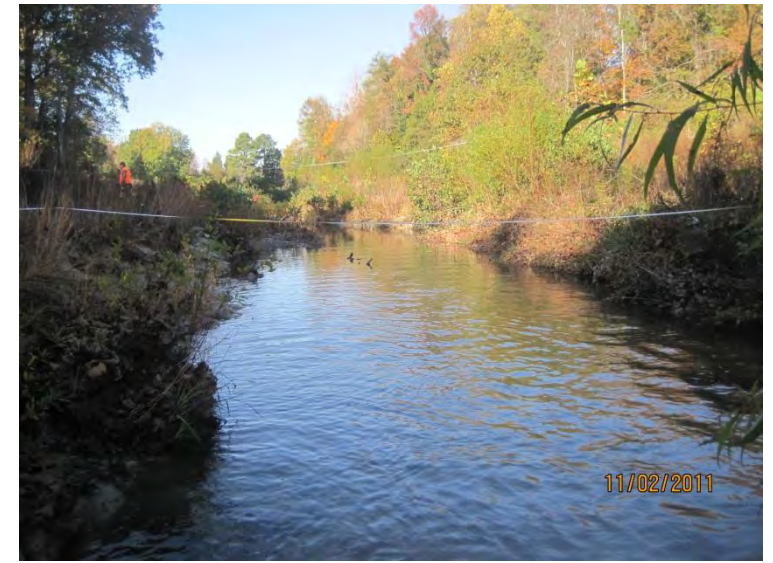
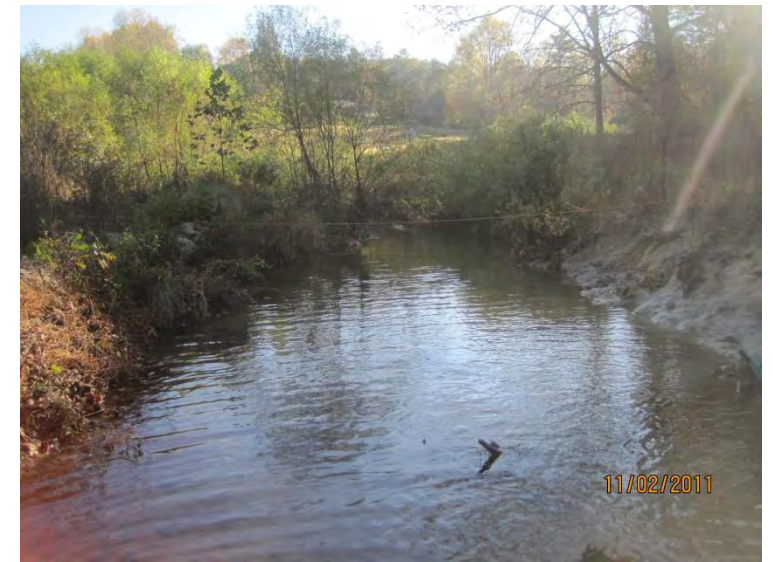
ID	YEAR	PHASE	FACET TYPE	Wbkf	Abkf	Dbkf
XS A11	2008	AB	POOL	49.9	133.9	5.1
XS A11	2010	MY1	POOL	41.6	74.6	3.5
XS A11	2011	MY2	POOL	41.5	61.4	3.6

NOTES: Impacted by beaver dam on downstream end of profile. Beaver dam also appears to be preventing the transport of bed material out of the pools.
