Valley Fields Farm Stream Restoration Project

Monitoring Report: Year 05

Davidson County, North Carolina
Upper Yadkin River Basin
Cataloging Unit 030401030
DMS Project ID #407

December 2015

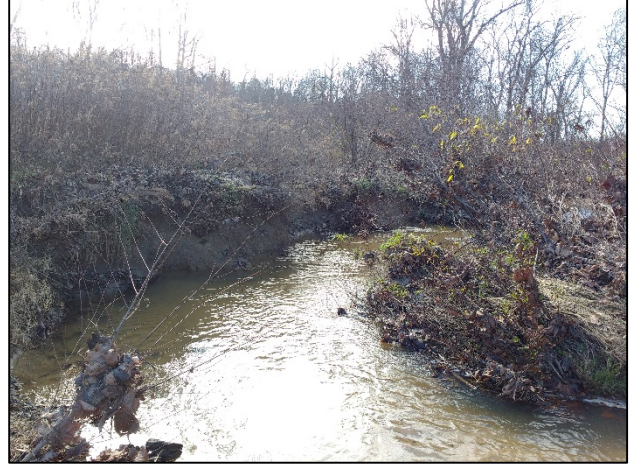
Thalweg shift (Station 84+00) – 12/7/2015
