MONITORING YEAR 4 ANNUAL REPORT

VILE CREEK MITIGATION SITE

Alleghany County, NC
DEQ Contract No. 5999
DMS Project No. 96582

Data Collection Period: April – November 2020
Submission Date: January 19, 2021

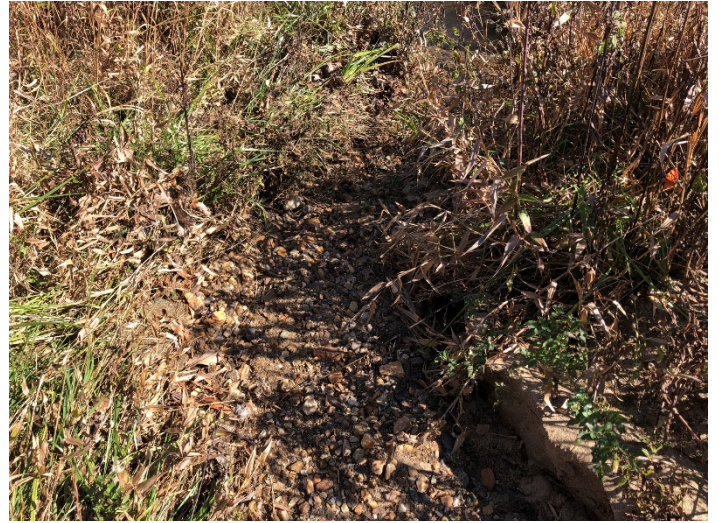
Photo 8– UT1 R1: Station 205+40-205+60 – Abandoned Ox Bow. 11-6-2020

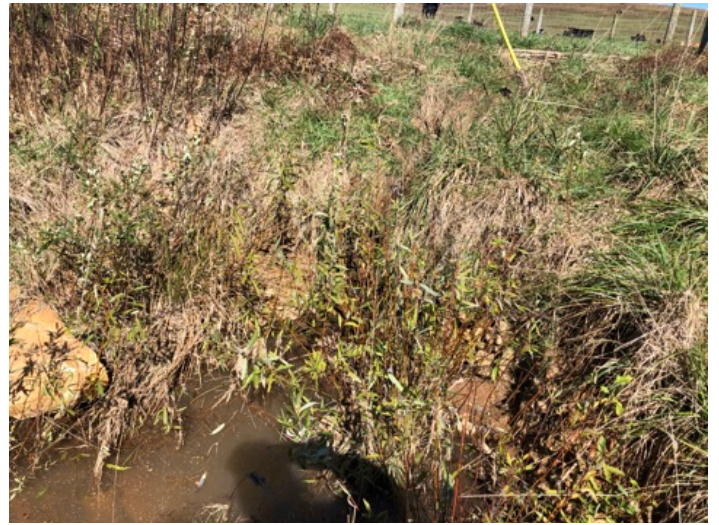
Photo 14– UT2 BMP: Headcut at intake. 11-6-2020

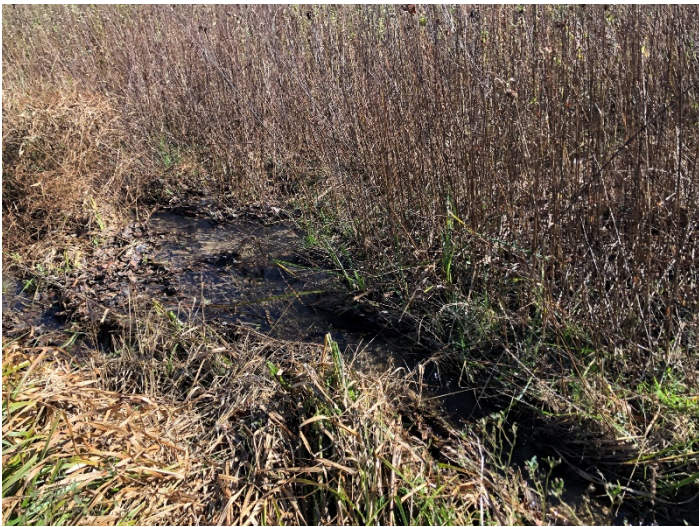
Photo 15 – UT1B: Stream aggradation. 11-6-2020
