**HORSE CREEK (WAKE FOREST COUNTRY CLUB)
2007 FINAL MONTORING REPORT
YEAR 2 OF 5
2007**

EEP Project # 409
Wake County, North Carolina

HORSE CREEK (WAKE FOREST COUNTRY CLUB) STREAM RESTORATION YEAR 2 MONITORING REPORT

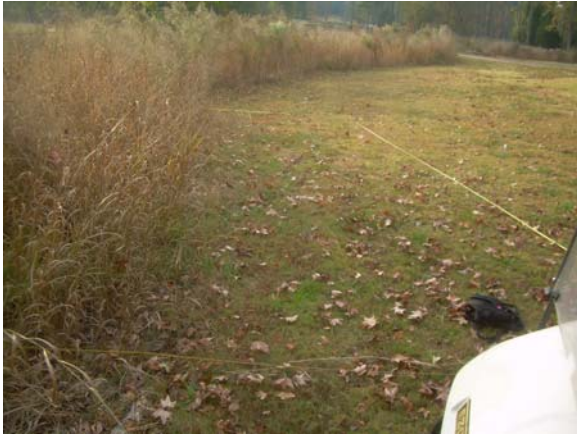
Table VI. Vegetative Problem Areas			
Feature/Issue	Station # / Range	Probable Cause	Photo #
Bare Flood Plain (Horse Creek)	Multiple Sections from 10+50 to 27+50, both sides	Regular fairway maintenance (mowing)	1 & 2
Bare Flood Plain (UT)	Entire Reach, both sides	Regular fairway maintenance (mowing)	1 & 2*

Photo 1. Representative bare floodplain problem area (Vegetation Plot C). Photo taken on 11/13/2007.
