**Big Warrior Creek Stream Restoration
2006 Monitoring Report
Monitoring Year Two**

Ecosystem Enhancement Program Project Number 00412

Submitted: January 19, 2007

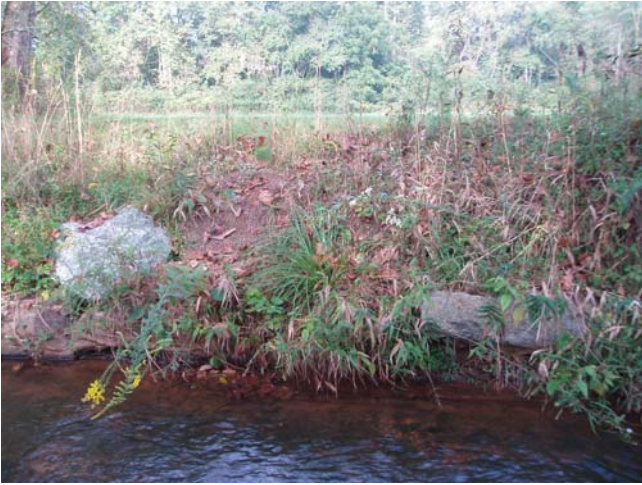
Table A6a. Vegetative Problem Areas – Big Warrior Creek				
Big Warrior Creek				
EEP Project Number 00412				
Feature #	Feature/Issue	Station #/Range	Probable Cause	Photo #
BWVPA1	Bare bank	2+00 to 8+00	Bank erosion	BWVPA1
BWVPA2	Invasive/exotic plant	12+00 to 20+10	Invasive/exotic plant	BWVPA2
BWVPA3	Bare bank	29+70	Bank erosion	BWVPA3
BWVPA4	Invasive/exotic plant	33+00 to 35+00	Invasive/exotic plant	BWVPA4
BWVPA5	Bare bank	43+15	Bank erosion	BWVPA5
BWVPA6	Invasive/exotic plant	43+15	Invasive/exotic plant	BWVPA6
BWVPA7	Bare floodplain, gully erosion	49+00 to 50+00	Poor soil	BWVPA7
BWVPA8	Invasive/exotic plant	63+50	Invasive/exotic plant	BWVPA8

Other problem areas include bare banks and floodplains along the mainstem (BWVPA1 through BWVPA8) and Mountain Creek (MCVPA1 through MCVPA8). No problem areas were documented along the Unnamed Tributary. These problems are likely resulting from poor site soils or soils that were compacted during construction. URS recommends soil amendments and reseeding in these areas.

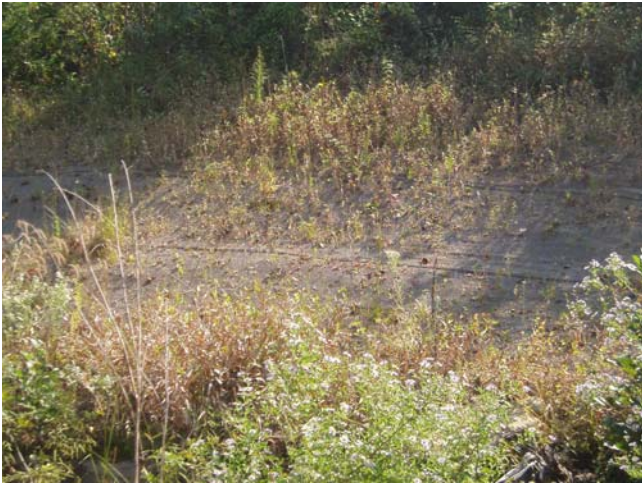
Vegetative Problem Areas – Big Warrior Creek				
Big Warrior Creek 00412				
Feature #	Feature/Issue	Station #/Range	Probable Cause	Photo #
BWVPA1	Bare bank	2+00 to 8+00	Bank erosion	BWVPA1
BWVPA2	Invasive/exotic plant	12+00 to 20+10	Invasive/exotic plant	BWVPA2
BWVPA3	Bare bank	29+70	Bank erosion	BWVPA3
BWVPA4	Invasive/exotic plant	33+00 to 35+00	Invasive/exotic plant	BWVPA4
BWVPA5	Bare bank	43+15	Bank erosion	BWVPA5
BWVPA6	Invasive/exotic plant	43+15	Invasive/exotic plant	BWVPA6
BWVPA7	erosion	49+00 to 50+00	Poor soil	BWVPA7
BWVPA8	Invasive/exotic plant	63+50	Invasive/exotic plant	BWVPA8

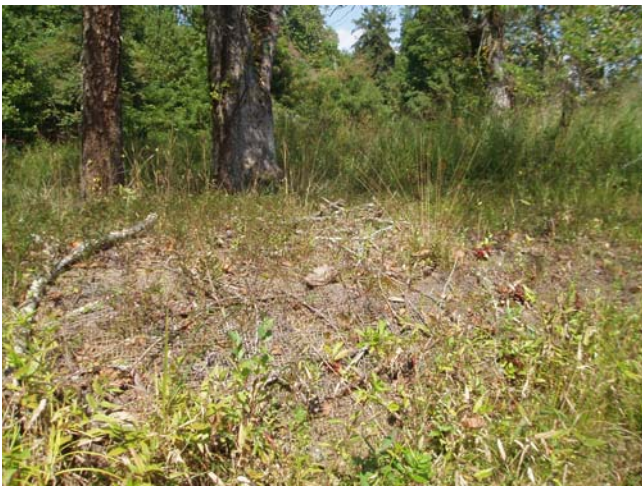
Table A6b. Vegetative Problem Areas – Mountain Creek				
Big Warrior Creek				
EEP Project Number 00412				
Feature #	Feature/Issue	Station #/Range	Probable Cause	Photo #
MCVPA1	Bare bank	5+00	Bank erosion	MCVPA1
MCVPA2	Bare bank	6+20	Bank erosion	MCVPA2
MCVPA3	Bare bank	13+60	Bank erosion	MCVPA3
MCVPA4	Bare bank	15+00	Bank erosion	MCVPA4
MCVPA5	Bare floodplain	17+00 to 17+60	Overflow	MCVPA5
MCVPA6	Bare bank	17+00	Bank erosion	MCVPA6
MCVPA7	Bare bank	17+60	Bank erosion	MCVPA7
MCVPA8	Bare bank	19+00	Bank erosion	MCVPA8

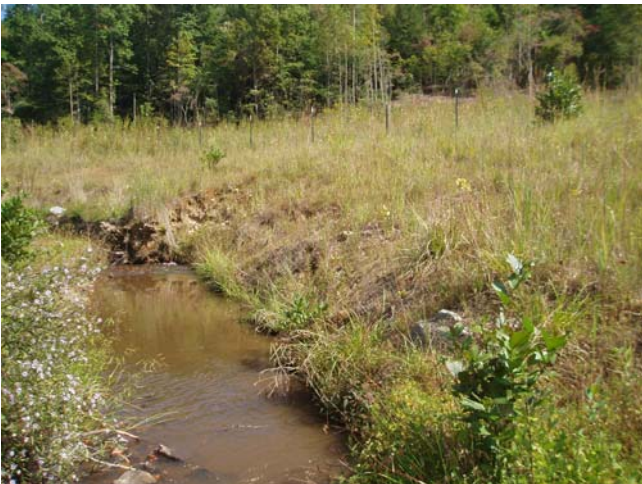
Vegetative Problem Areas – Mountain Creek				
Big Warrior Creek 00412				
Feature #	Feature/Issue	Station #/Range	Probable Cause	Photo #
MCVPA1	Bare bank	5+00	Bank erosion	MCVPA1
MCVPA2	Bare bank	6+20	Bank erosion	MCVPA2
MCVPA3	Bare bank	13+60	Bank erosion	MCVPA3
MCVPA4	Bare bank	15+00	Bank erosion	MCVPA4
MCVPA5	Bare floodplain	17+00 to 17+60	Overflow	MCVPA5
MCVPA6	Bare bank	17+00	Bank erosion	MCVPA6
MCVPA7	Bare bank	17+60	Bank erosion	MCVPA7
MCVPA8	Bare bank	19+00	Bank erosion	MCVPA8

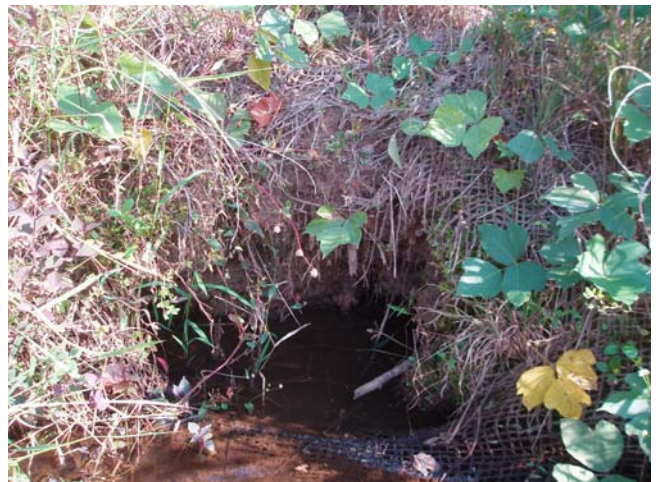
BWPA6 facing right bank

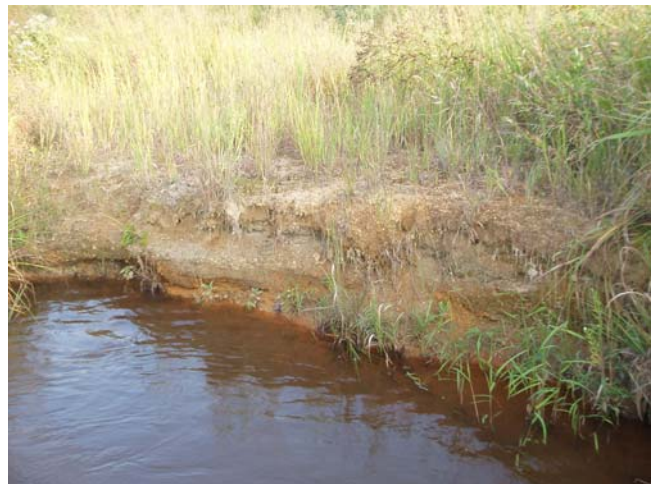
Table B1a. Stream Problem Areas – Big Warrior Creek				
Big Warrior Creek				
EEP Project Number 00412				
Feature #	Feature Issue	Station	Suspected Cause	Photo #
BWPA1	Structure failure	5+00	Rocks obstructing flow, causing flow diversion into banks	BWPA1
BWPA2	Structure failure	11+00	Scour	BWPA2
BWPA3	Structure failure	16+00	Rocks obstructing flow, causing flow diversion into banks	BWPA3
BWPA4	Structure failure	17+60	Scour	BWPA4
BWPA5	Bank erosion, failure of log toe protection	20+80	Scour	BWPA5
BWPA6	Bank erosion	34+50	Scour	BWPA6
BWPA7	Bank erosion	34+75	Scour	BWPA7
BWPA8	Bank erosion	34+90	Scour	BWPA8
BWPA9	Aggradation, mid-channel bar formation	43+00	Inadequate sediment transport	BWPA9
BWPA10	Structure failure	42+60	Rocks obstructing flow, causing flow diversion into banks	BWPA10
BWPA11	Aggradation, lateral bar formation	44+70	Lateral migration of channel	BWPA11
BWPA12	Bank erosion	49+75	Lateral migration of channel	BWPA12

BWPA12 facing right bank

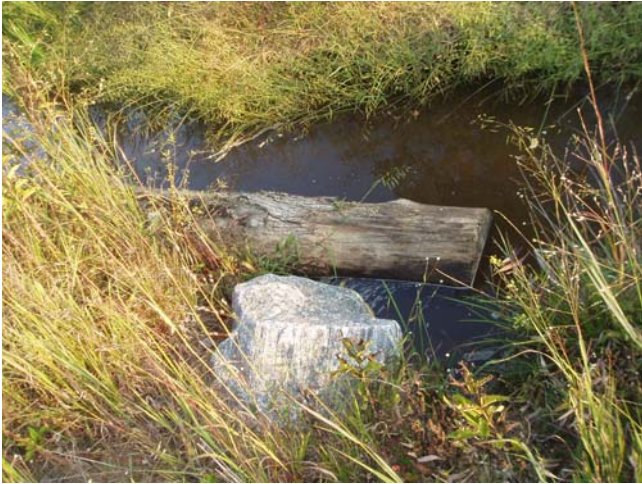
BWPA13	Structure degradation	49+60	Stability	BWPA13
BWPA14	Aggradation, mid-channel bar formation	52+00	Inadequate sediment transport	BWPA14
BWPA15	Structure degradation	54+80	Scour	BWPA15
BWPA16	Structure degradation	56+00	Floodplain flow is undermining log structure	BWPA16
BWPA17	Structure degradation	62+60	Scour	BWPA17
BWPA18	Structure degradation	64+90	Scour	BWPA18
BWPA19	Structure degradation	67+00	Stability	BWPA19

BWPA13 looking down at left bank

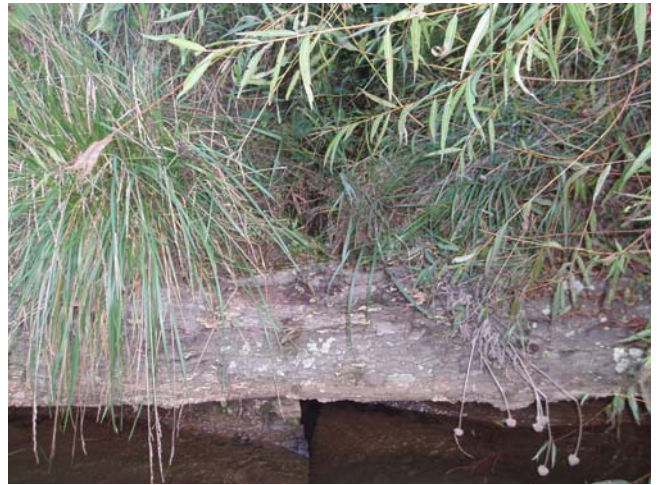
BWPA16 facing right bank

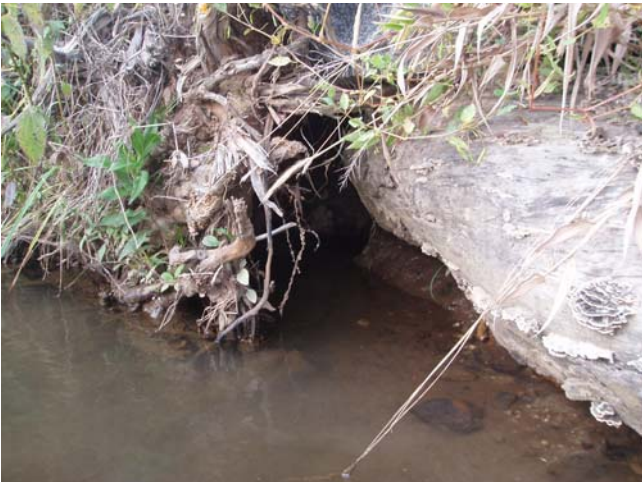
BWPA17 facing right bank

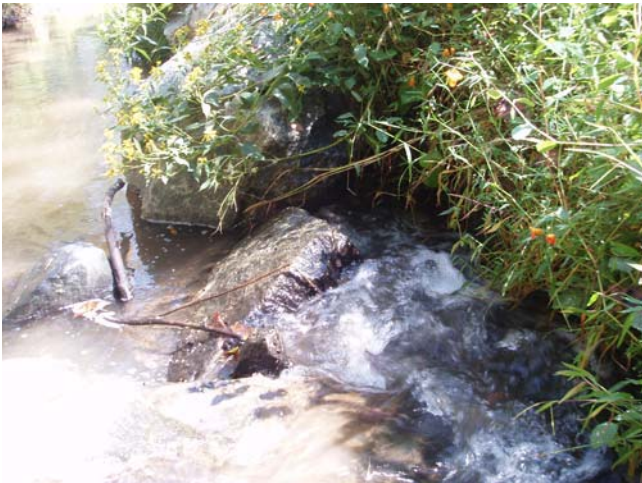
Table B1b. Stream Problem Areas – Mountain Creek				
Big Warrior Creek				
EEP Project Number 00412				
Feature #	Feature Issue	Station	Suspected Cause	Photo #
MCPA1	Structure failure	0+00	Too much elevation drop	MCPA1
MCPA2	Structure degradation	0+25	Potentially constructed with large gaps	MCPA2
MCPA3	Structure failure	1+80	Log not keyed into bank adequately	MCPA3
MCPA4	Bank erosion	2+10	Scour	MCPA4
MCPA5	Bank erosion	13+75	Scour	MCPA5
MCPA6	Bank erosion and aggradation	17+00	Excessive scour	MCPA6
MCPA7	Bank failure	17+60	Excessive scour	MCPA7

MCPA1 facing downstream at right bank

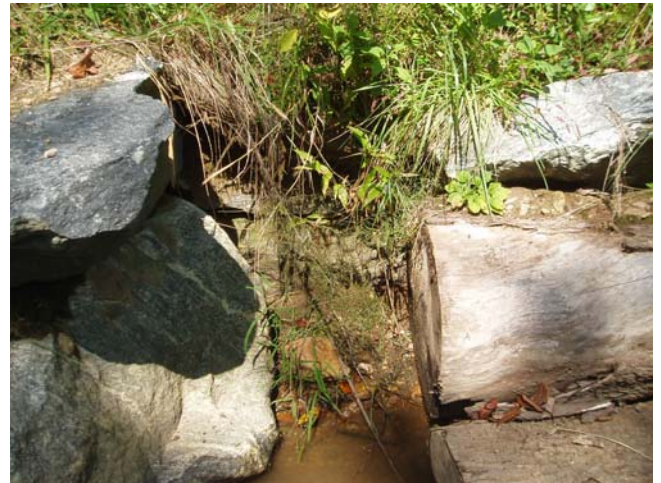
MCPA2 facing right bank

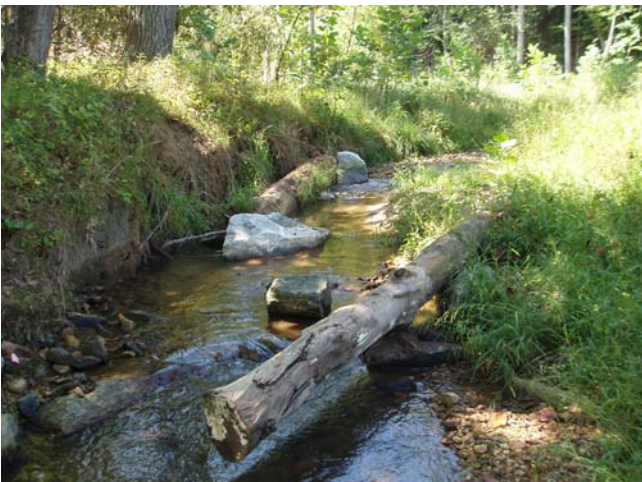
MCPA3 facing upstream

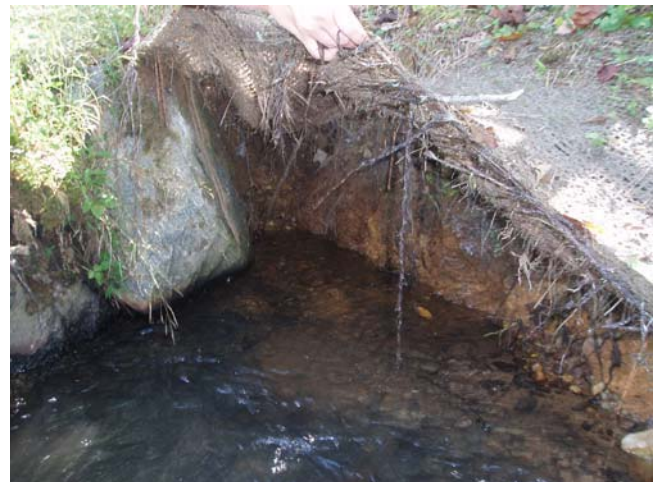
MCPA4 facing right bank

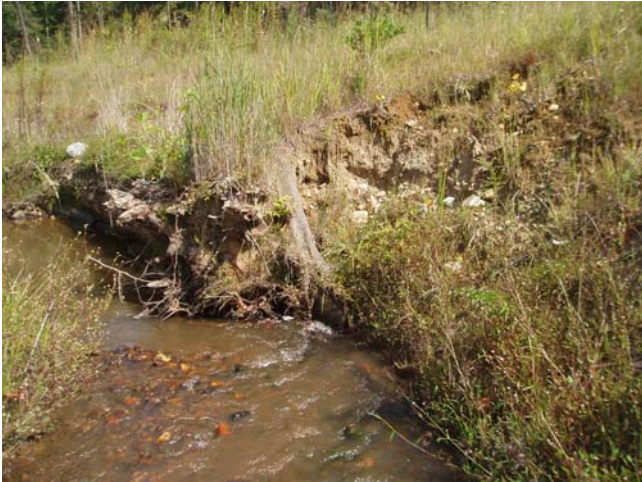
MCPA5 facing upstream

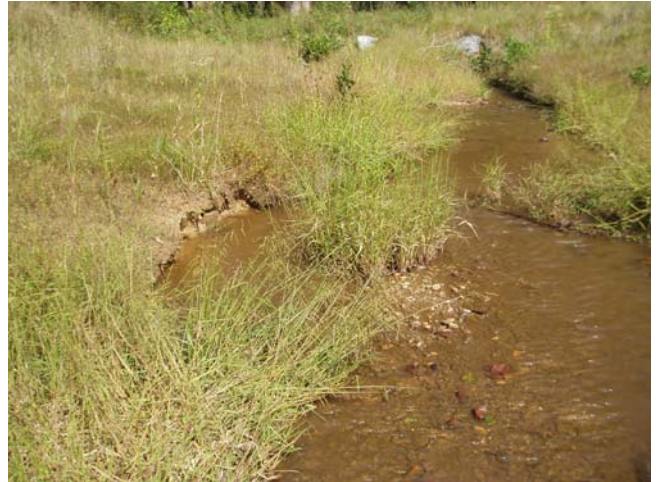
MCPA6 facing downstream

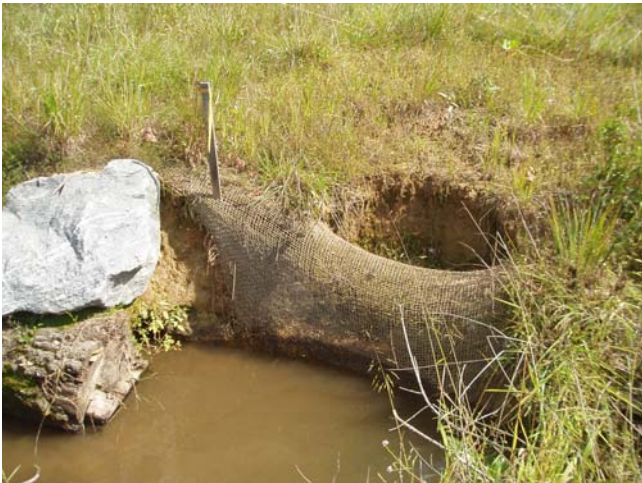
MCPA7 facing right bank
