**Big Warrior Creek Stream Restoration
2007 Final Monitoring Report
Monitoring Year Three**

Ecosystem Enhancement Program Project Number 00412

Prepared by: URS Corporation – North Carolina
1600 Perimeter Park Drive, Suite 400
Morrisville, NC 27560

Submitted: February 26, 2007

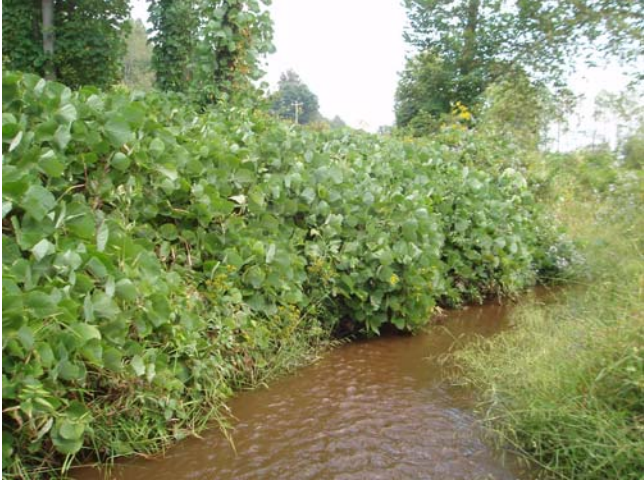
The presence and abundance of kudzu along Big Warrior Creek appears to have increased dramatically since 2006. Four notable areas are shown as problem areas. However, small patches of kudzu were observed along the majority of Big Warrior Creek. Because of the highly aggressive growth habit of kudzu, it is expected to continue expanding across the site and endangering the planted vegetation if it is not treated. American hogpeanut is also growing very aggressively along the Unnamed Tributary and portions of the other reaches. While this vine is a native species, it is a vigorous climber and may threaten the survivability of planted stems. Small Chinese privet were observed along the mainstem of Big Warrior Creek during the 2006 and 2007 monitoring periods. While these individuals do not pose an immediate threat, their presence should be noted and monitored.

Table A6a. Vegetative Problem Areas – Big Warrior Creek				
Big Warrior Creek				
EEP Project Number 00412				
Feature #	Feature/Issue	Station #/Range	Probable Cause	Photo #
BWVPA2	Invasive/exotic plant	12+00 to 20+10	Invasive/exotic plant	BWVPA2
BWVPA4	Invasive/exotic plant	33+00 to 35+00	Invasive/exotic plant	BWVPA4
BWVPA5	Bare bank	43+15	Bank erosion	BWVPA5
BWVPA6	Invasive/exotic plant	43+15	Invasive/exotic plant	BWVPA6
BWVPA7	Bare floodplain, gully erosion	49+00 to 50+00	Poor soil	BWVPA7
BWVPA8	Invasive/exotic plant	63+50	Invasive/exotic plant	BWVPA8
BWNVPA1	Bare bank	21+00 to 22+00	Bank erosion	BWNVPA1

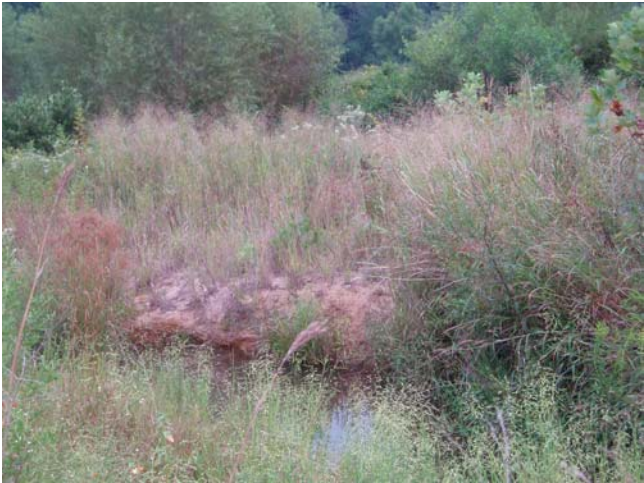
BWVPA5

Other problem areas include bare banks and floodplains along the mainstem and Mountain Creek. These problems are likely resulting from poor site soils or soils that were compacted during construction. URS recommends soil amendments and reseeded in these areas. No problem areas were documented along the Unnamed Tributary.

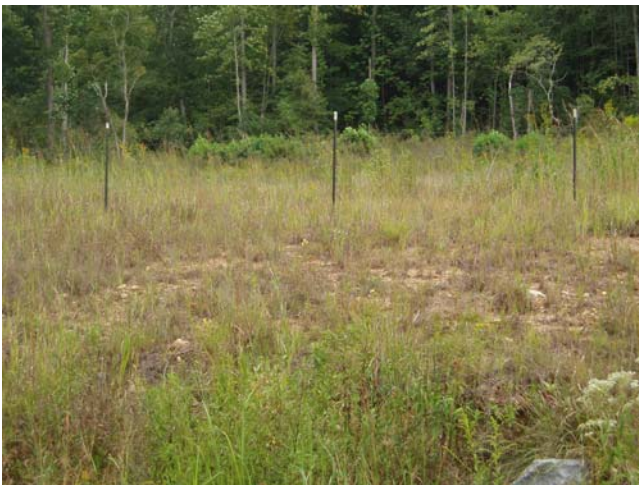
Table A6b. Vegetative Problem Areas – Mountain Creek				
Big Warrior Creek				
EEP Project Number 00412				
Feature #	Feature/Issue	Station #/Range	Probable Cause	Photo #
MCVPA1	Bare bank	5+00	Bank erosion	MCVPA1
MCVPA2	Bare bank	6+20	Bank erosion	MCVPA2
MCVPA3	Bare bank	13+60	Bank erosion	MCVPA3
MCVPA4	Bare bank	15+00	Bank erosion	MCVPA4
MCVPA5	Bare floodplain	17+00 to 17+60	Overflow	MCVPA5
MCVPA6	Bare bank	17+00	Bank erosion	MCVPA6
MCVPA7	Bare bank	17+60	Bank erosion	MCVPA7
MCVPA8	Bare bank	19+00	Bank erosion	MCVPA8

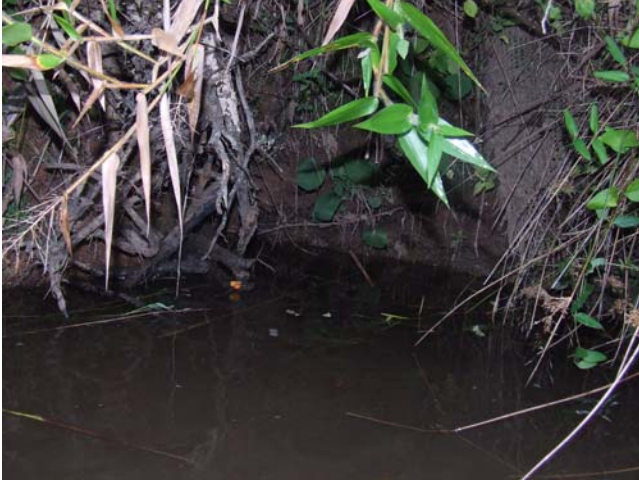
Table B1a. Stream Problem Areas – Big Warrior Creek				
Big Warrior Creek				
EEP Project Number 00412				
Feature #	Feature Issue	Station	Suspected Cause	Photo #
BWPA1	Structure degradation	5+00	Bank scour behind rootwad	BWPA1
BWPA2	Structure failure	11+00	Scour	BWPA2
BWPA3	Structure failure	12+60	Rocks obstructing flow, causing flow diversion into banks	BWPA3
BWPA4	Structure failure	17+60	Scour	BWPA4
BWPA5	Ponding	22+40	Beaver presence / beaver dam	BWPA5
BWPA6	Structure degradation	23+60	Scour behind log vane	BWPA6
BWPA7	Bank erosion	34+50	Scour	BWPA7
BWPA8	Bank erosion	34+75	Scour	BWPA8
BWPA9	Bank erosion	34+90	Scour	BWPA9
BWPA10	Aggradation, mid-channel bar formation	43+00	Inadequate sediment transport	BWPA10
BWPA11	Aggradation, mid-channel bar formation	40+00	Upstream erosion	BWPA11
BWPA12	Structure failure	42+60	Rocks obstructing flow, causing flow diversion into banks	BWPA12
BWPA13	Aggradation, lateral bar formation	44+70	Lateral migration of channel	BWPA13

BWPA1 facing right bank

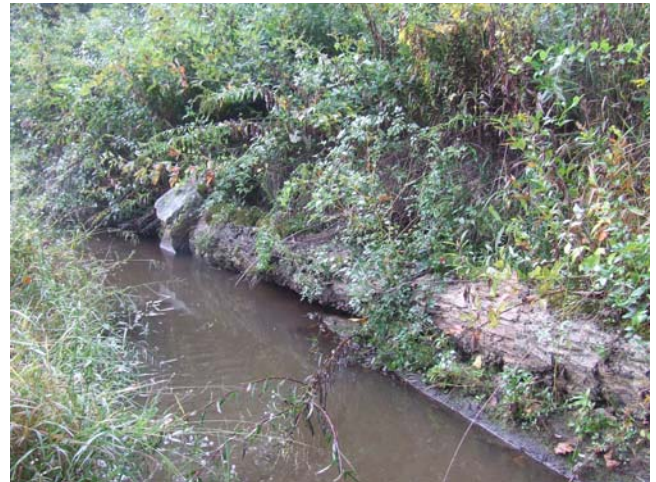
BWPA6 facing right bank

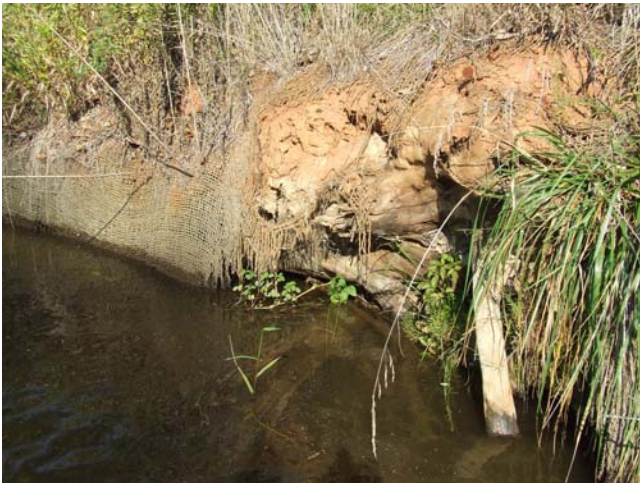
BWPA7 facing right bank

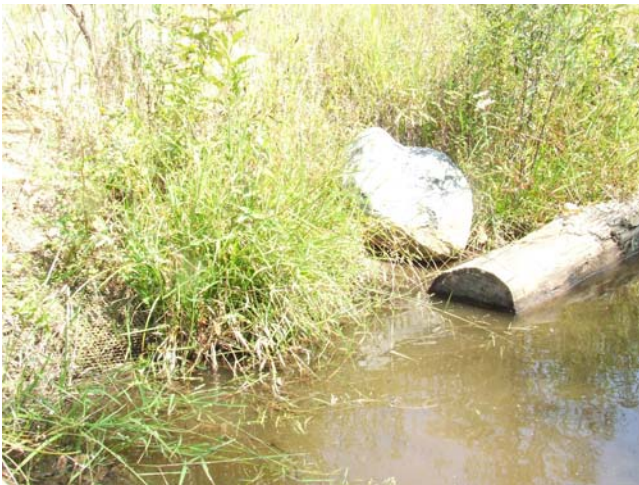
BWPA14	Bank erosion	49+75	Lateral migration of channel	BWPA14
BWPA15	Structure degradation	49+60	Stability	BWPA15
BWPA16	Aggradation, mid-channel bar formation	52+00	Inadequate sediment transport	BWPA16
BWPA17	Structure degradation	54+80	Scour	BWPA17
BWPA18	Structure degradation	56+00	Floodplain flow is undermining log structure	BWPA18
BWPA19	Structure degradation	56+10	Scour	BWPA19
BWPA20	Structure degradation	62+60	Scour	BWPA20
BWPA21	Structure degradation	63+10	Scour	BWPA21
BWPA22	Structure degradation	64+90	Scour	BWPA22
BWPA23	Bank erosion	65+20	Scour	BWPA23
BWPA24	Structure degradation	67+00	Stability	BWPA24
BWPA25	Aggradation, mid-channel bar formation	67+80	Upstream erosion	BWPA25

BWPA15 looking down at left bank

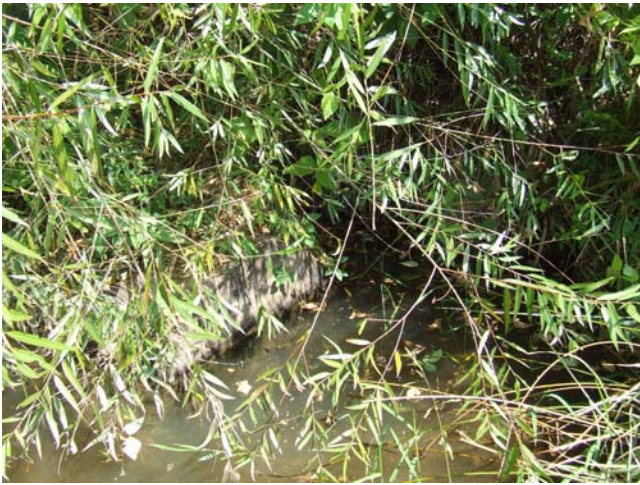
BWPA19 facing right bank

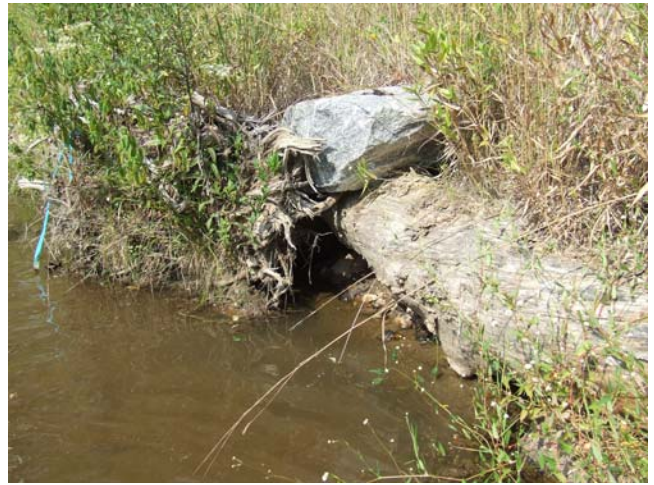
BWPA20 facing right bank

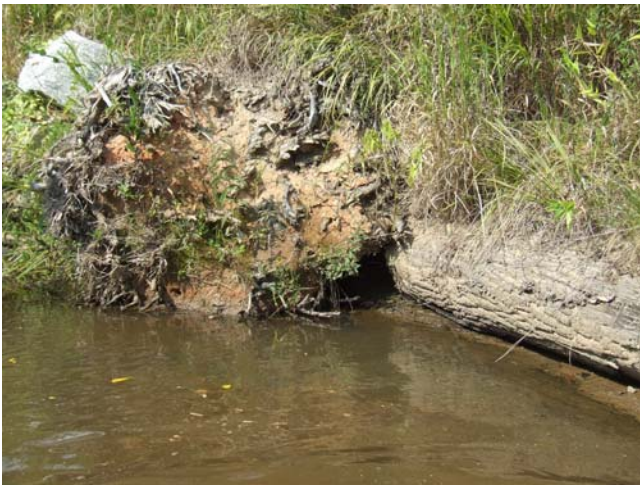
BWPA21 facing right bank

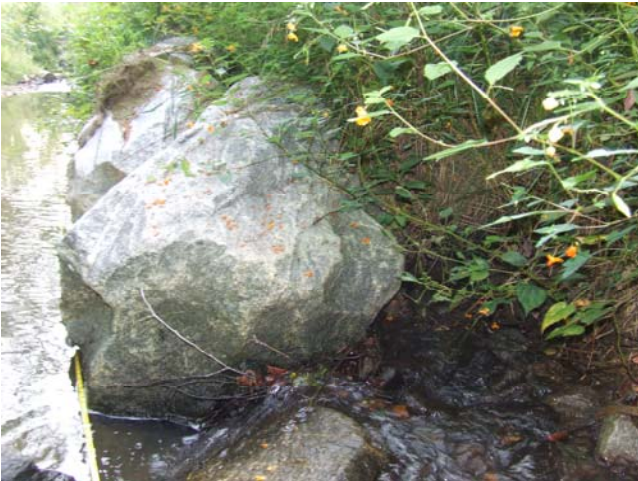
Table B1b. Stream Problem Areas – Mountain Creek Big Warrior Creek EEP Project Number 00412				
Feature #	Feature Issue	Station	Suspected Cause	Photo #
MCPA1	Structure failure	0+00	Too much elevation drop	MCPA1
MCPA2	Structure failure	1+80	Log not keyed into bank adequately	MCPA2
MCPA3	Bank erosion	2+10	Scour	MCPA3
MCPA4	Bank erosion	6+80	Scour	MCPA4
MCPA5	Bank erosion	10+00	Scour	MCPA5
MCPA6	Bank erosion	13+75	Scour	MCPA6
MCPA7	Bank failure	14+80	Scour	MCPA7
MCPA8	Bank erosion and aggradation	17+00	Excessive scour	MCPA8
MCPA9	Bank failure	17+60	Excessive scour	MCPA9
MCPA10	Aggradation, mid-channel bar formation	23+90	Upstream scour	MCPA10

MCPA1 facing downstream at right bank

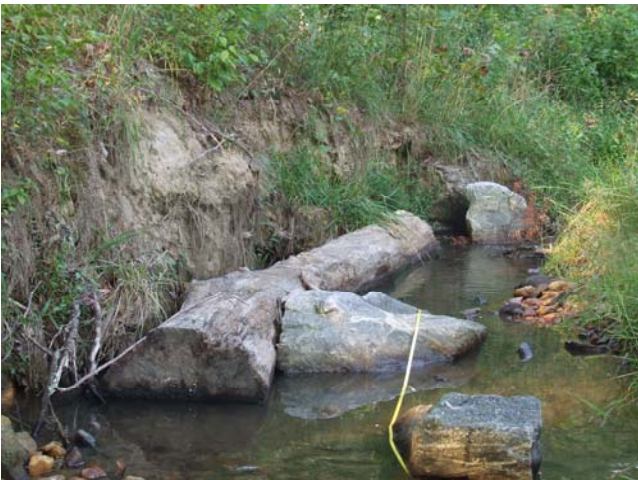
MCPA3 facing upstream

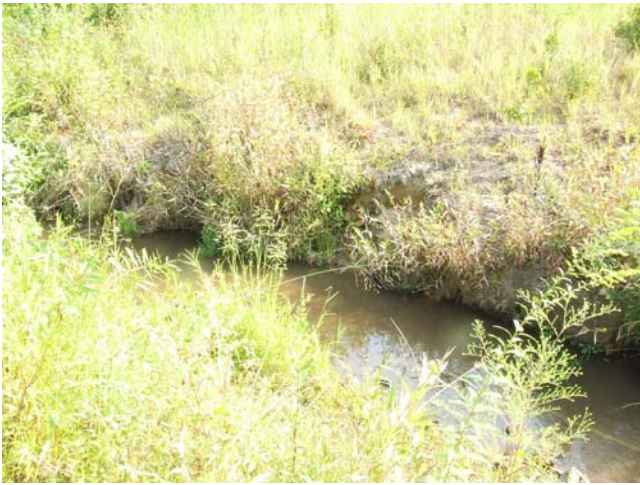
MCNPA5 facing right bank

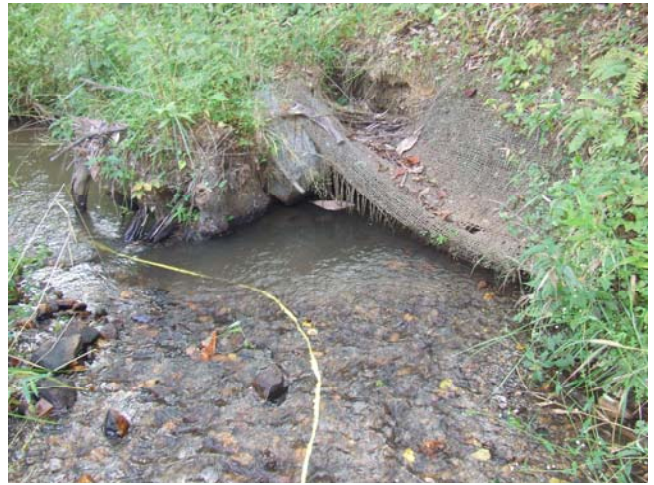
MCPA6 facing right bank

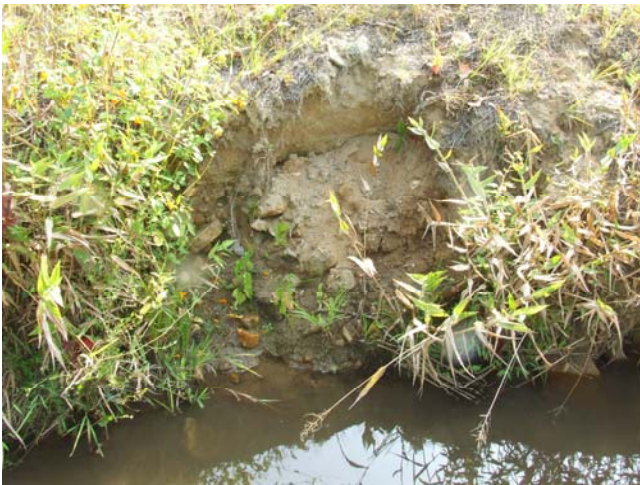
MCPA7 facing right bank

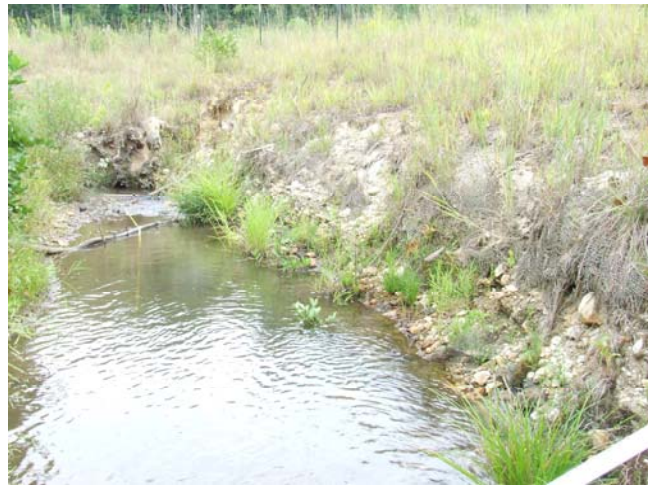
MCPA8 facing downstream

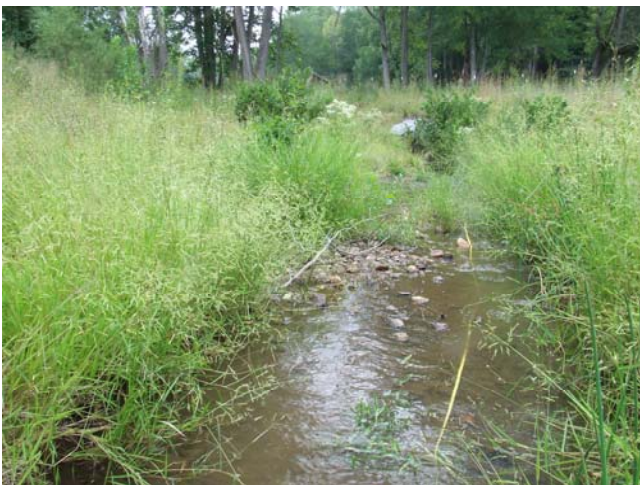
MCPA9 facing downstream

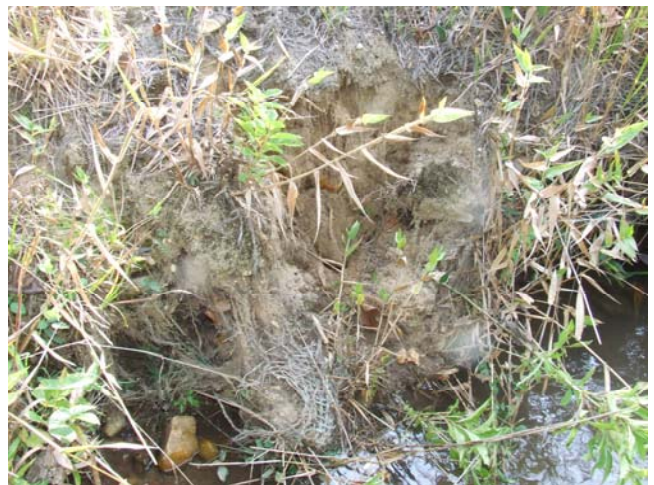
MCPA10 facing right bank

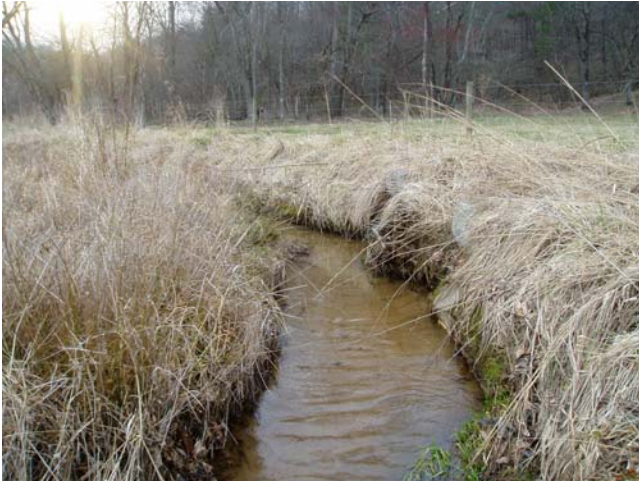
Table B1c. Stream Problem Areas – Unnamed Tributary Big Warrior Creek EEP Project Number 00412				
Feature #	Feature Issue	Station	Suspected Cause	Photo #
UTPA1	Severe sedimentation (pool filled in)	5+00	Upstream erosion/clearcut	UTPA1
UTPA2	Severe sedimentation (pool filled in)	9+00	Upstream erosion/clearcut	UTPA2

UTPA1 facing upstream

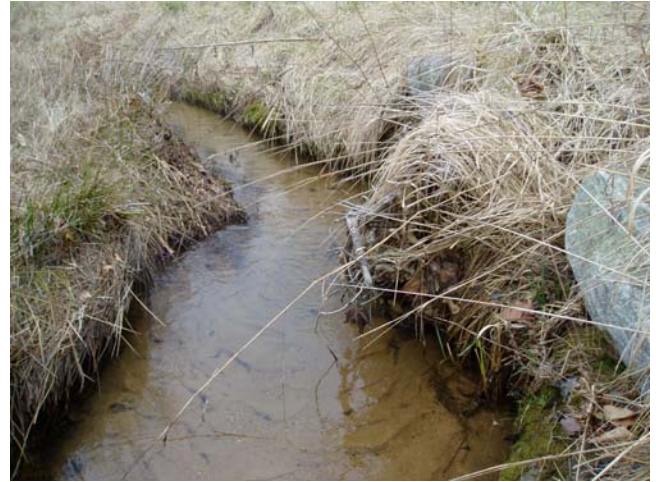
UTPA2 facing upstream

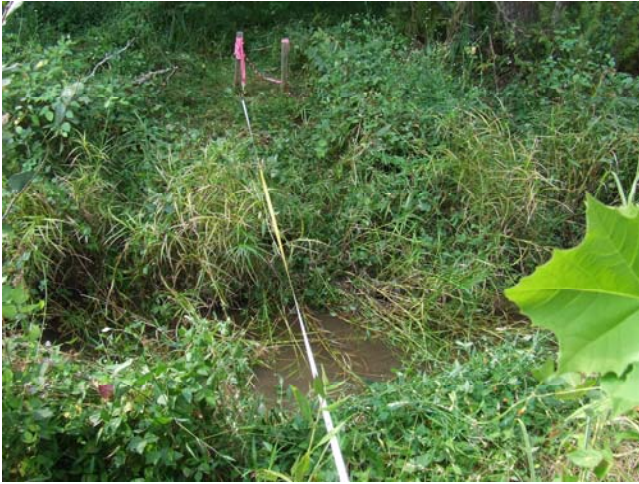
XS1 facing left bank

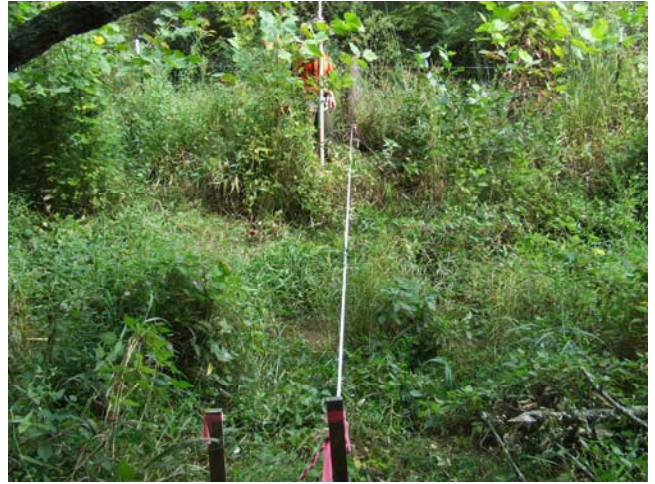
XS1 facing right bank

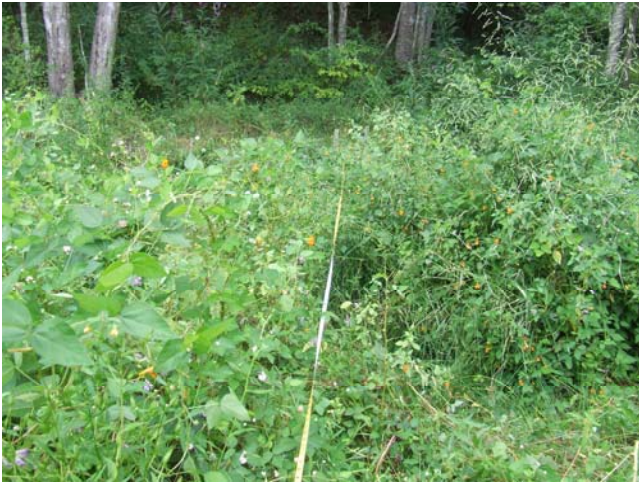
XS2 facing left bank

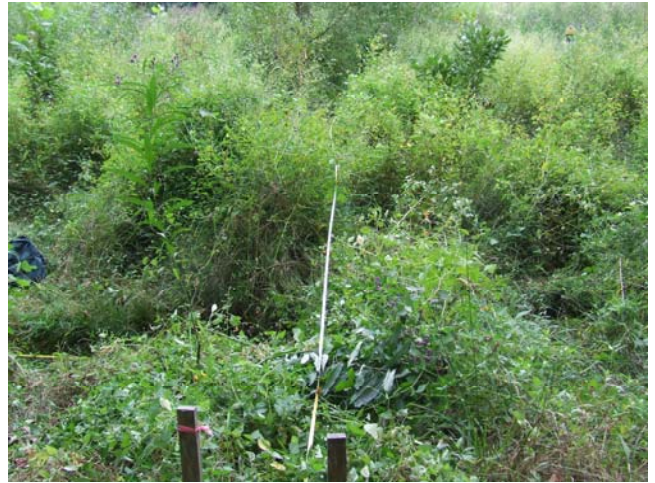
XS2 facing right bank
