Big Warrior Creek Stream Restoration 2008 Final Monitoring Report Monitoring Year Four

Ecosystem Enhancement Program Project Number 000412

Submitted: February 17, 2009

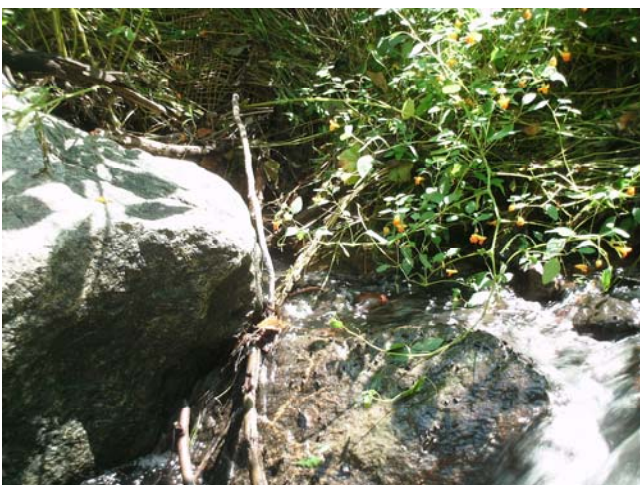
MCPA1 facing right bank

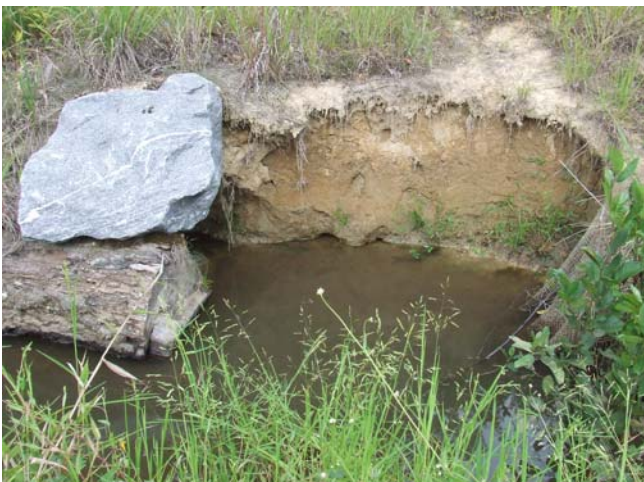
MCPA7 facing right bank (9/12/07)

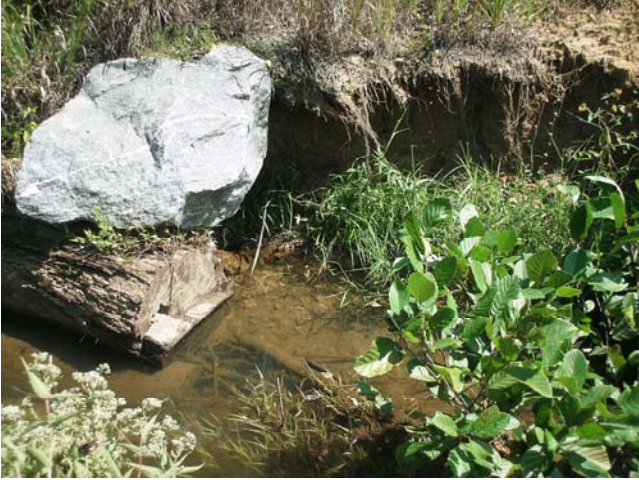
MCPA10 facing right bank

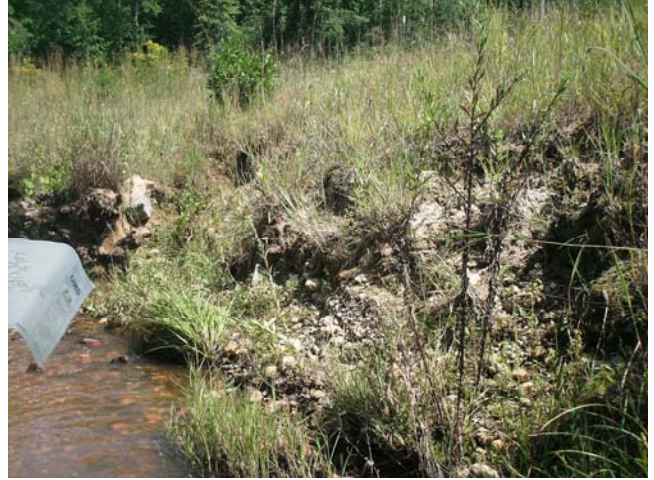
MCPA11 facing right bank

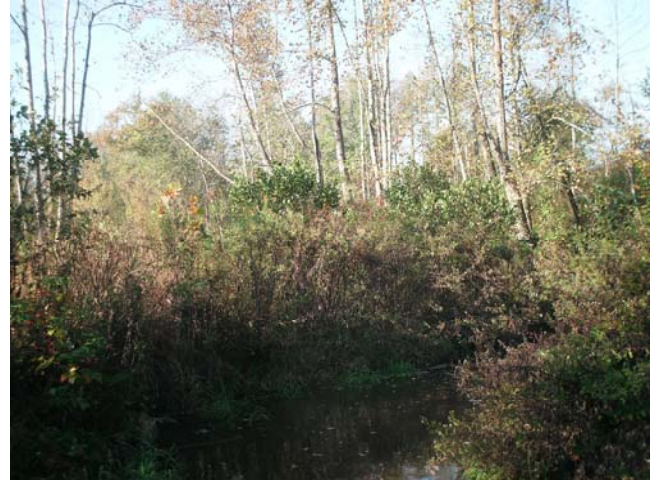
PS32 facing upstream

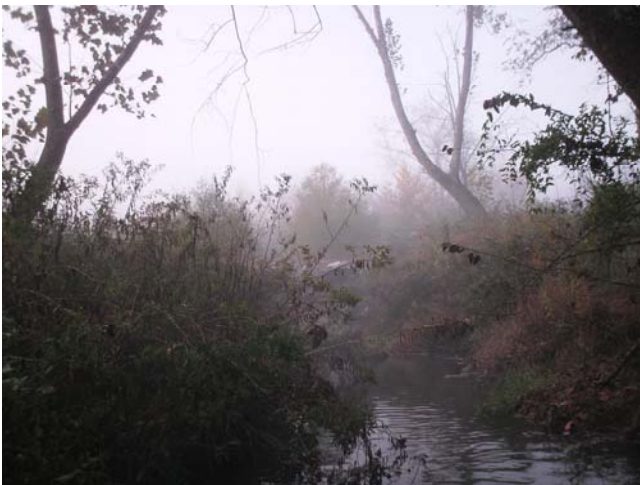
PS33 facing upstream
