**WELLS CREEK
FINAL MONITORING REPORT
YEAR 2 OF 5
2006**

EEP Project # 414
Alamance County, North Carolina

1025 Wade Avenue
Raleigh, NC 27605
Phone: (919)789-9977
Project Manager:
Phillip Todd
ptodd@sepiengineering.com

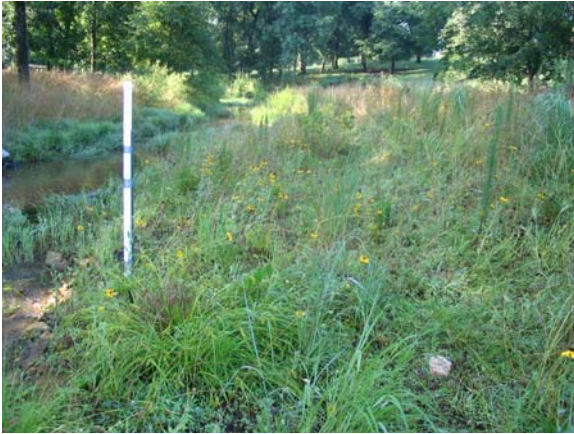
Photo 1: Reach 1 Japanese Grass Right Bank

Table VI. Vegetative Problem Areas			
Feature/Issue	Station # / Range	Probable Cause	Photo #
Bare Flood Plain	UT - Station 11+80	area washed from storm events	6
	UT - Station 12+50	area washed from storm events	5
	UT - Station 14+20	area washed from storm events	4
	UT - Station 18+50	area washed from storm events	2
Invasive/Exotic Populations	Reach 1 - Station # 20+50 Lt	Japanese grass overtaking area - from off site	8
	Reach 1 - down from Crest Gauge	Japanese grass overtaking area - from off site	1
	Reach 2 - Station #11-13	Japanese grass overtaking area - from off site	7

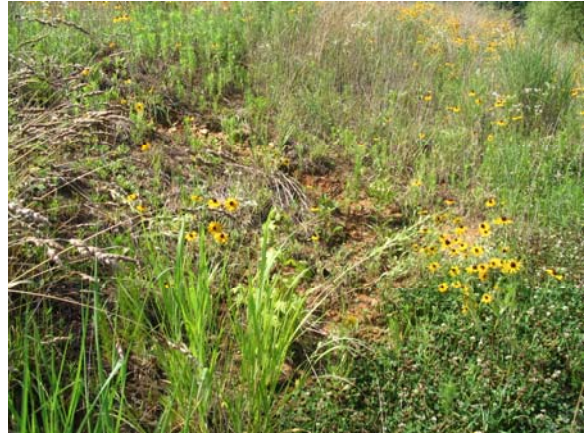
Photo 4: UT 14+20 Left Bank barren terrace

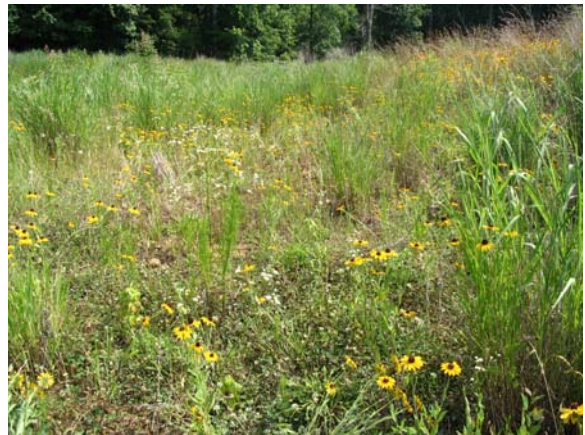
Photo 5: UT 12+50 Left Bank barren terrace

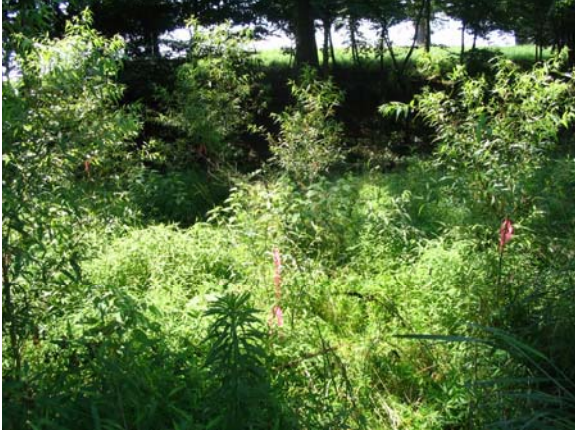
Photo 7: Japanese grass

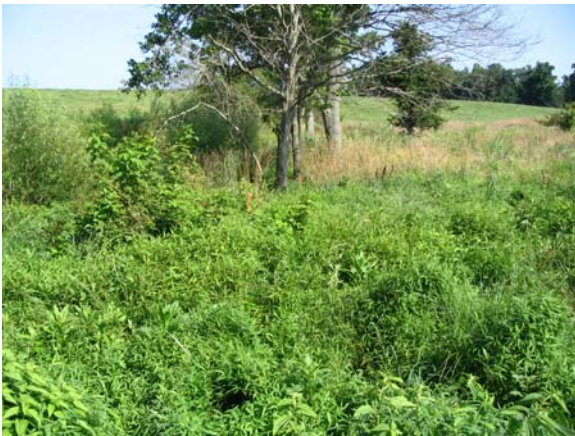
Photo 8: Japanese grass

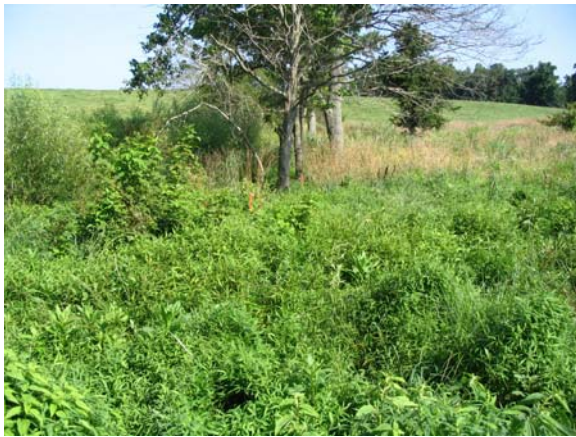
Vegetation Plot 3

There are also extensive stands of Japanese grass (*Microstegium vimenium*) in all of the monitored reaches. This grass is very prevalent in Vegetation Plot (VP) #3 and #7 with some of the grass in VP #5. The grass is likely impeding bare root growth in VP #3; however, it is not affecting the growth of trees in VP #7. The largest areas of the grass are noted on the plan view sheets in Appendix C.
