**WELLS CREEK
FINAL MONITORING REPORT
YEAR 3 OF 5
2007**

EEP Project # 414
Alamance County, North Carolina

1025 Wade Avenue
Raleigh, NC 27605
Phone: (919)789-9977
Project Manager:
Phillip Todd
ptodd@sepiengineering.com

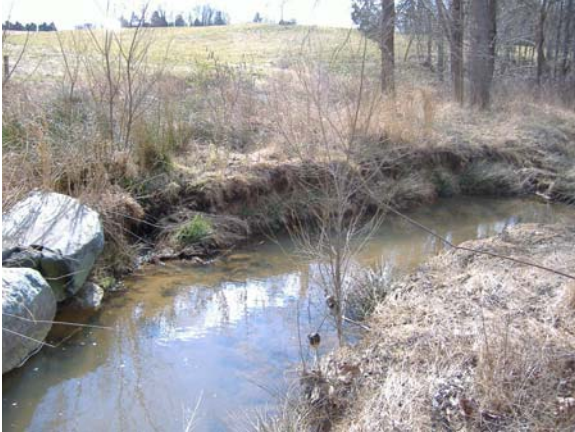
Photo 1: Bank Erosion (Station 10+20 along plan view).

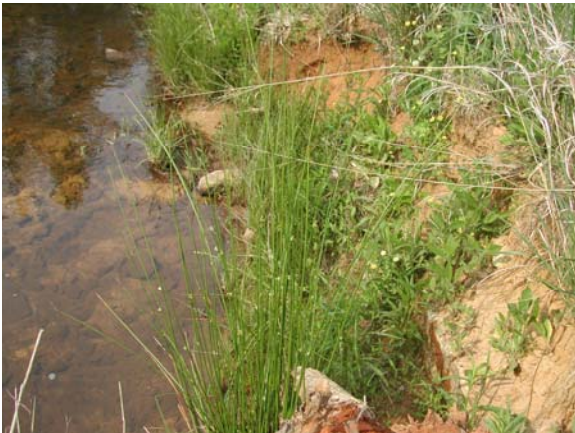
Photo 2: Bank erosion

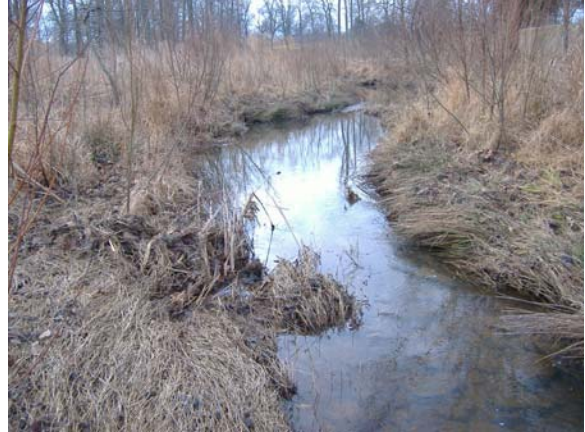
Photo 2: Representative cattail aggradation problem area (18+63.51 along plan view).

18+25.08		
Aggradation (cattails)	18+63.51	Channel too wide; narrowing to a stable dimension	Photo 2
	18+68.58		
Aggradation (grass)	19+06.73	Channel built too wide; narrowing to a stable dimension	Photo 1
	19+20.77		
Aggradation (grass)	19+69.79	Channel built too wide; narrowing to a stable dimension	
	19+82.28		
Aggradation (grass)	19+96.65	Channel built too wide; narrowing to a stable dimension	
	20+05.09		
Aggradation (grass)	21+55.88	Channel built too wide; narrowing to a stable dimension	
	21+65.65		
Central Bar	21+65.65	Deposition from upstream sediment sources.	
	21+76.54

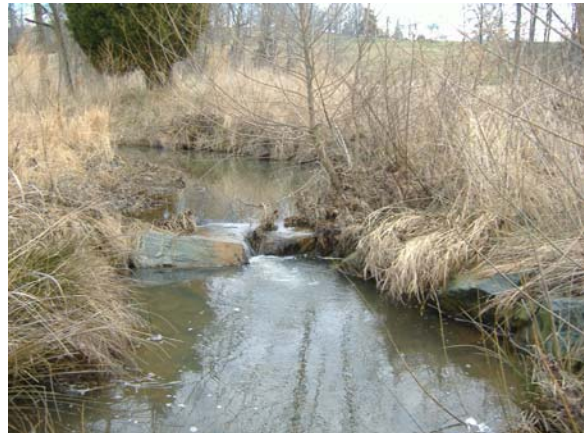
Photo 4: Representative problem cross vane (12+75.47 along plan view).
