**WELLS CREEK
FINAL MONITORING REPORT
YEAR 4
2008**

EEP Project # 414
Alamance County, North Carolina

Original Design Firm:
ARCADIS G&M of North Carolina, Inc.
801 Corporate Center Drive, Suite 300
Raleigh, NC 27607

Monitoring Firm:

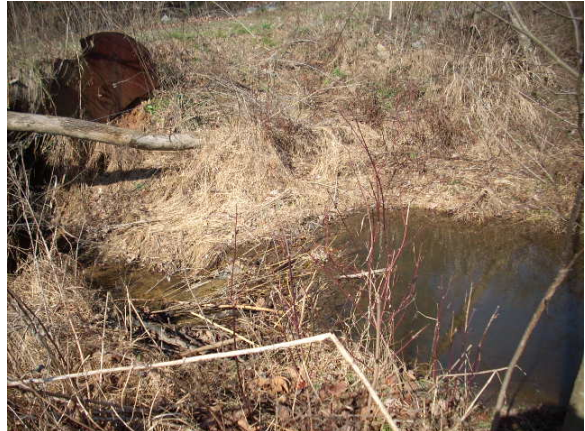
Photo 4: Representative beaver dam problem area (Station No. 12+59; view downstream; 2-25-2008).
