Whittier Creek Mitigation Project

Year 2 (2023) Monitoring Report

Surry County, North Carolina

DMS Project ID No. 100020

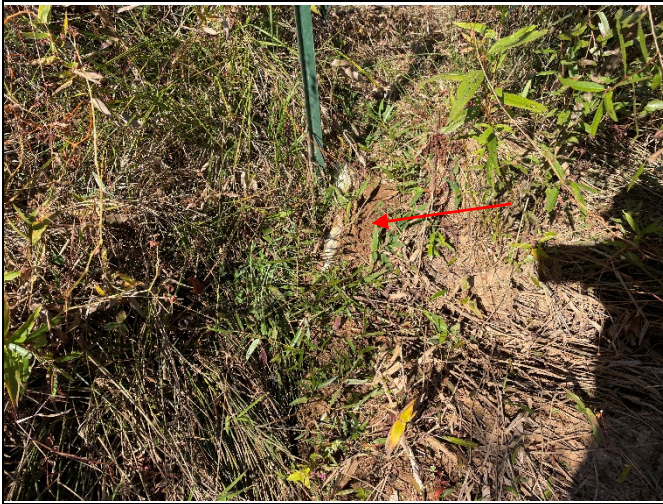
R7 Overbank Event Evidence (10/25/2023)

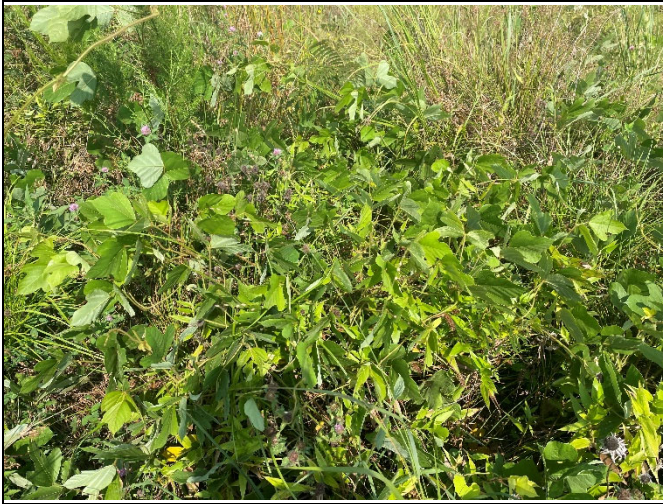
Kudzu growing along R7 (8/22/2023)
