Wolf Pond Stream Restoration Project Annual Monitoring Report

Monitoring Year: 2009

Monitoring Year: 2

NCEEP Project Number: D 06054-B

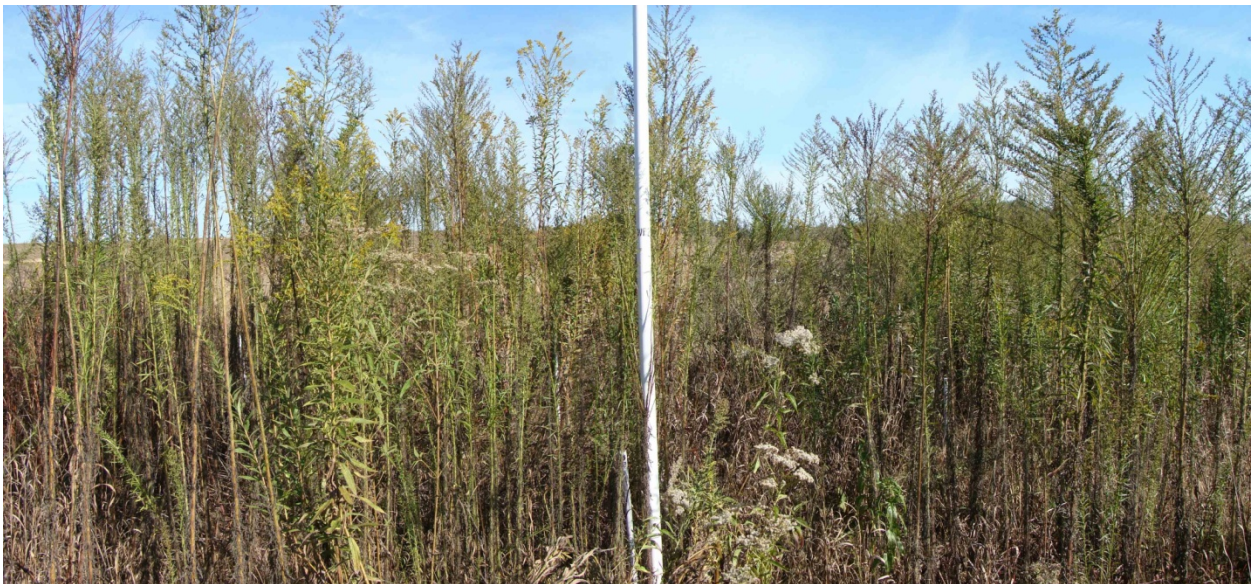
Photo D 2 - Vegetation Plot WP2

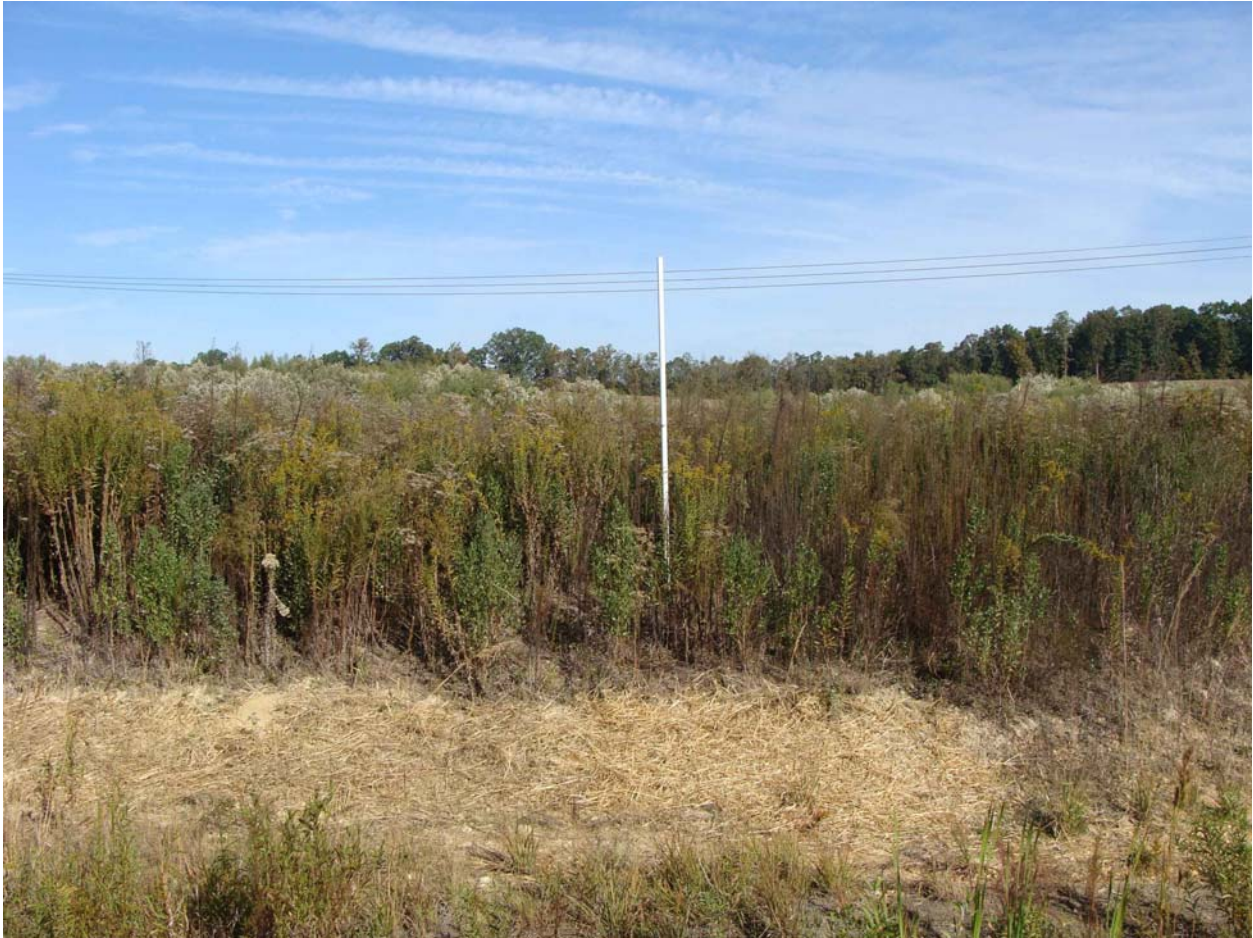
Photo D 3 - Vegetation Plot WP3

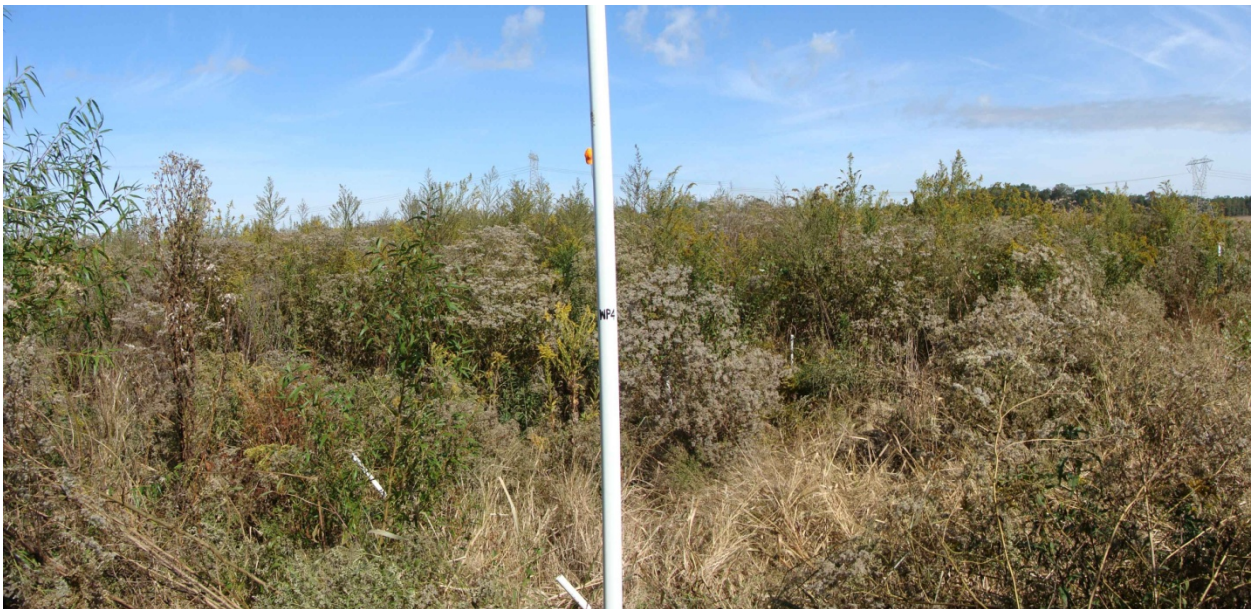
Photo D 4 - Vegetation Plot WP4

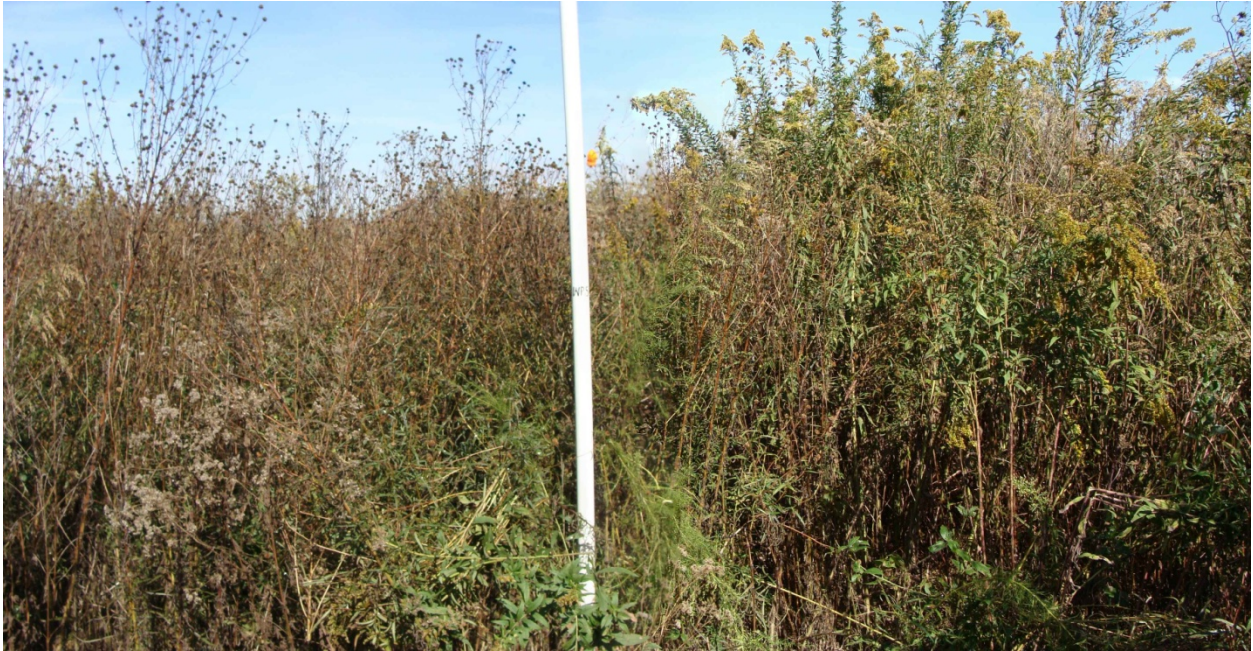
Photo D 5 - Vegetation Plot WP5
