MONITORING YEAR 3 ANNUAL REPORT FINAL

WYANT LANDS MITIGATION SITE

WYANT LANDS MITIGATION SITE
Monitoring Year 3 Annual Report

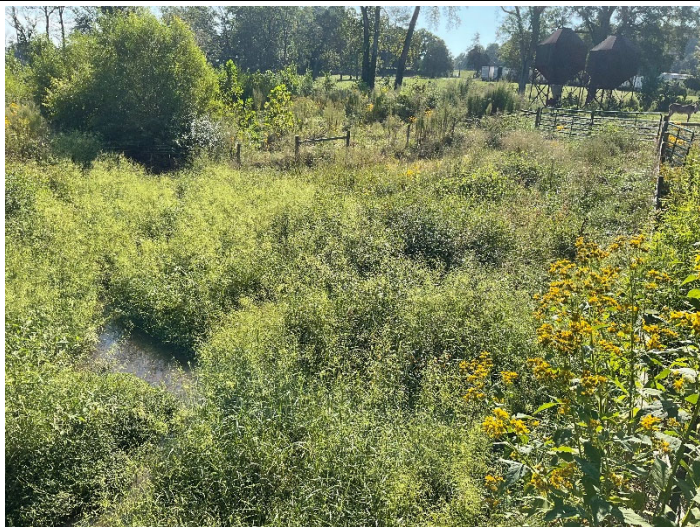
Wyant Creek R3 – Ford Crossing Vegetation Cover (9/19/2023)
