Zacks Fork Creek Stream Restoration Monitoring Report

Monitoring Year: 2008
Measurement Year: 3
As-Built Date: 2005
NCEEP Project #: AW03003A

Submitted on December 17, 2008
Revised on February 4, 2009

Prepared by: Environmental Services, Inc.
524 S. New Hope Road
Raleigh, NC 27610

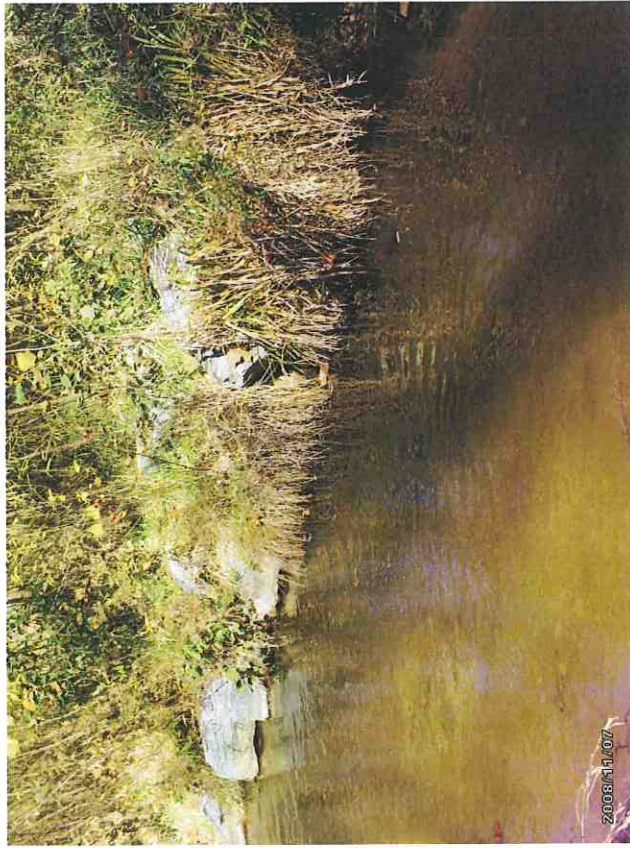
Photo Station 21

The Year-3 assessment of vegetation indicates continued success in the establishment of both planted and indigenous vegetation. There is evidence of beaver herbivory in the middle and lower reaches. An ancillary effort of selective spraying of wild rose was undertaken in the summer and appears to have been partially effective at suppressing this invasive species.

Feature/Issue	Station#/Range	Probable Cause	Photo #
Herbivory	25+00 – 36+00	Beaver activity	21

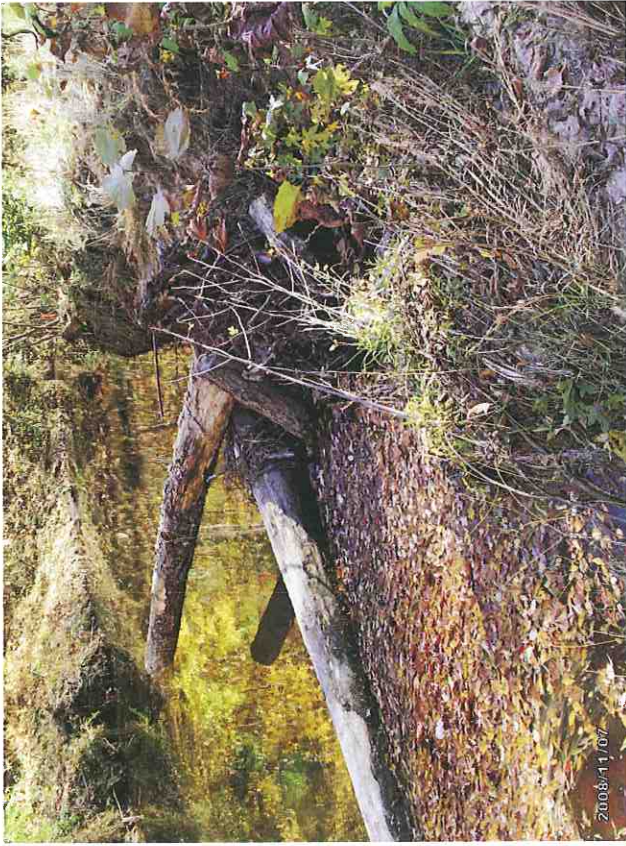
Problem Area 9 - log vane displaced
