Aluminum Box Culverts with Bottoms Review

North Carolina Department of Environment and Natural Resources

Division of Water Quality

February 2012

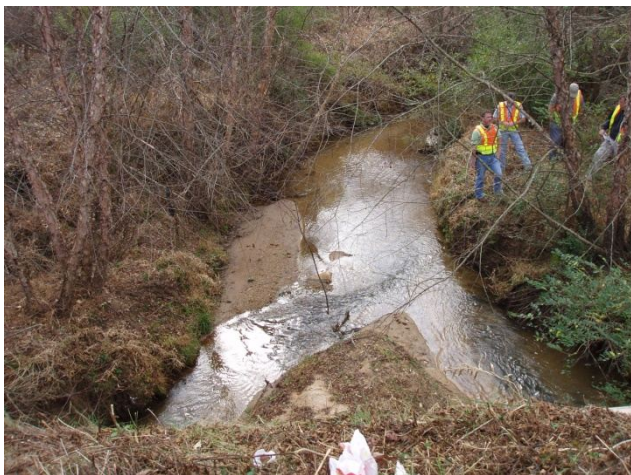
Downstream of structure

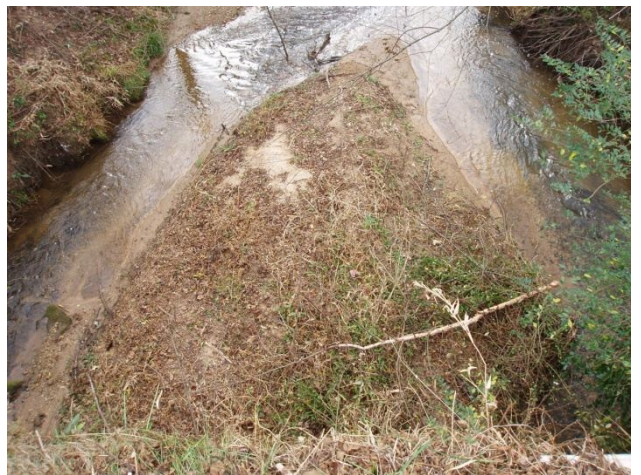
Downstream of structure

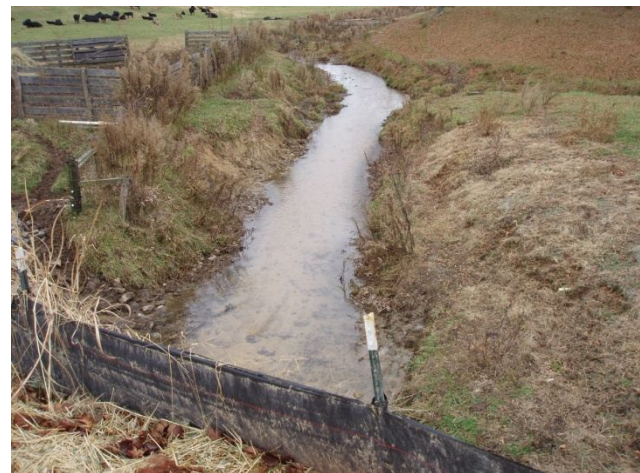
All four quadrants of the structure were actively being used as cattle pasture. The areas are not fenced off from the stream, so cattle have and do access the stream regularly. As a result, many areas of the banks are unstable and being used as access areas. There is an area on the downstream left bank that shows signs of erosion. No scour was noted at the headwalls of the structure. There was a floodplain, but it would only be accessible at higher flows.

Downstream of structure

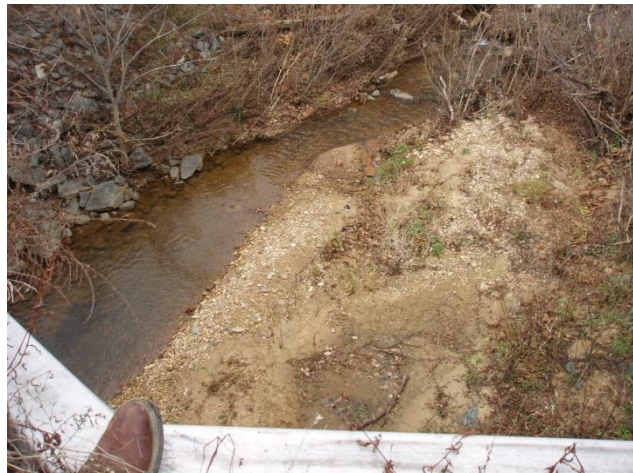
Downstream of structure

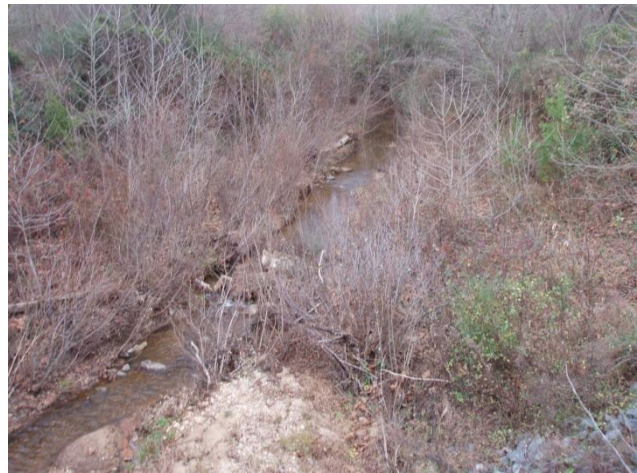
Downstream of structure

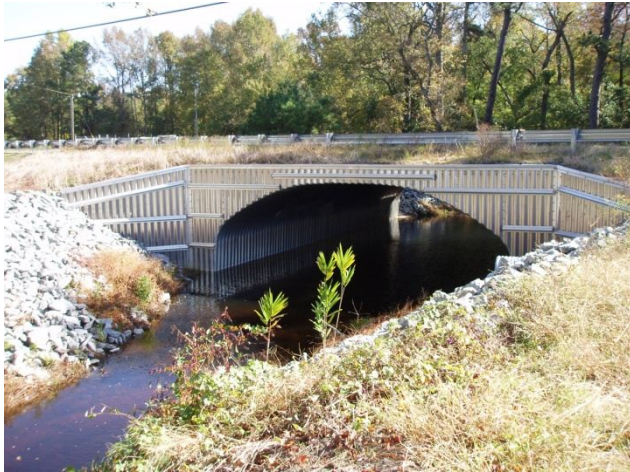
Downstream of structure

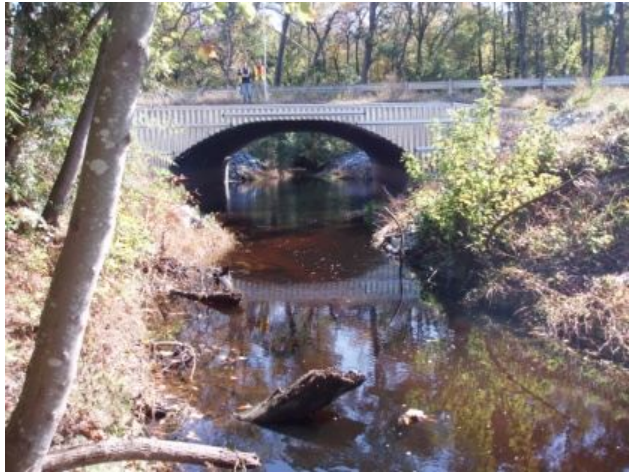
Downstream of structure

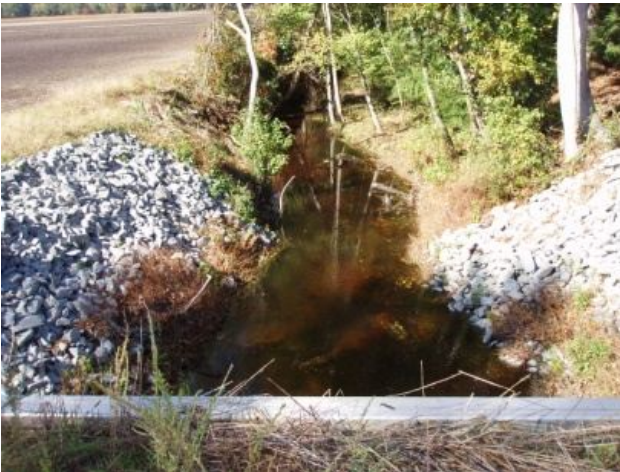
Downstream of structure
